Central City Asset Assessment Report

Condition Assessment of Horizontal Infrastructure within the Central City

Investigation Report

Date: 11th May 2012

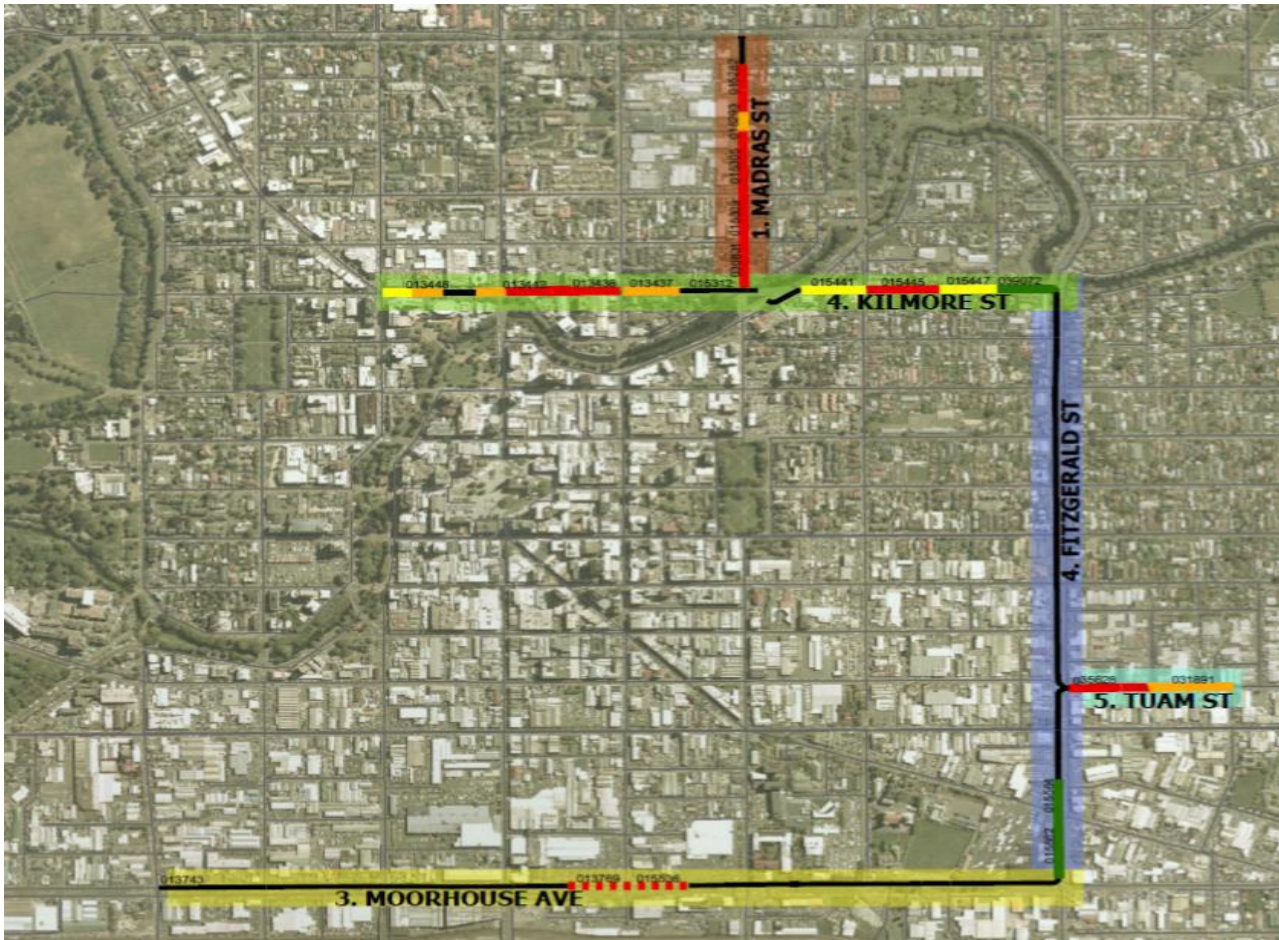
Figure 3 Central City Wastewater Brick Barrel Sewers Damage Synopsis (at Nov 2011)

Figure 3 below indicates the damage assessed for the Madras St, Kilmore St and Tuam St sewers with red indicating sewers in critical condition and orange those with a risk of failure within 2 years.

- 40% of the brick barrel sewers (red legend) CCTV surveyed have suffered obvious and visible structural failures and a further 40% show signs of earthquake damage which will probably cause structural failures or loss of service within 2 years, unless remedial action is taken,
- Lack of serviceability is significant due to infiltration of liquefaction silts
- Aggressive cleaning of brick barrel sewers through contracting activity² has been seen to exacerbate damage through removing grout in brick crowns for example, weakening structural integrity

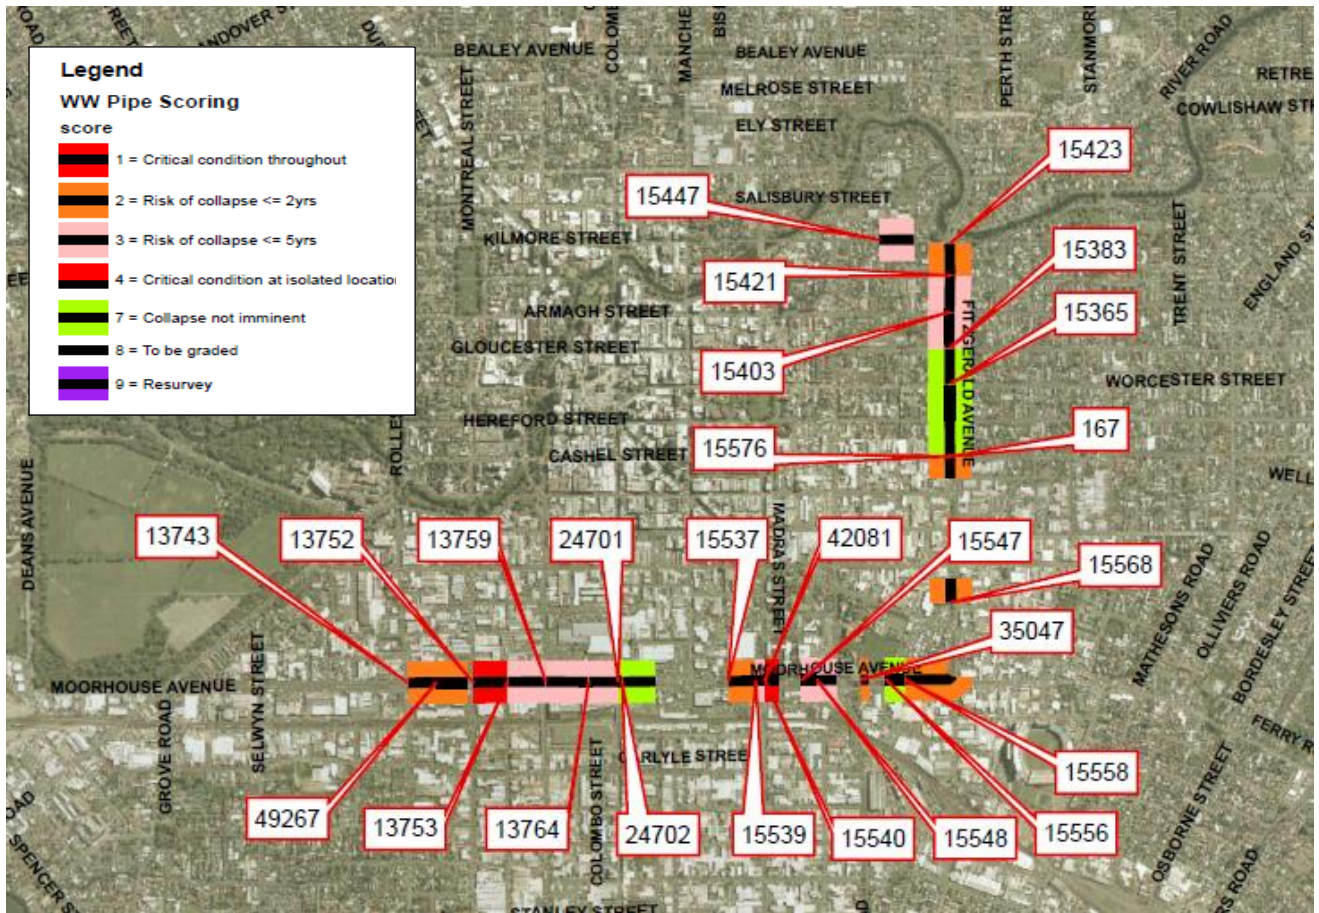
Figure 4 Central City Wastewater Brick Barrel Sewers Damage Synopsis (at May 2012)

This assessment of these sewers has found that although nearly all Brick Barrels have visible signs of earthquake damage, their potential risk of failure is less than the Tuam, Kilmore and Madras sewers, and are hence damaged to a lesser extent.

The wastewater brick barrel structures are being prioritised in view of the criticality these structures provide in sustaining the trunk network operation. Lining of the brick barrel sewers using Cured in Place Pipe (CIPP) has been identified as the preferred method of rehabilitation.

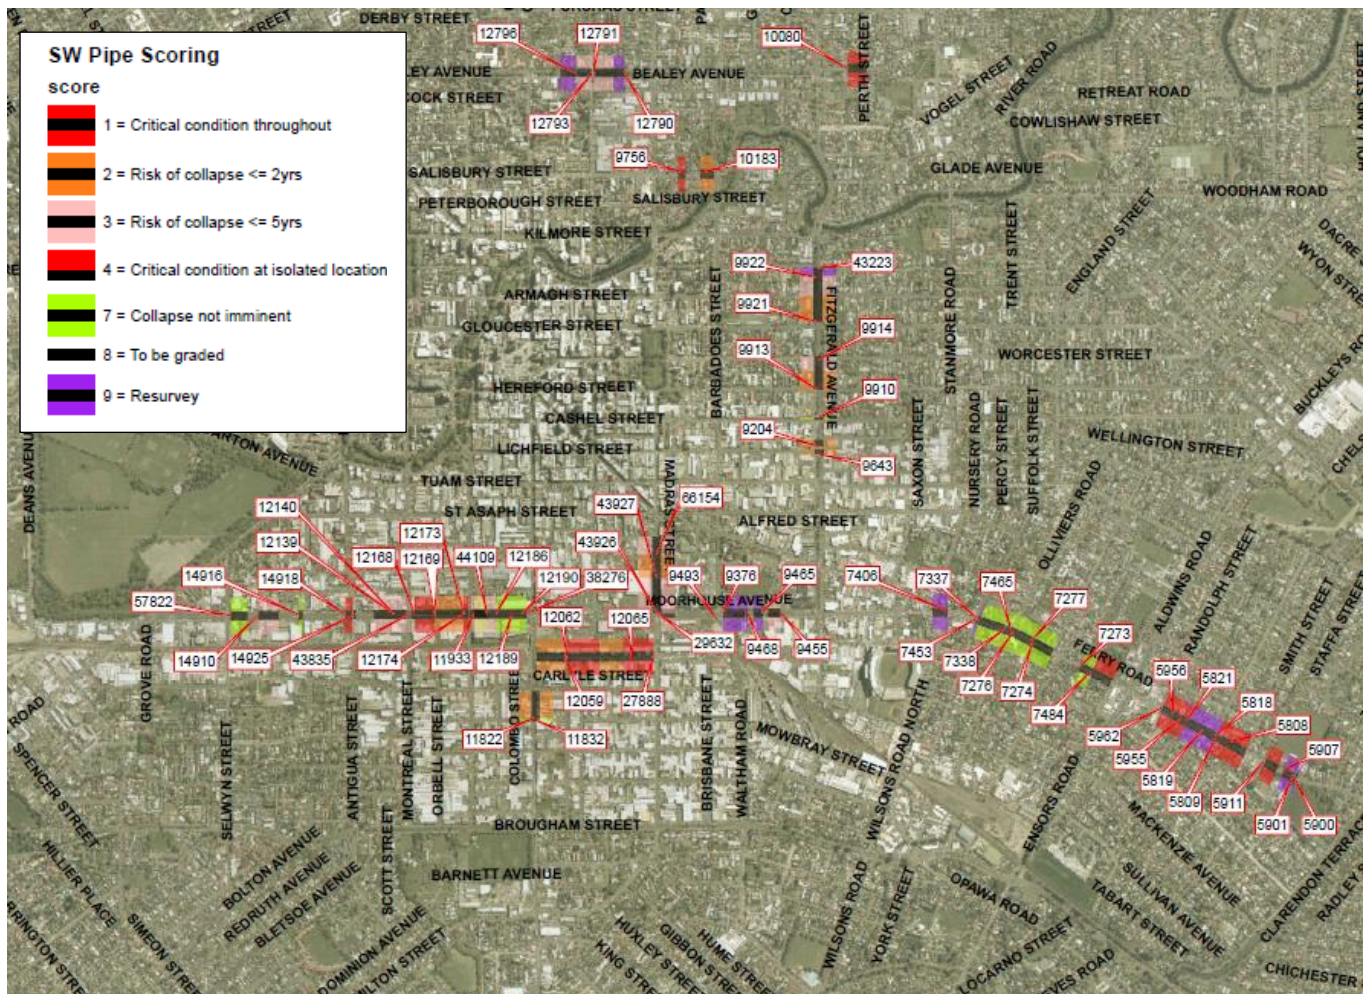
Figure 5 Central City Stormwater Brick Barrel Sewers Damage Synopsis (at May 2012)

Similar to, and to a greater extent than the wastewater network, the lack of serviceability is significant due to infiltration of liquefaction silts. The aggressive cleaning of brick barrel sewers has been seen to exacerbate damage, weakening structural integrity.

The storm water brick barrel structures are being prioritised in view of the criticality these structures provide in sustaining the trunk network operation. Lining of the brick barrel sewers using Cured in Place Pipe (CIPP) has been identified as the preferred method of rehabilitation.

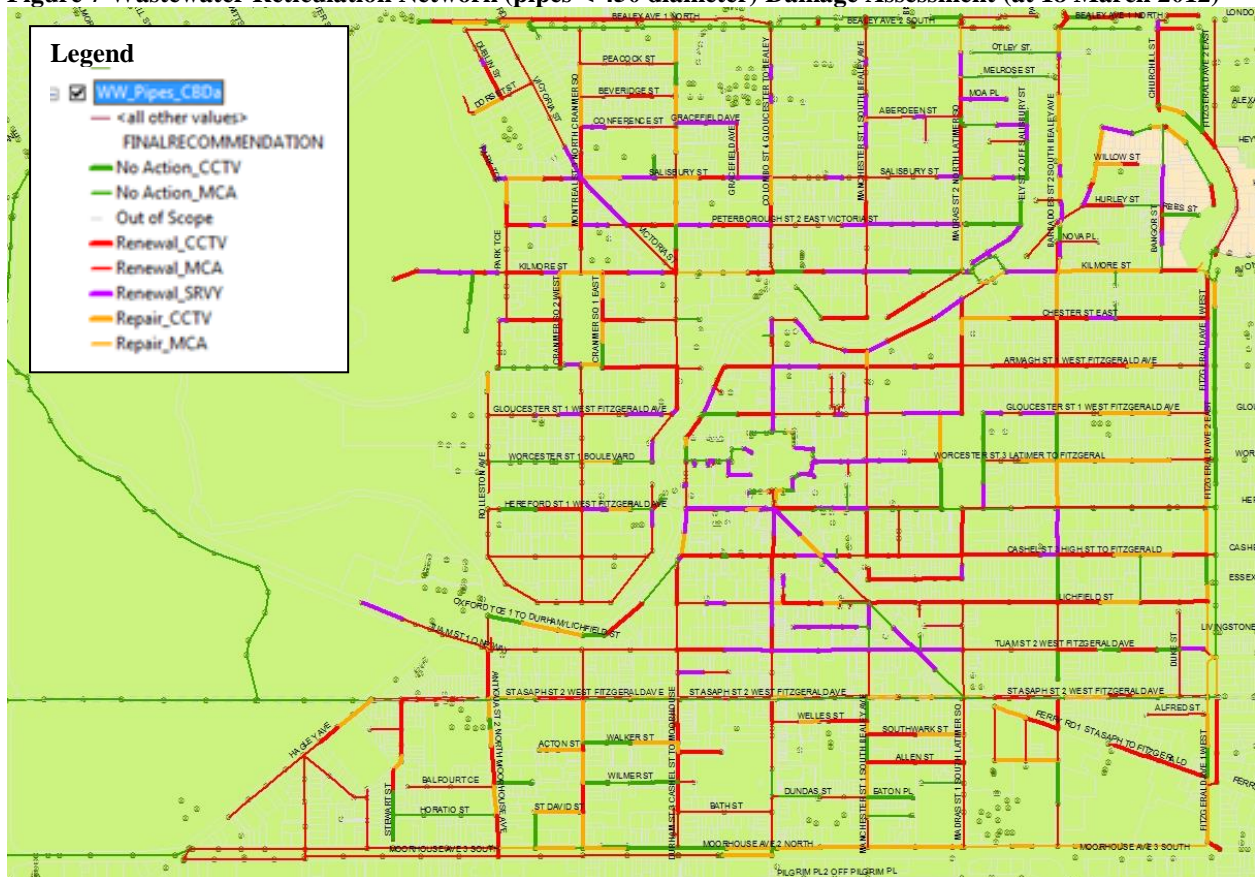
Figure 7 Wastewater Reticulation Network (pipes < 450 diameter) Damage Assessment (at 18 March 2012)

- Combining the CCTV, Grade damage information and the MCA analysis results therefore gives a holistic view of predicted damage levels to the reticulation system and can be seen below in Figure 6.

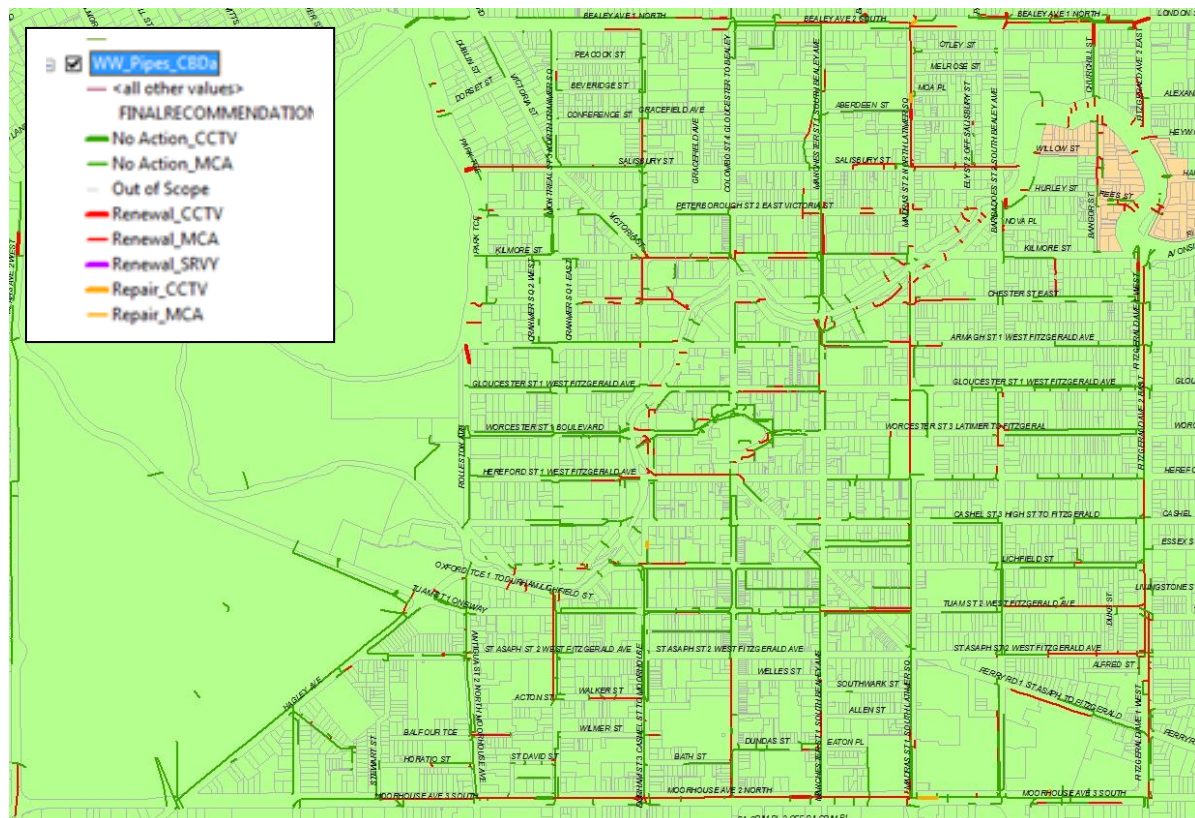
Figure 8 Stormwater Reticulation Network Damage Assessment (at 18 March 2012)

Minimal CCTV has been undertaken to date therefore all asset damage data has been assessed using the MCA tool. Levels of accuracy will then be confirmed through programmed CCTV surveys. It can be noted though that 75% of the network was constructed between 1970 and 2000 using RCRR pipework. The performance of which on the network has been satisfactory showing good resilience. Therefore much lower levels of repair and replacement are expected on the network, summarised below

- No flooding has been reported following rainfall experienced since the earthquake events.
- Localised surface ponding has been observed due to kerb & channel damage (slumping) caused by the ground settlement and liquefaction. Some of this damage may require addressing prior to the pavement renewal /rebuild work to resolve LOS issues to assist the redevelopment of the city, particularly in commercial areas.

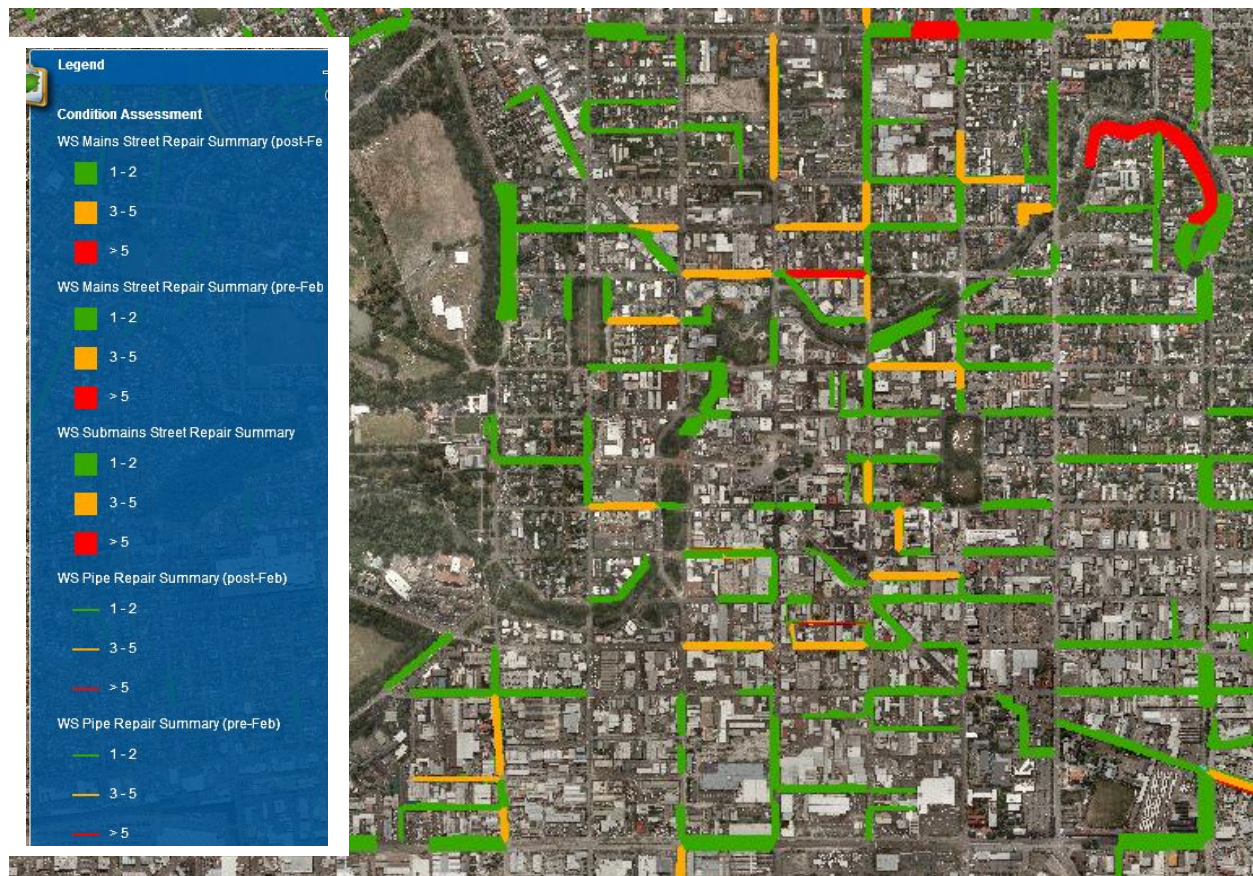
Figure 9 Water Supply Network Asset Repairs (based upon City Care CAM data, at 8 March 2012)

Figure 9 has been developed from City Care CAM data with the number of breaks recorded on individual mains and sub mains. The CAM data used to populate Figure 7 is currently being validated as inaccuracies were identified during the initial emergency response period.

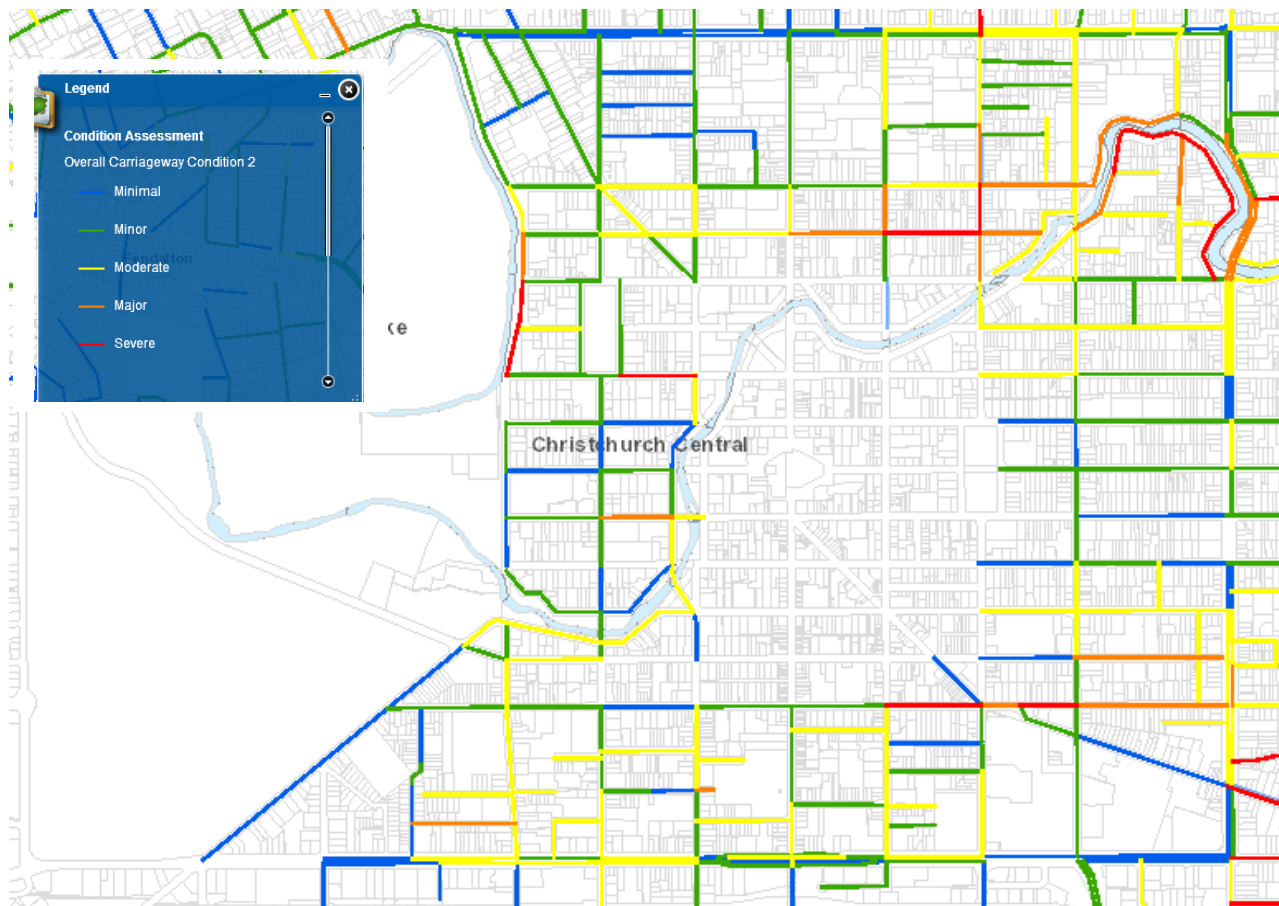
Figure 11 Road RAMM Condition Rating - Carriageways

cumulative score was then taken for each intersection to intersection length of road and ranged into an overall Condition Rating from 1 to 5 (1 being Minimal damage, 5 being Severe). The results of which can be seen in Figure 11 overleaf for the pavement assets.

- Major and severe damage levels generally follow liquefaction areas and the river course. Liquefaction intrusion into the sub base layers are expected where this is the case. As with other areas, liquefaction has travelled horizontally between layers, often contained by the top surface layer causing humps and hollows in the road.
- Cracking and differential settlement also caused damage to the pavement layers, particularly around the river and bridge approaches due to lateral spread.

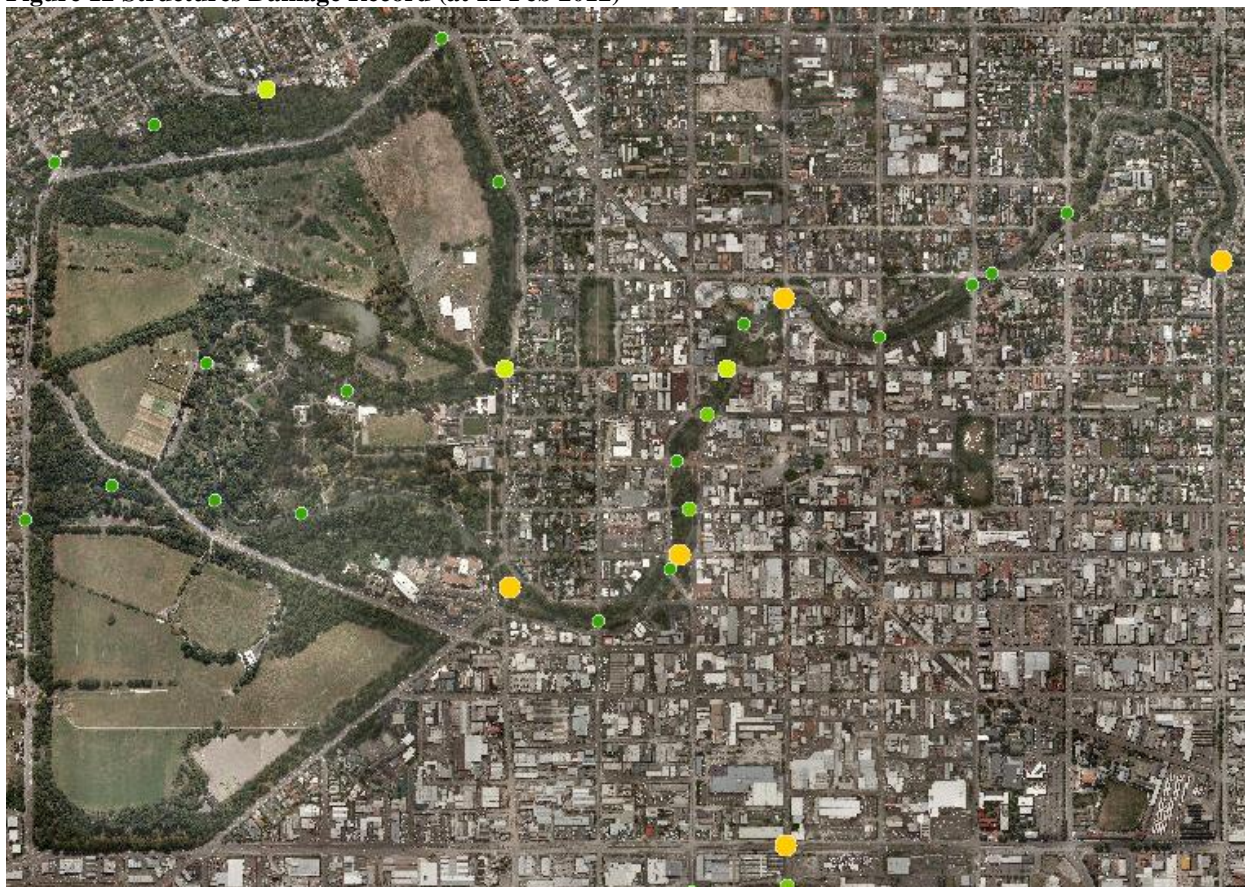
Figure 12 Structures Damage Record (at 12 Feb 2012)

Figure 12 shows the location and damage levels to the bridge structures. Green represents low levels of damage requiring minor repair works with yellow representing moderate to major refurbishment. Currently, only Antigua St footbridge and Fitzgerald Ave twin bridges are being reviewed with regard to replacement rather than repair.
