Lessons learned from one of New Zealand's most challenging civil engineering projects: rebuilding the earthquake damaged pipes, roads, bridges and retaining walls in the city of Christchurch 2011 - 2016.

New Zealand Geomechanics News Magazine June 2013 Article - Retaining Walls and Ground Improvements in Christchurch

Retaining Walls and Ground Improvement in Christchurch – General

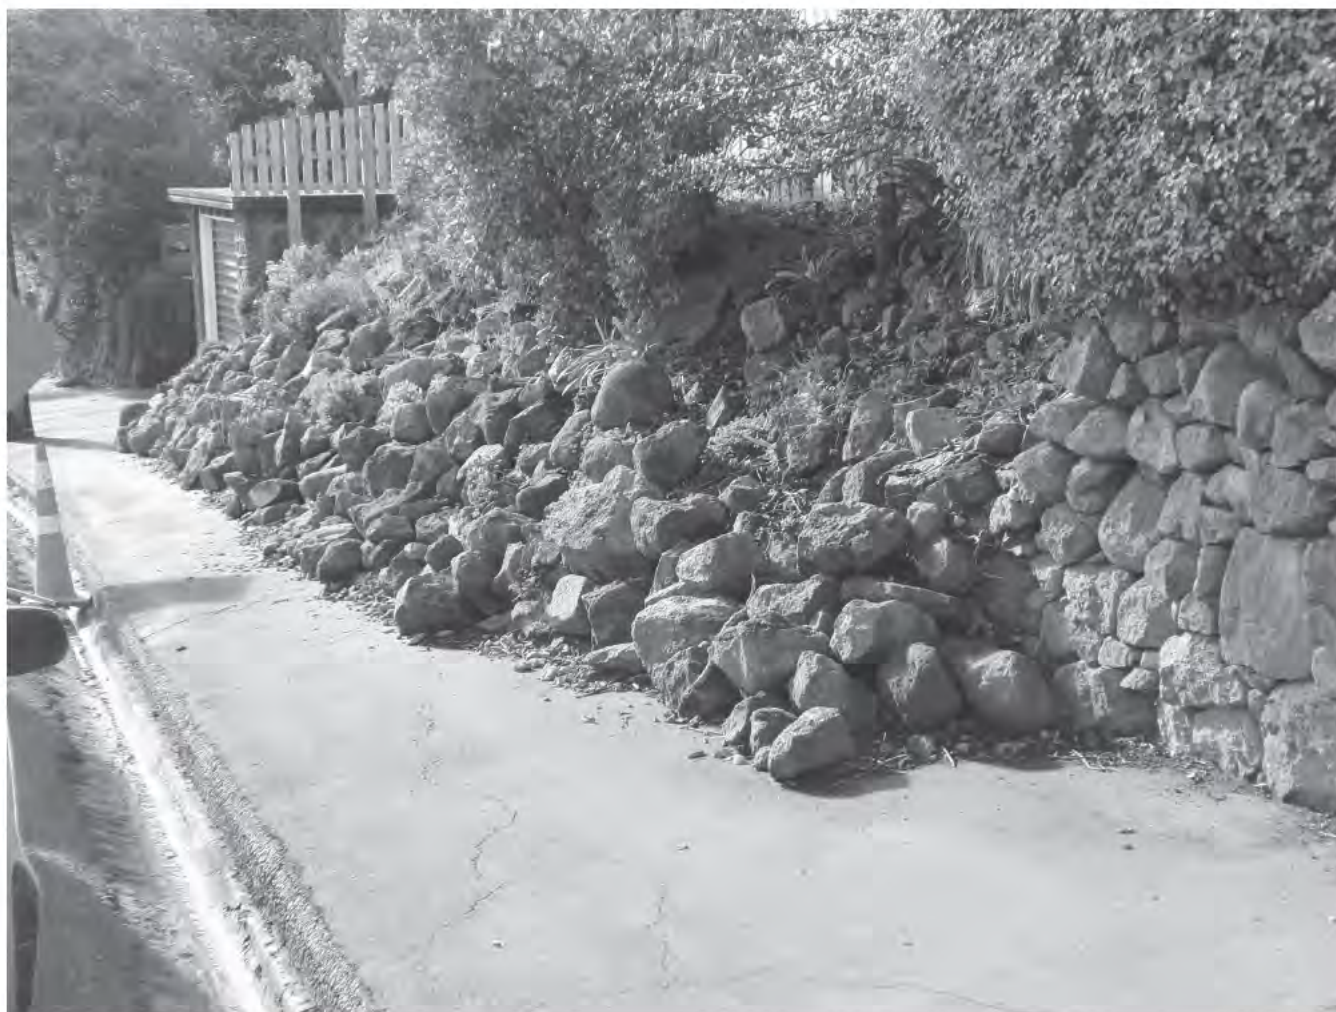
Photograph 1 shows a stone wall which has suffered collapse over the majority of its length, with a short section remaining virtually undamaged for some reason. This wall initially had very little mortar placed between the blocks. Significantly variable behaviour such as this is a common feature of these walls. It is difficult to provide conclusive explanations for this variance in behaviour, but factors such as vegetation, the direction and severity of accelerations,

Photograph 1: Collapsed Stone Block Wall

wall backslope, and the method of construction are all likely to have played a part in determining whether any given section of a stone wall has collapsed or not.

It appears from the above two examples that a cost effective measure of reducing the risk of complete collapse of stone block facing walls would be to point them.

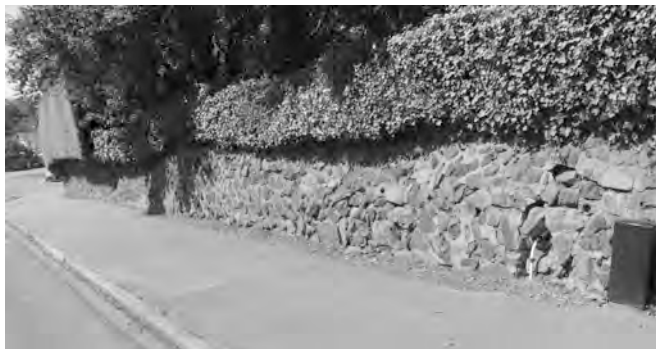
Photograph 2: Stone block wall with cracked “panels”

Photograph 2 shows another example of a stone wall but in contrast to that in Photograph 1, mortar has been placed between the blocks at some point. It can be seen that the recent earthquakes have caused the wall to crack into discrete “panels” but the wall has not suffered complete collapse.

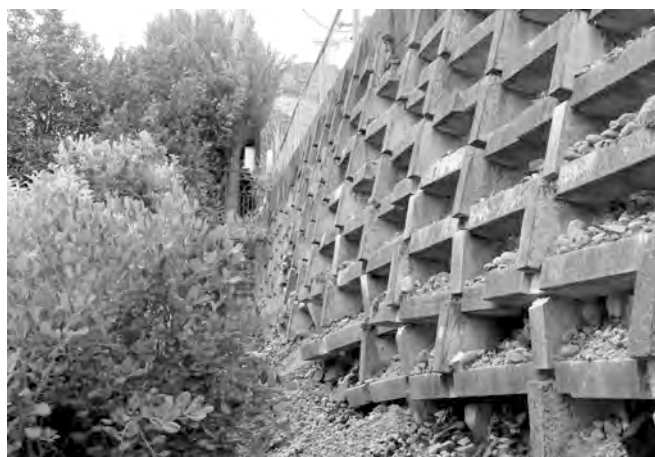
Similar to stone walls, the general performance of concrete crib walls has been extremely variable. Although the factors listed above all probably play a part in determining the degree of damage suffered, it appears from recent inspections that a key factor governing the resilience of concrete cribs is the degree of face vegetation which, crucially, seems to have held the infill stones in place. It is conceded that formal research testing this observation, has not been carried out and this is an impression based on a few inspections only. Nevertheless, it does appear to the authors that highly vegetated concrete crib walls have fared better. Photographs 3 and 4 below show examples of these two types of behaviour.

Photograph 3: Unvegetated Crib – fill loss and collapse.

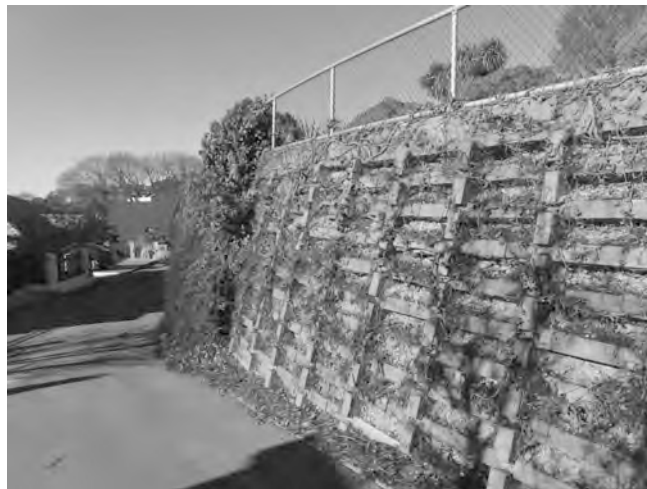
Photograph 4: Vegetated crib – fill intact & in good condition.

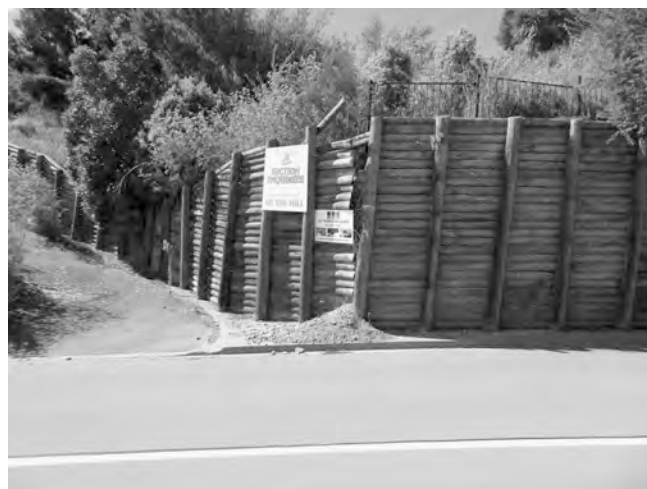
Timber pole walls have not fared well on outside corners (see Photograph 5)

Photograph 5: Timber pole wall – damaged corner section

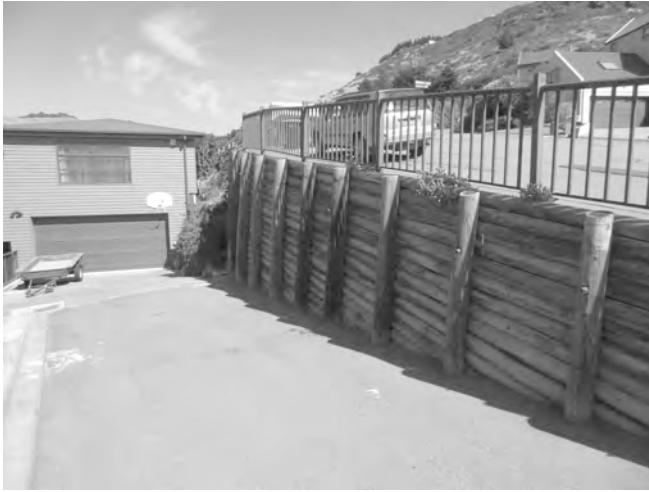
The flexibility of timber pole walls appears to have reduced damage to the wall itself but the footway and road behind have suffered subsidence and cracking due to the high degree of seismic movement.

Photograph 6: Intact timber pole wall with cracked road behind

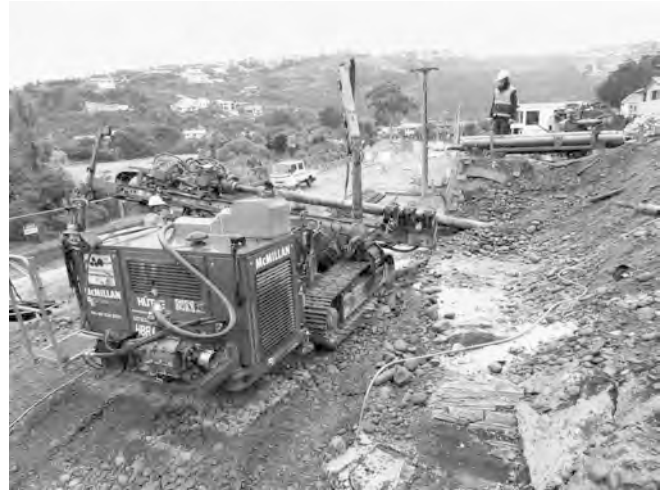
Photograph 7: Anchor Installation at Maffey's Road

All the anchors for Maffey's Road Retaining Wall were installed and bonded 5m in rock. The distance to rock varied across the site and anchors were installed through Loess or soft organic silt soils for a distance of between zero and 15m.

All anchors were subject to acceptance testing to 150% of the design working load. At Maffey's Road, where the anchors were bonded about 5m into rock, the measured extension was typically between 2mm and 8mm, with all the anchors fixed directly into rock generally not extending more than about 3mm. All anchors at Maffey's Road passed acceptance testing.

Unexpected poor ground conditions meant that a number of anchors had to be drilled further than initially planned at Maffey's Road in order to create the desired bond in basalt. At Cunningham Terrace, installation was significantly easier in the loess but a longer bond length was required than for the Maffey's wall.

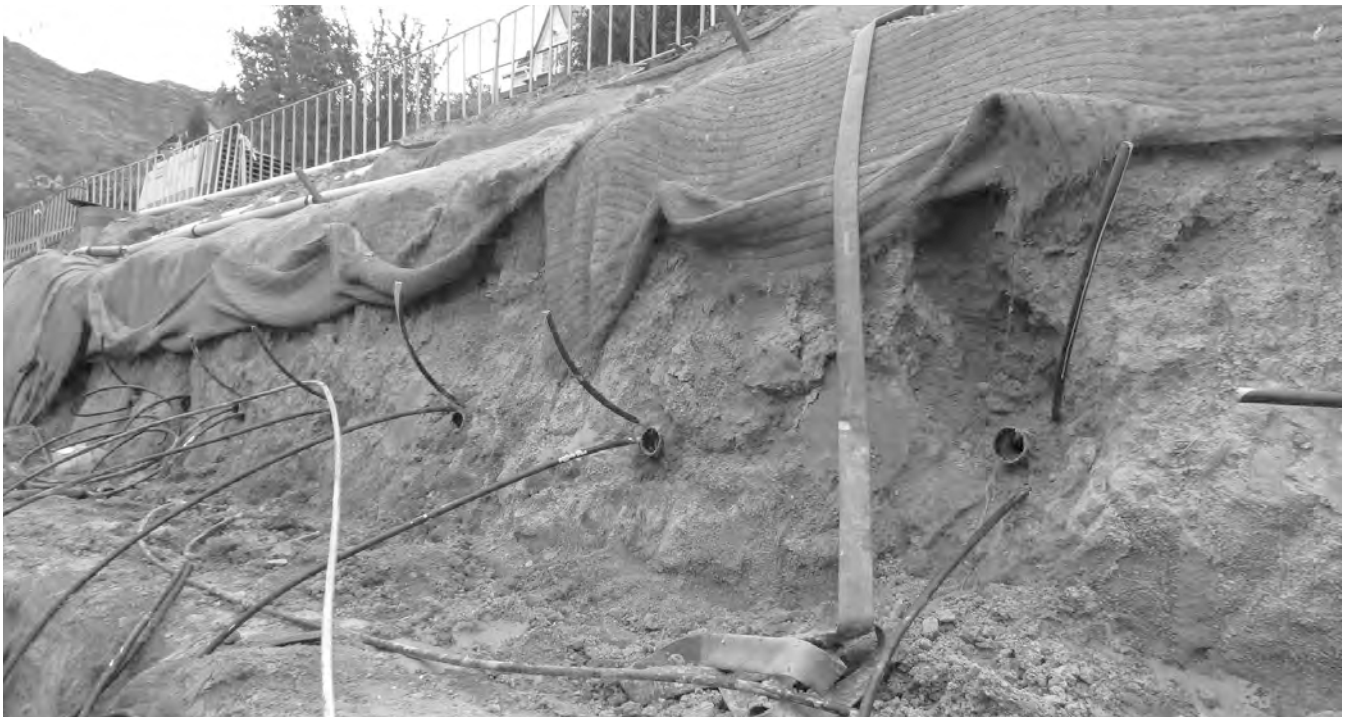
Photograph 8: Grouted Anchors at Cunningham Terrace

At Cunningham Terrace Retaining Wall rock was not encountered and all anchors were installed in Loess. The strength of Loess was variable across the site and the anchor lengths ranged from 6m to 15m.

At Cunningham Terrace initial testing cycles typically gave rise to extension of between 2mm and 15mm. The apparent free length was calculated for each load test and where the apparent free length was outside of acceptable

limits, as described in BS8081, further load cycles were carried out in order to ensure the anchor response was elastic. Approximately 30% of the anchors installed required retesting to ensure they were acceptable with 6% of anchors being replaced.

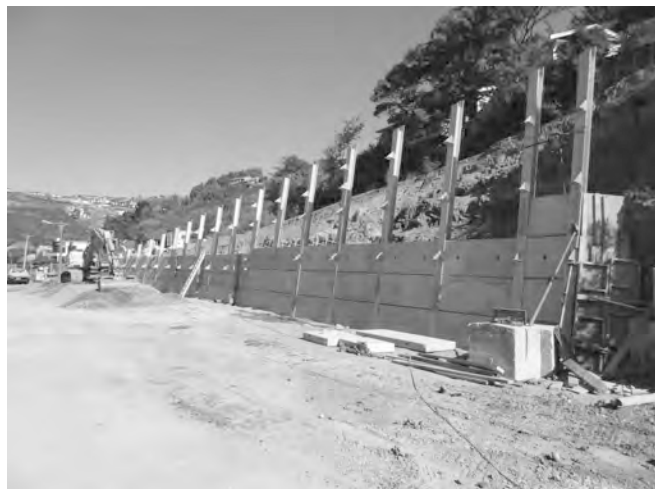
Photograph 9: Maffey's Road RW as at end of March 2013

Cunningham Terrace Retaining Wall and Maffey's Road Retaining Wall are being rebuilt as anchored king post walls. The design working load for the anchors of both walls was 100kN. These are distal plate anchors, comprising of a plate secured at the end of a 32mm bar, grouted within a 110mm diameter novacoil sheath. The bar is debonded from the grout to transfer the load to the distal plate. These prefabricated units were installed in 165mm diameter drill holes and grouted.

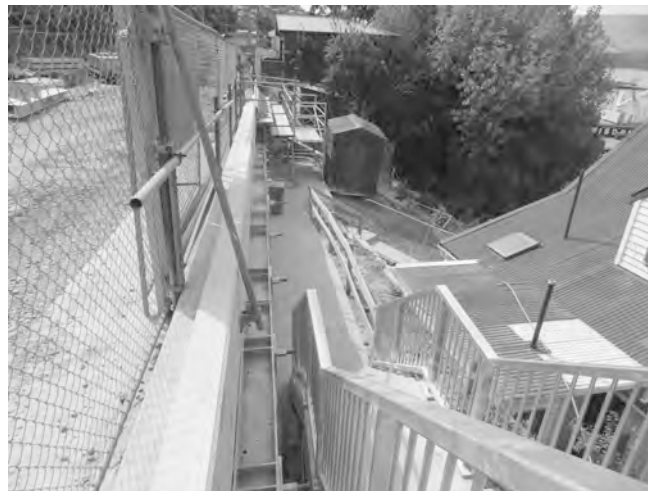
Photograph 10: Installed anchors and Waling at Cunningham Terrace

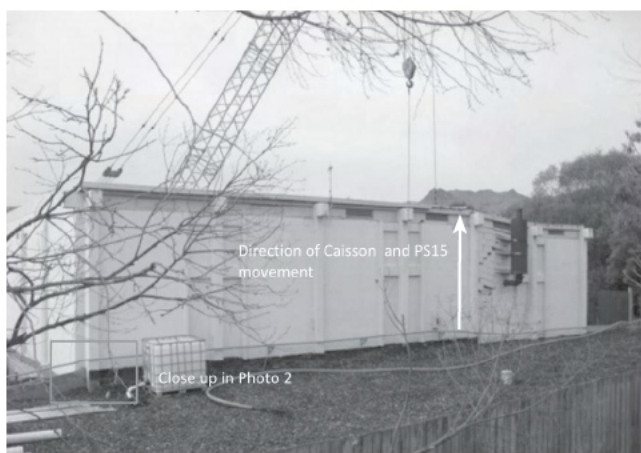
Photograph 11a: Pump station 15, note damage at right hand side of structure

co-operation between all the contractors. The ground improvement work is currently being completed under a design-build contract and at the time of writing was in the detailed design phase. The proposed design will see a grid of deep soil mixing (DSM) piles across the site with a ring around the caisson and particular focus being put on the prevention of floatation.

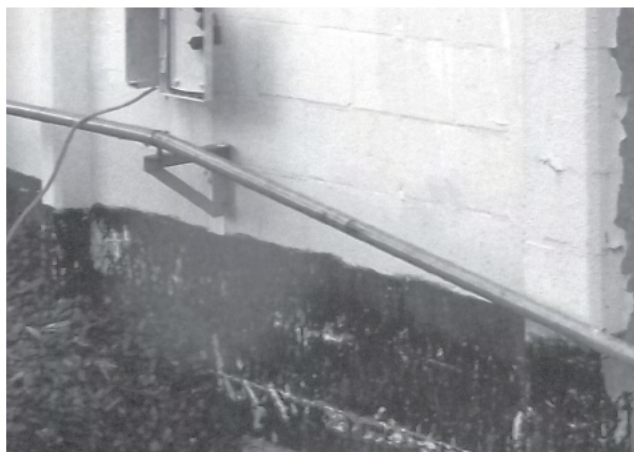
Photograph 11b: Damage due to floatation of Caisson

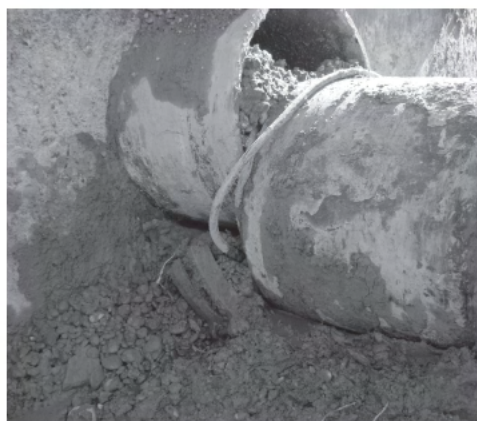
Photograph 11c: Damage to pipe connected to PS15 caisson

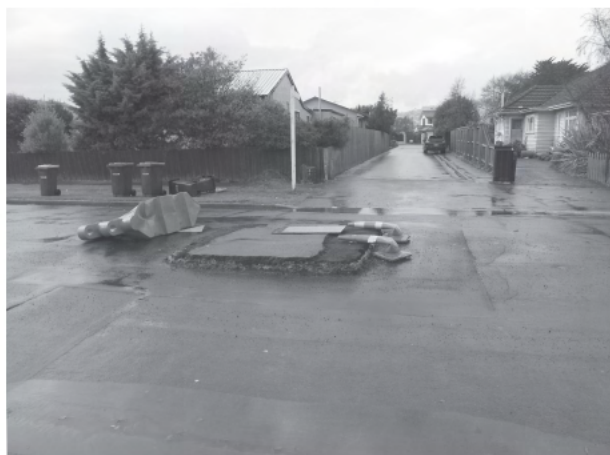
Photograph 11d: Floatation of manhole on street outside PS15
