Lessons learned from one of New Zealand's most challenging civil engineering projects: rebuilding the earthquake damaged pipes, roads, bridges and retaining walls in the city of Christchurch 2011 - 2016.

## Observed Earthquake Damage to Christchurch City Council Owned Retaining Walls and the Repair Solutions Developed

L. Kendal Riches<sup>1</sup>

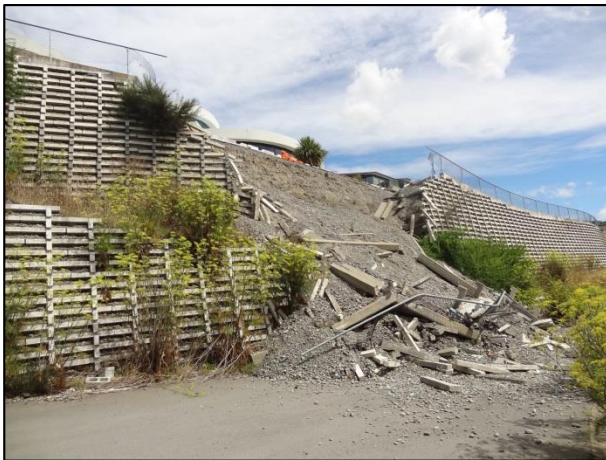
Crib walls developed a poor reputation because of the performance of some walls in the earthquakes. There is little holding the crib units together except gravity, so under vertical accelerations the crib units were able to shake apart and catastrophic collapse of these walls was not uncommon. An example is shown in Figure 1. Other walls were less damaged, but significant volumes of fill were lost from the wall and this reduced the stability of the structure as shown in Figure 2. The tendency to use rounded river run as fill for the walls was particularly detrimental because these rounded stones were easily mobilised during shaking and lost through the front of the wall.

Figure 1. An example of a collapsed crib wall

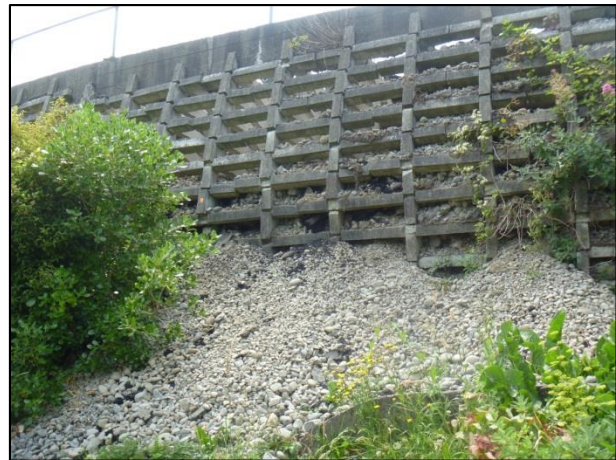
Figure 2. A crib wall showing bulging and loss of fill

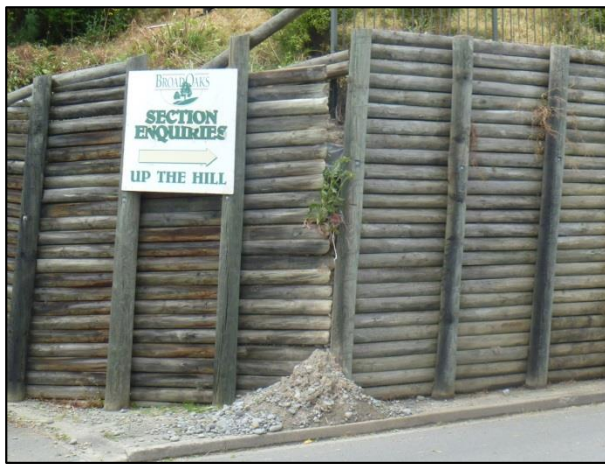
Both anchored and unanchored timber pole walls are common in Christchurch. The damage to these walls tended to be to individual elements or points of weakness. For example outside corners were often vulnerable, like the example shown in Figure 3, and lagging could pop out from behind the vertical poles. In other walls individual poles may splinter. However collapse of these walls was not routinely observed. One particular phenomenon was where anchors have small plates on the face of the timber poles and the shaking has caused the poles to move, but the anchors have remained in place. This often resulted in the anchor plate punching into the pole, as shown in Figure 4, or else the anchor head failing. Elsewhere walls may have deformed by moving forward during shaking and then the fill behind the wall has settled. This prevents the wall from returning to its original position and results in ground deformation behind the wall.

Figure 3. Damage to a vulnerable corner of a timber pole wall

Typically timber pole walls needed little repair and in some instances it was sufficient to replace damaged elements on a like for like basis. Where, for example, corner sections had been damaged additional poles or anchors were added.

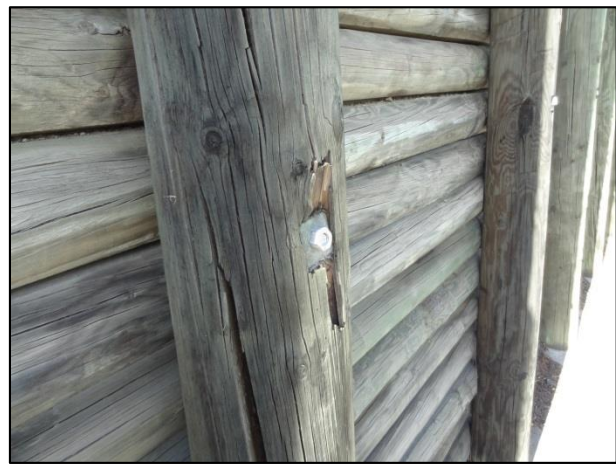
Figure 4. Damage around the anchor head of a timber pole wall

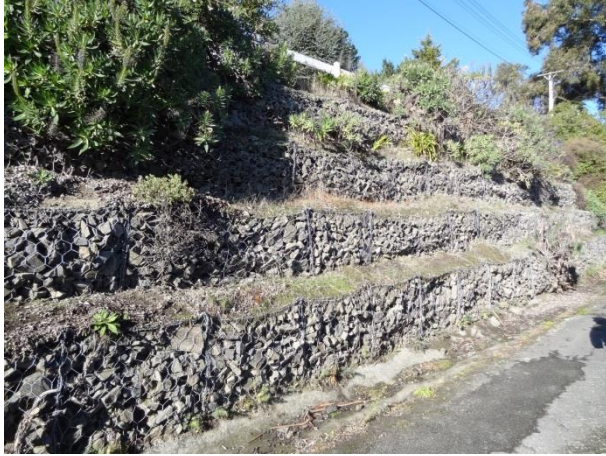
Gabion baskets are inherently flexible structures. Therefore during earthquake loading these walls tended to deform as can be seen in Figure 5. Generally baskets did not rupture and in the majority of cases the roads and infrastructure behind the walls remained serviceable, however deformation in both the wall a surface behind the wall could be considerable. Often where a road or footpath was above the wall, cracking could be observed in line with the back of the baskets. An example of this can be seen in Figure 6. Baskets filled with rounded river run or else loosely packed stone of any type often suffered greater deformation.

Figure 5. A badly deformed gabion wall

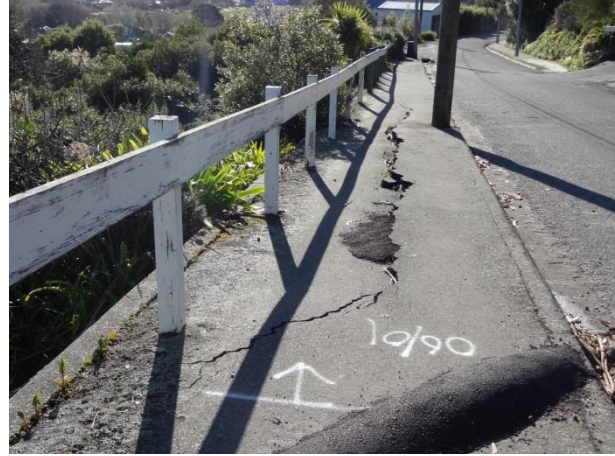
Figure 6. Footpath above a gabion wall showing cracking

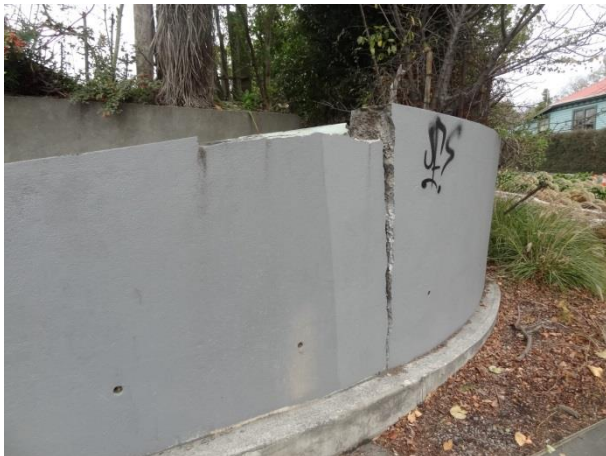
The performance of concrete walls could often be attributed to the pre-earthquake condition of the structure. For example a poorly reinforced or badly maintained wall would be more likely to be damaged. Cracking was usually at points of weakness and often resulted in excess rotation, rather than collapse as shown in Figure 7. One wall which performed well had been constructed as part of a hospital complex c.1900. Despite the age of the wall it showed no damage, except to a parapet which retained no fill. This parapet cracked as shown in Figure 8.

Figure 7. A typically damaged concrete retaining wall

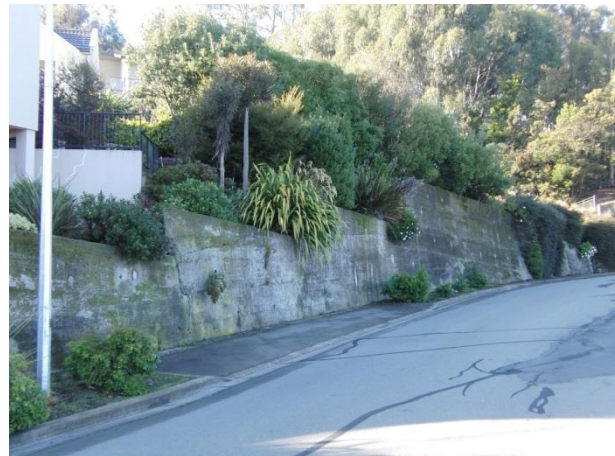
Figure 8. A concrete retaining wall c.1900 showing little damage

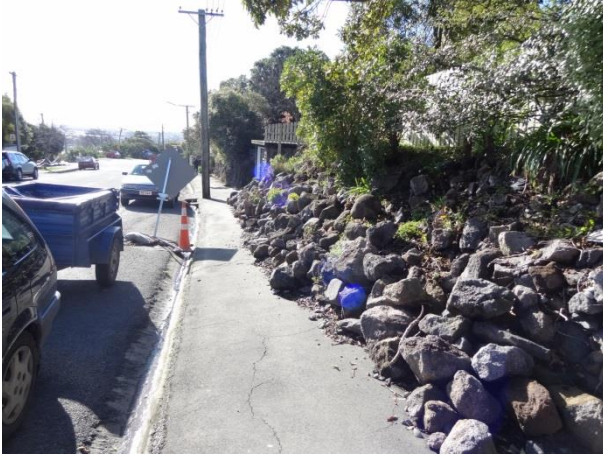
There are many stone walls in Christchurch. Typically these were at least 100 years old and were not engineered. It was not uncommon for these walls to have suffered complete collapse as

shown in Figure 9. In fact many of the stone walls act as a facing to protect the loess slope behind. So it was not uncommon that when the wall collapsed that the loess face remained stable. This can be seen at the top of the wall shown in Figure 10. While these walls were typically in the region of 100 years old, those which had been rebuilt more recently did perform better. This may be due to younger mortar having greater flexibility.

Figure 9. A completely collapsed stone wall

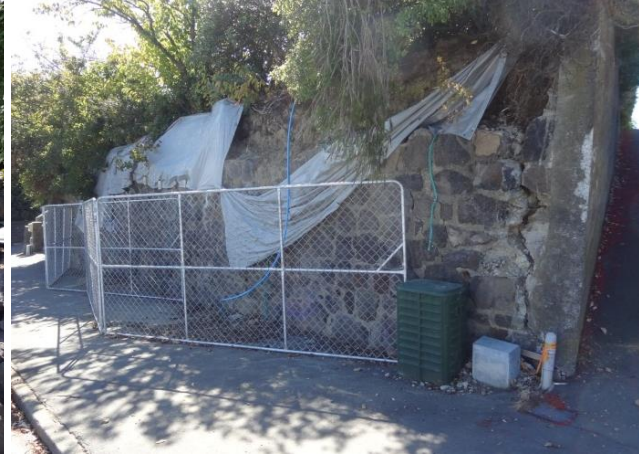
Figure 10. A partially collapsed stone wall showing typical damage

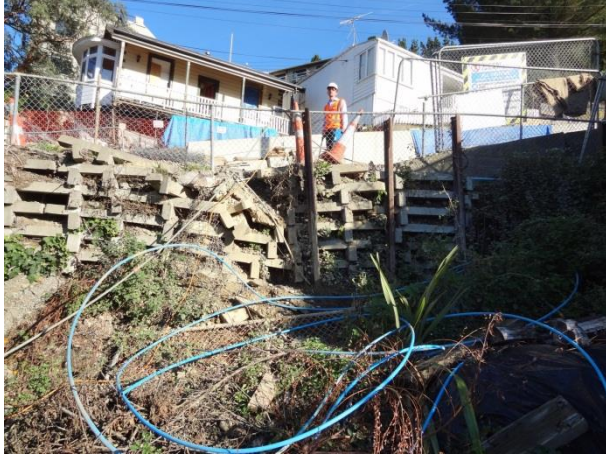
Figure 11. Damaged crib wall due for refurbishment as a soil nail wall

The analysis of a soil nail wall considers the nails to form a solid mass of soil which can resist soil and earthquake loading. In this case the existing crib wall is also considered to be part of this mass. An example of this can be seen in Figures 11 and 12.

In order to install soil nails through this crib wall the nails had to be drilled through a PVC casing through the crib units. Ideally the angle of the nails would match that of the crib units so as they do not need to be drilled through the rear stretchers, but this location had shallow buried services behind the wall which meant that the anchors had to be steeper and therefore extra drilling was necessary. A shotcrete facing was applied as the final face and this would hold in place the existing crib fill in the event of a future earthquake and maintain the mass of the structure.

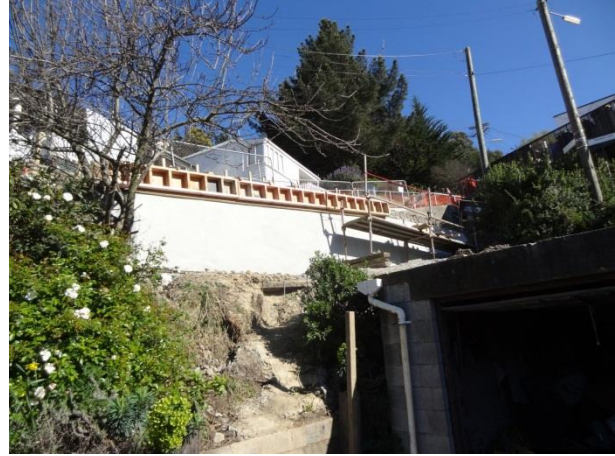
Figure 12. A soil nail wall refurbishment with shotcrete facing

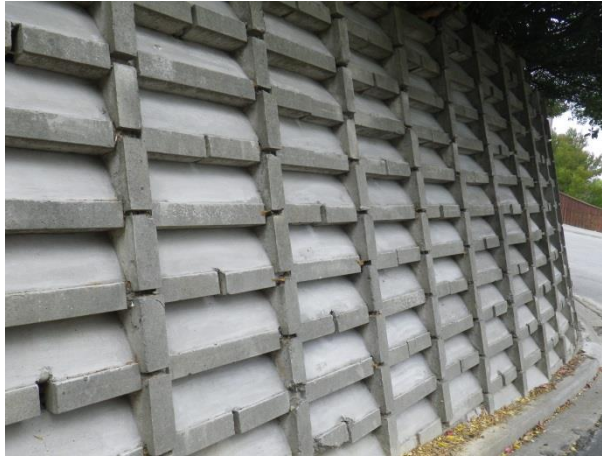
Figure 13. A crib wall with minor repairs to prevent future loss of fill

Some walls had minor damage to individual crib units and were at risk of loss of fill. These could be repaired by adding something to the front of the wall to block the front of the crib units. Options developed for this included cast in place concrete or geotextile strips. An example using concrete is shown in Figure 13. This would ensure the stability of the wall. Where the front of the wall became a solid face, drainage weep holes were also included in the design.

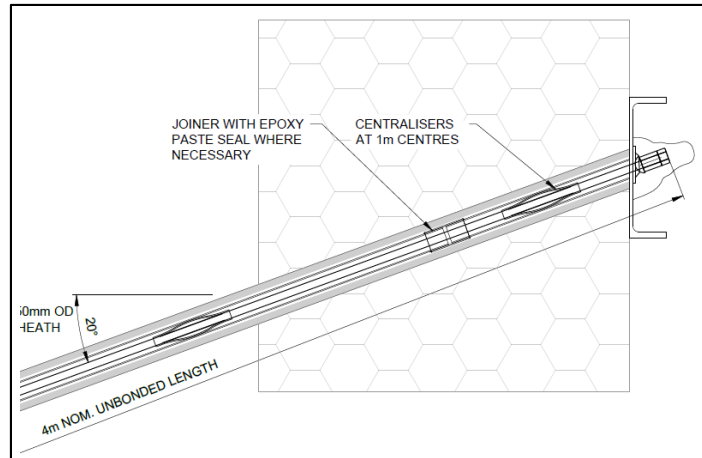
Figure 14. Sketch showing arrangement of anchors through gabion baskets

The anchored solution, shown in Figure 14, is designed to prevent further deformation under future seismic loading. In this case a PFC waling will span between anchors on the face of the wall. Drilling anchors through the gabion baskets was achievable, but there were some particular lessons learnt:

- Drilling of the anchors was possible and while the basket mesh at the rear of the basket was awkward to penetrate, it could be done.
- During grouting there is no grout recovery and therefore there is less certainty regarding how complete the grout is. Therefore all anchors were load tested.
- The testing regime needs careful consideration because measuring deflection was challenging because the baskets did not provide the required reaction for the jacking during testing.
- The gabion baskets were damaged by the plate used in testing. Therefore using a textile layer or other protection under the plate is recommended.
