Ferry Road Stormwater Brick Barrel Christchurch: Report on Archaeological Monitoring

FERRY ROAD STORMWATER BRICK BARREL CHRISTCHURCH: REPORT ON ARCHAEOLOGICAL MONITORING

SCIRT 11115 AND 11159

SEPTEMBER 2016

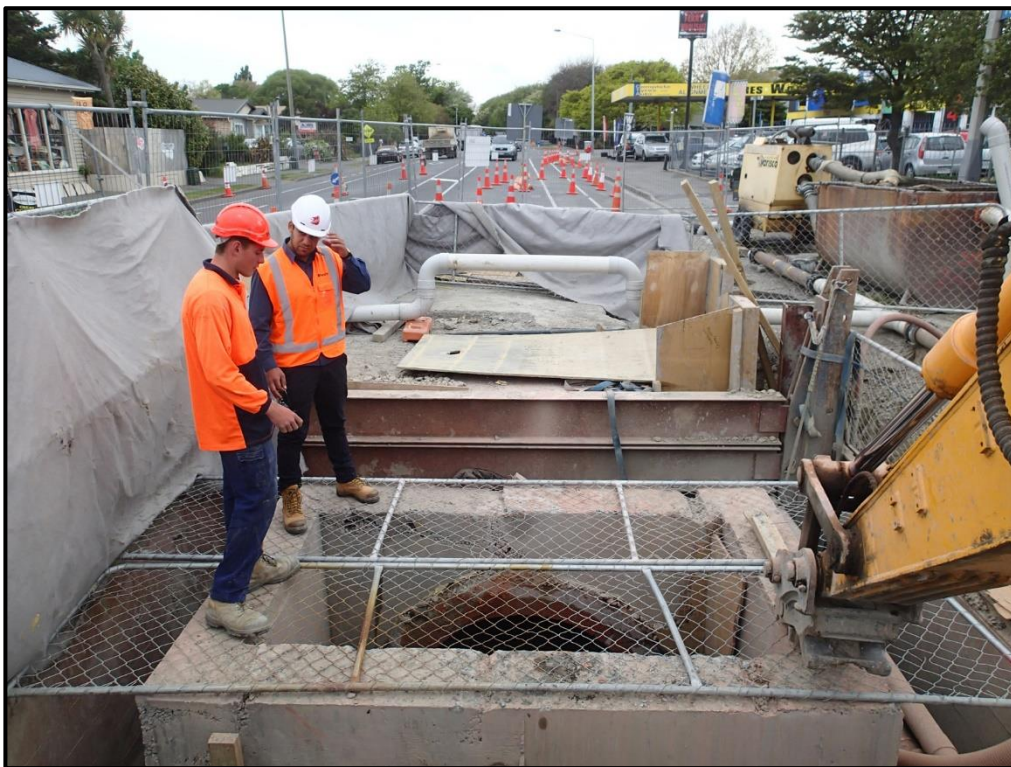
Figure 5. Looking east along Ferry Road, with the completed manhole atop the brick barrel in the foreground.

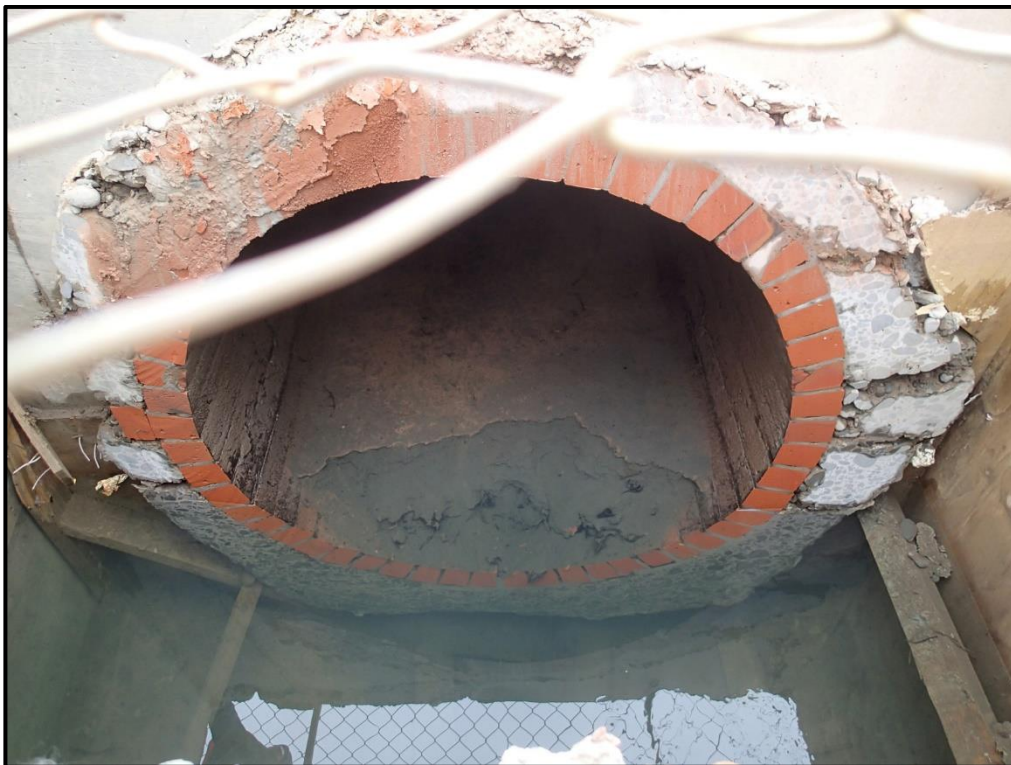
Figure 6. The eastern side of the brick barrel as exposed after wire cutting.

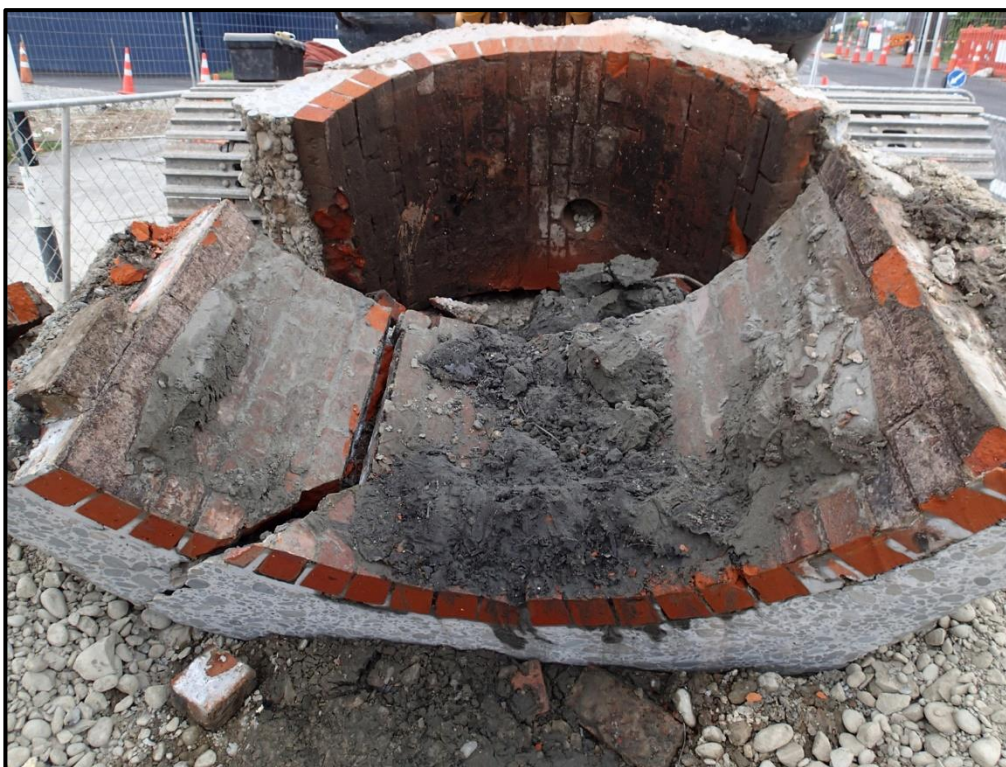
The brick barrel as exposed at the location of the new manhole had an internal diameter of 1300 mm and was formed of a single skin of standard sized red bricks and was fully encased in unreinforced

Figure 7. The removed section of brick barrel.

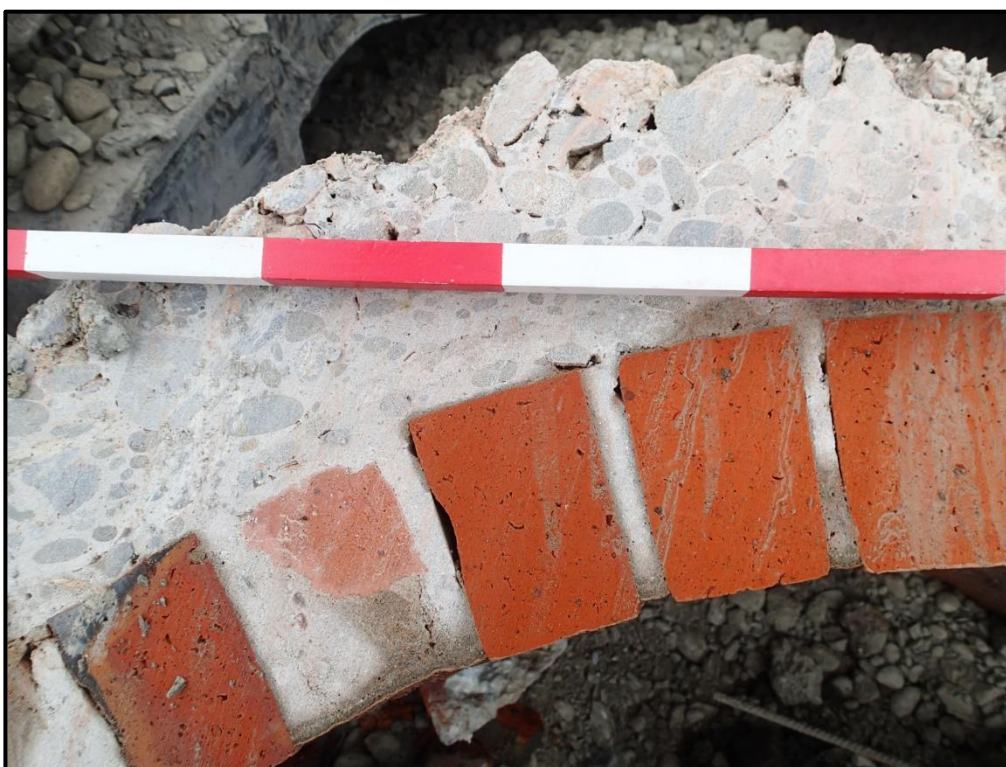
concrete (Figure 7). The concrete below the brick invert was up to 380 mm thick, and above the upper arch up to 130 mm thick (Figure 8). Standard sized hand-pressed bricks marked 'WN' were used in the construction of the brick barrel, laid in a standard running bond (Figure 9). These bricks were manufactured by William Neighbours, one of the largest of Christchurch's brick making firms that was in operation in the 19th century. William Neighbours began making bricks in Christchurch from 1863 (Matt Hennessey, pers. comm. 12/9/2016). The presence of an earthenware drainage pipe below the invert was noted by the crew, although the remaining in situ parts of this pipeline were not visible at the time of the archaeologist's site visit and nor was the removed section retained. This pipeline would have been installed at the time of construction to remove groundwater from the works area when the brick barrel was being built. At the time of the site visit, there was an estimated 300 mm of water in the invert of the sewer, believed to be tidal in nature.

Figure 8. A section of the upper crown of the brick barrel, showing the arrangement of bricks haunched in concrete.

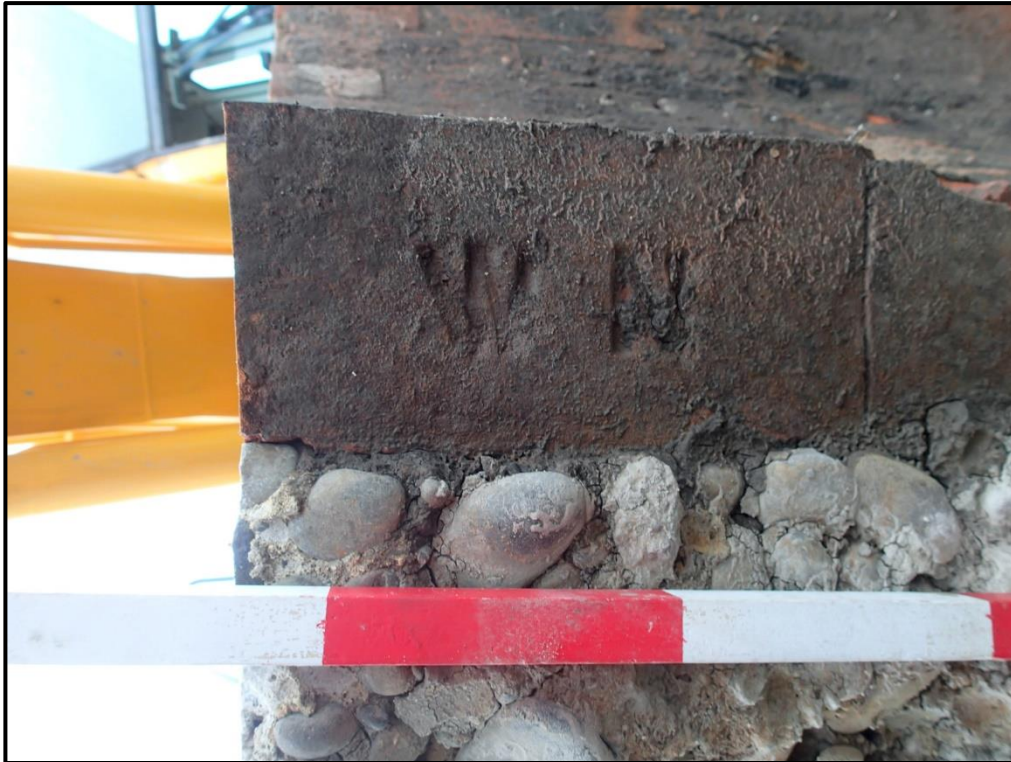
Figure 9. One of the marked 'WN' bricks used in the construction of the brick barrel.

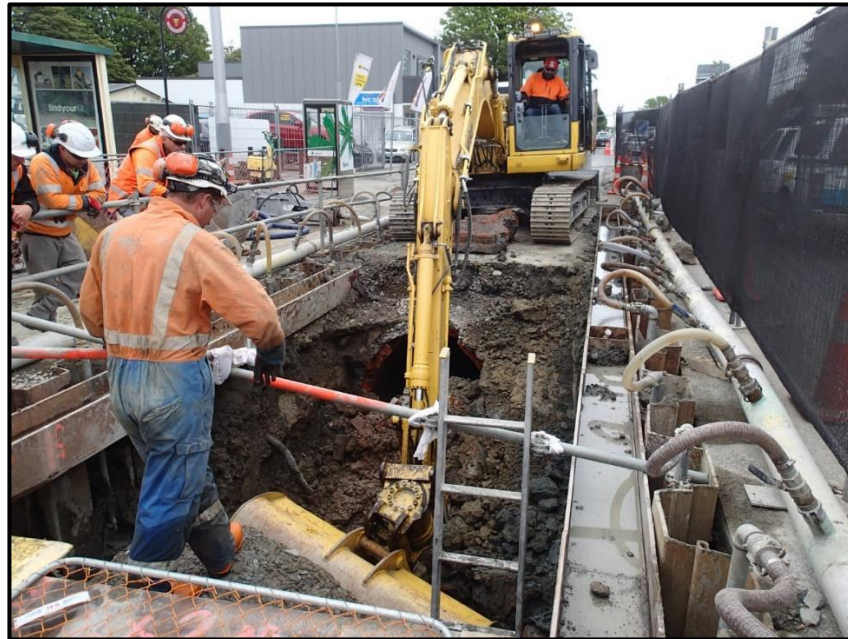
The segment repairs took place within a sheet-piled area 4 metres wide, with excavations extending to a depth of up to 3.2 metres. Groundwater was removed from the excavation area by means of dewatering spears, and the damaged sections of the brick barrel were broken out with a mechanical excavator equipped with a hydraulic breaker attachment (Figure 11).

Figure 11. Segment repair 1 under excavation, looking northwest.

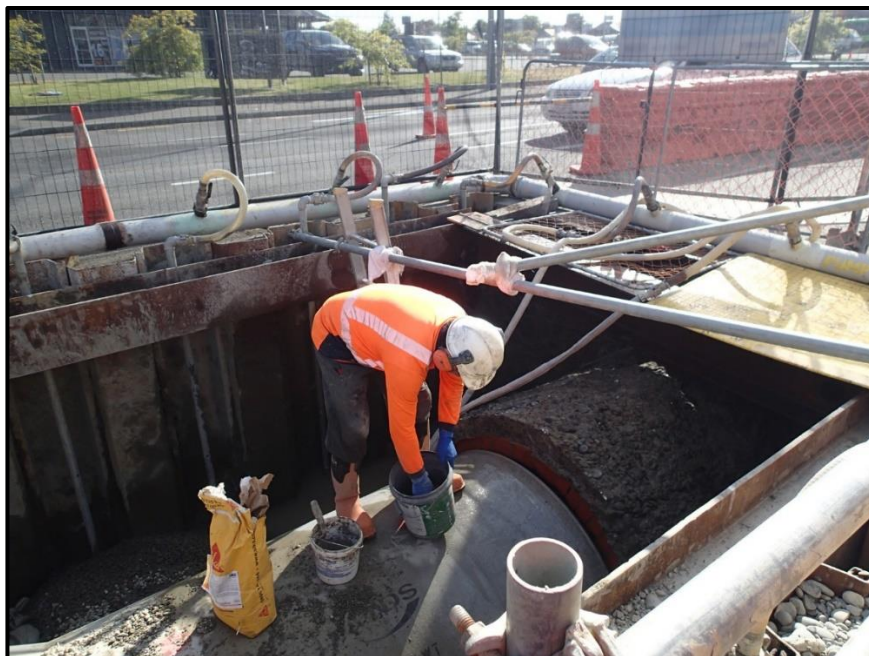
Figure 12. The southern end of the segment repair 1 works area, showing the first of the replacement concrete pipes under installation.

A wire cutting saw was used to cut a clean section through the brick barrel at both the upstream and downstream ends of each of the segment repair locations. Reinforced concrete rubber ring jointed pipes of 1350 mm diameter were used to replace the damaged sections of the brick barrel, with the exception of at segment repair location 5, where the brick barrel was of a larger diameter (1420 mm), and 1600 mm diameter pipes were used (Figure 12). Where subsoil drainage pipes were exposed below the invert, these were replaced with 150 mm diameter PVC pipes before the replacement concrete pipes were installed.

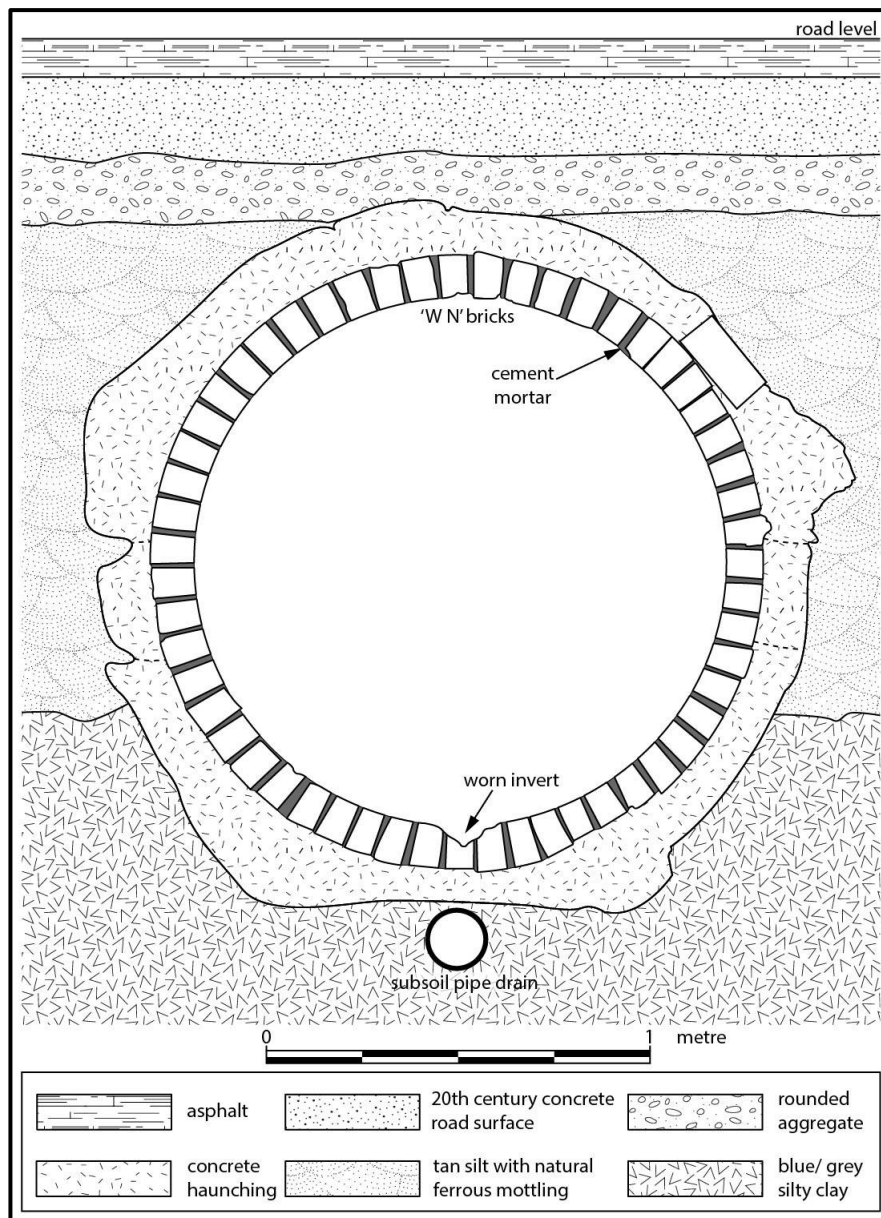
Figure 13. Stratigraphic detail of the Ferry Road stormwater brick barrel as recorded at the eastern end of the segment repair 6 works area.

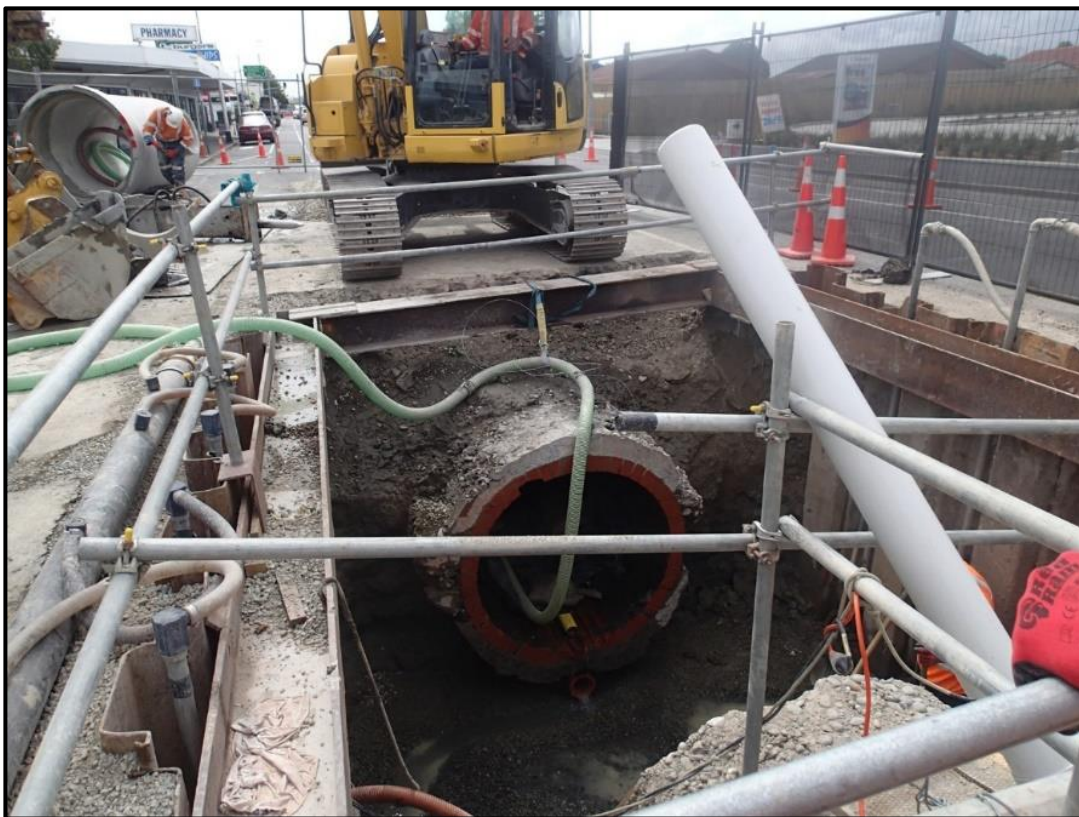
Archaeological investigations of the brick barrel at segment repair location 6 took place on 27 November 2015, after excavation had been completed to 2845 mm (Figure 14). The top of the brick barrel was exposed at a depth of approximately 600 mm. The modern road asphalt surface had been laid directly atop of an earlier 20th century concrete road surface, which had an aggregate base course of approximately 160 mm thickness. No metalled road surface potentially dating to the 19th century period was exposed during the course of this work, and it is suspected that any evidence of such a layer would have been removed during the course of 20th century road surfacing renewals.

Figure 14. Looking northwest across the sheet-piled segment repair 6 excavation area.

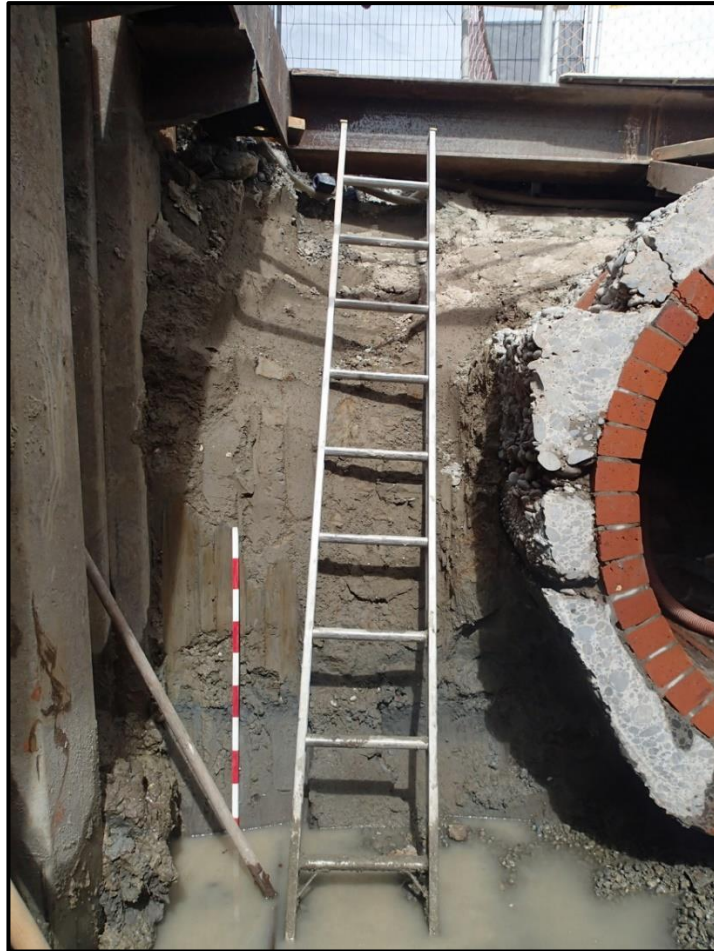
The brick barrel had been laid directly into the natural blue-grey silty gleysol clay substrate, which was waterlogged. Atop this was a tan coloured silt that had natural ferrous mottling – this mottling is indicative of mean groundwater level (Figure 15). The unreinforced concrete below the brick invert was up to 240 mm thick, and this had been laid atop a 150 mm diameter unglazed earthenware pipe drain. The pipes were of the standard socket and spigot type. This subsoil pipe drain had been laid directly into the silty gleysol clay with no differential pipe bedding or backfill. As this pipe drain was removed prior to the site visit being carried out, little can be said about these pipes, including whether

Figure 15. The stratigraphy exposed adjacent to the eastern (downstream) end of the brick barrel at segment repair location 6. Note the two differential natural silty subsoil layers, and groundwater pooling in the foreground.

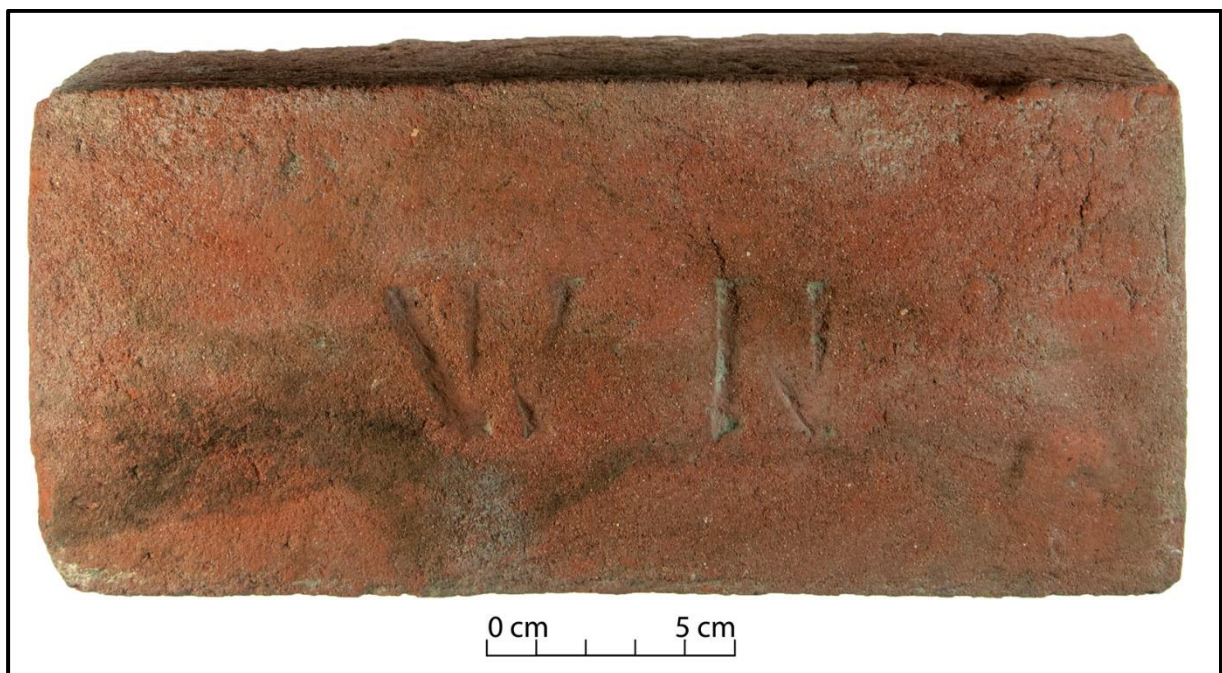
As was observed during SCIRT 11159 works as well as at segment repair locations 1 and 2, standard sized hand pressed bricks marked 'WN' and manufactured locally by brickmaker William Neighbours were used in the construction of the brick barrel, laid in a standard running bond (Figure 16 and Figure 17). The concrete atop the upper arch was up to 130 mm thick, and contained rounded greywacke stones as the aggregate component. Bricks were found to be incorporated into the concrete as well (Figure 18). The presence of these 'WN' bricks was later confirmed across the other segment repair locations. 34 mm of the uppermost portion of the brick at the invert was completely abraded away (Figure 19). The wear to the invert was likely caused by the passage of grit and other particulate matter that had been carried through the sewer over the course of the 137 years that it had been in operation.

Figure 16. One of the marked WN bricks used in the construction of the brick barrel.

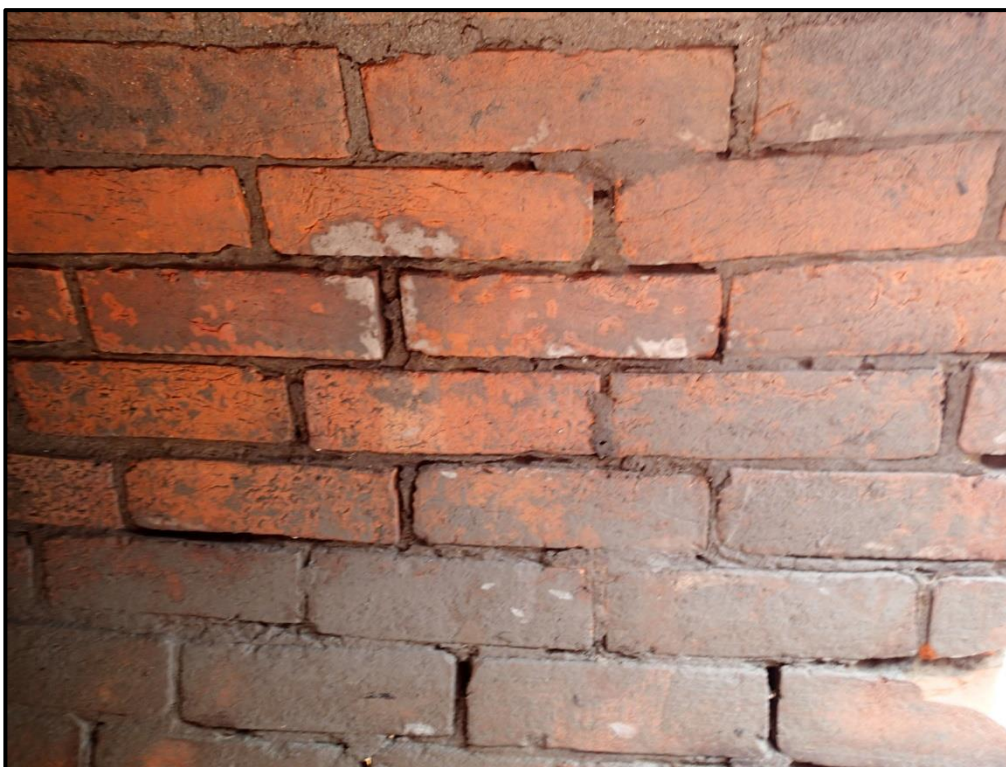
Figure 17. The inside of the brick barrel at the eastern end of segment repair 6, showing the arrangement of the bricks in a standard running bond.

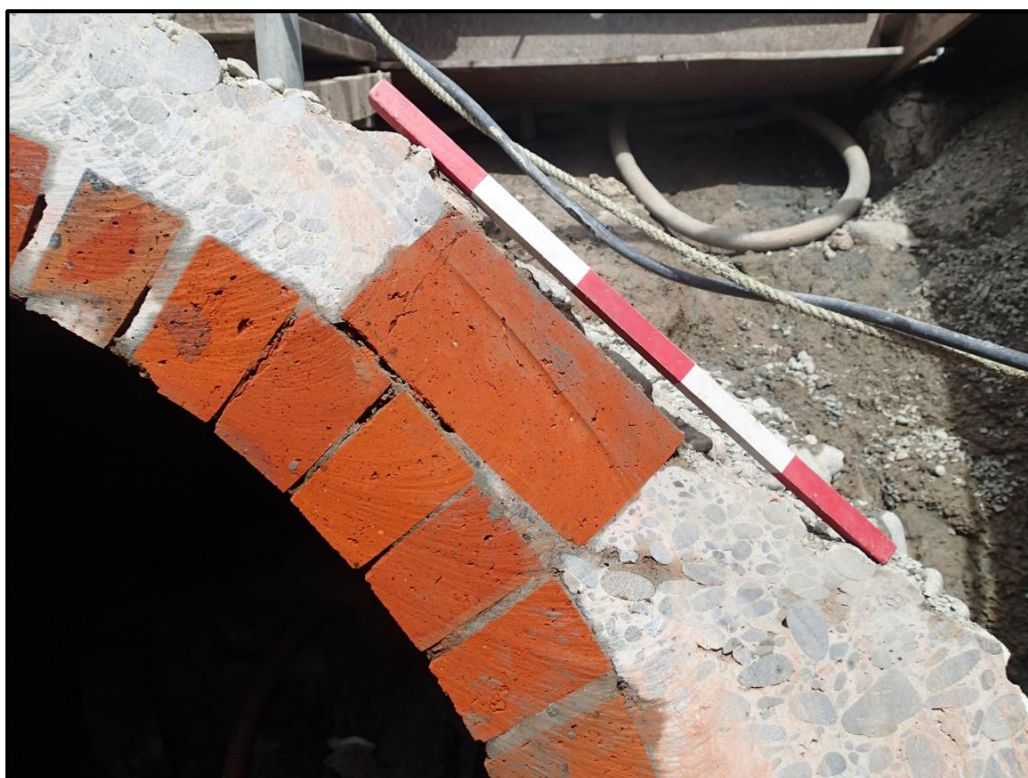
Figure 18. Section of the upper crown of the brick barrel. Note the rounded aggregate in the concrete, and the brick incorporated as aggregate.

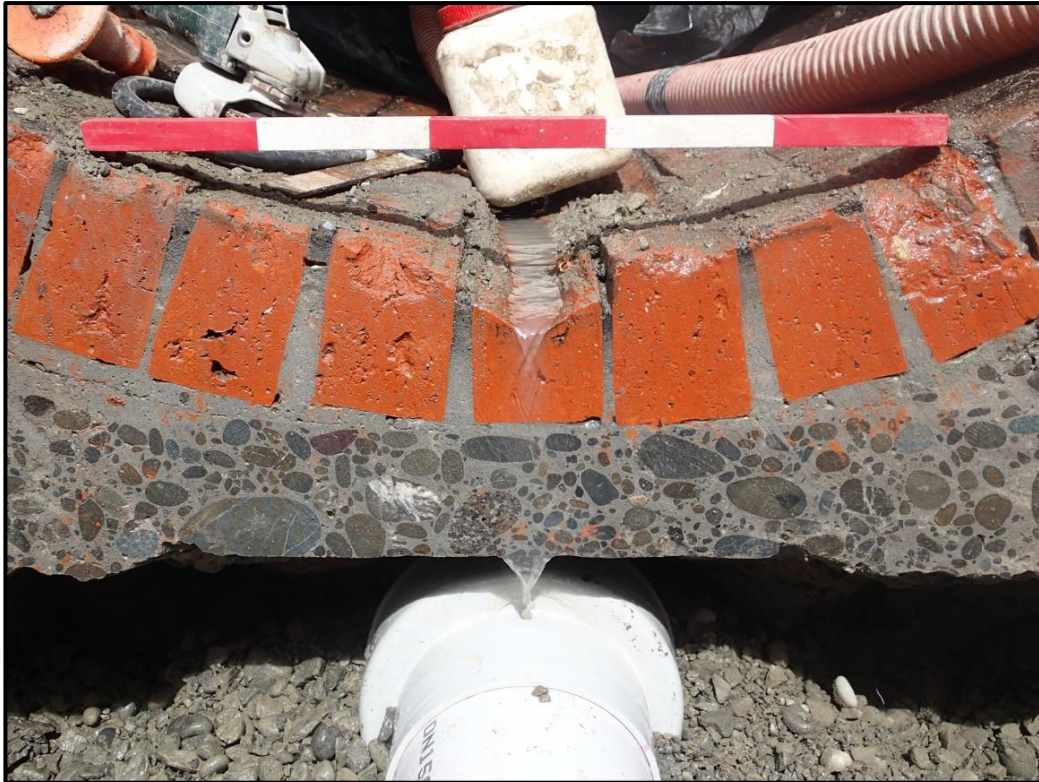
Figure 19. Detail of the invert at the eastern end of segment repair location 6. Note the groove formed in this brick, caused by the passage of grit and other particulate material washed into the sewer.

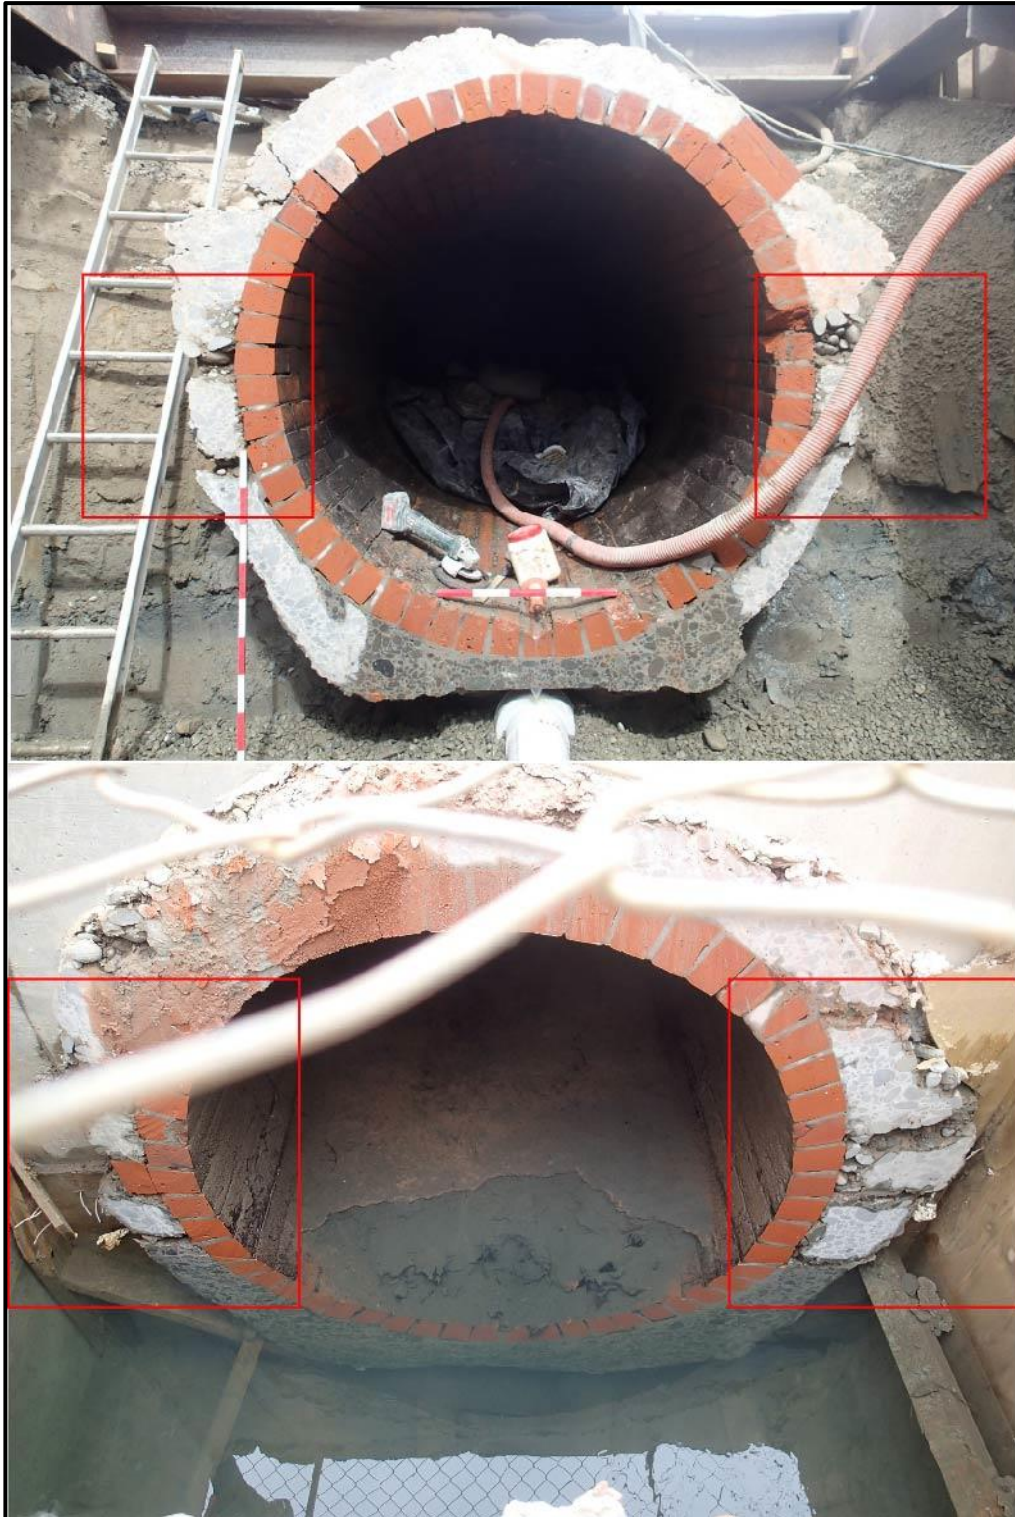
7. Concrete would be poured atop the completed section of brick arch, in at least three separate pours. It is suspected that the reason for this is to facilitate the easy removal of the timber formwork, though this is pure supposition. That the concrete of the brick barrel had been laid in more than 2 successive pours was evident not only in the wire cut ends of segment repair 6, but also at the location of the new manhole and wastewater crossing (Figure 20). It is suspected that this is a consistent feature of this brick barrel conduit along its whole length.
8. Once the upper arch had been fully haunched in concrete, and this concrete joined to the concrete of the sewer invert, the completed section of the brick barrel would have been backfilled with the excavated material, and the metalled road surface reinstated.

Figure 20. At top, the Ferry Road brick barrel as wire cut at the eastern end of segment repair 6, and at bottom, the downstream end at the location of the SCIRT 11159 manhole. The evidence for the successive concrete pours exposed in both these locations is highlighted with red squares.
