Bridge of Remembrance poster for awards application

BRIDGE OF REMEMBRANCE TRIUMPHAL ARCH SEISMIC STRENGTHENING

Location	Christchurch CBD
Client	Part of the SCIRT Programme, funded by Christchurch City Council and New Zealand Government
Structural Engineer	Opus International Consultants, seconded to SCIRT
Completion Date	November 2015

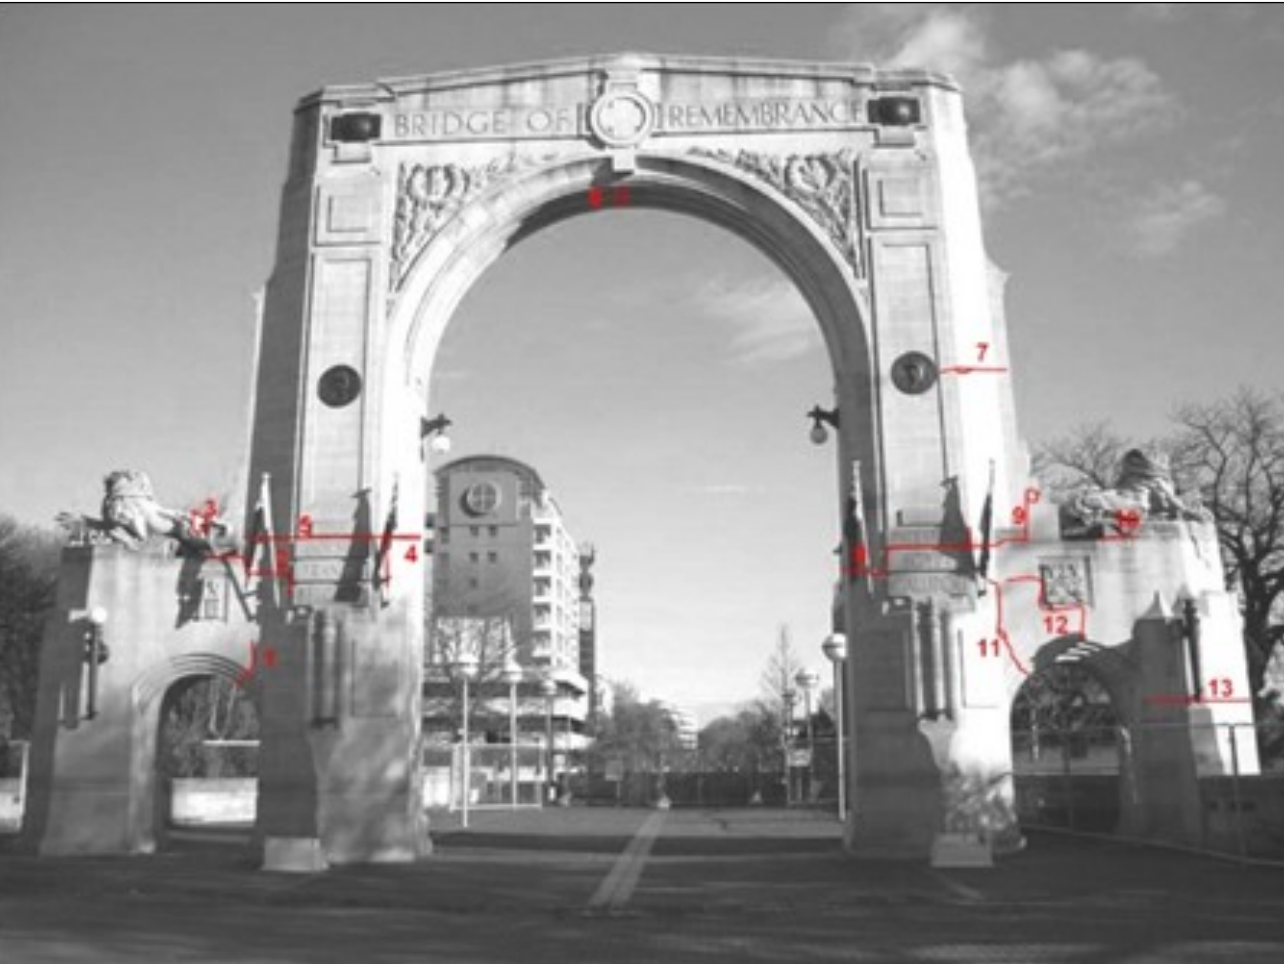
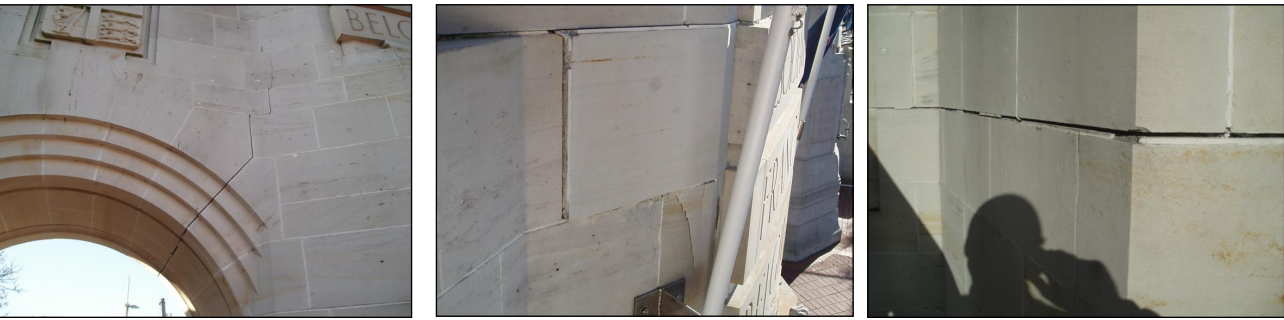
Figure 1: Crack map and typical cracks recorded after the February 2011 Earthquake

The Bridge of Remembrance Triumphal Arch suffered moderate damage in the February 2011 earthquake. This prompted seismic assessment by Opus Consultants on behalf of Christchurch City Council. The project was transferred to the SCIRT alliance with the Opus structural engineers seconded to SCIRT to develop the strengthening solution.

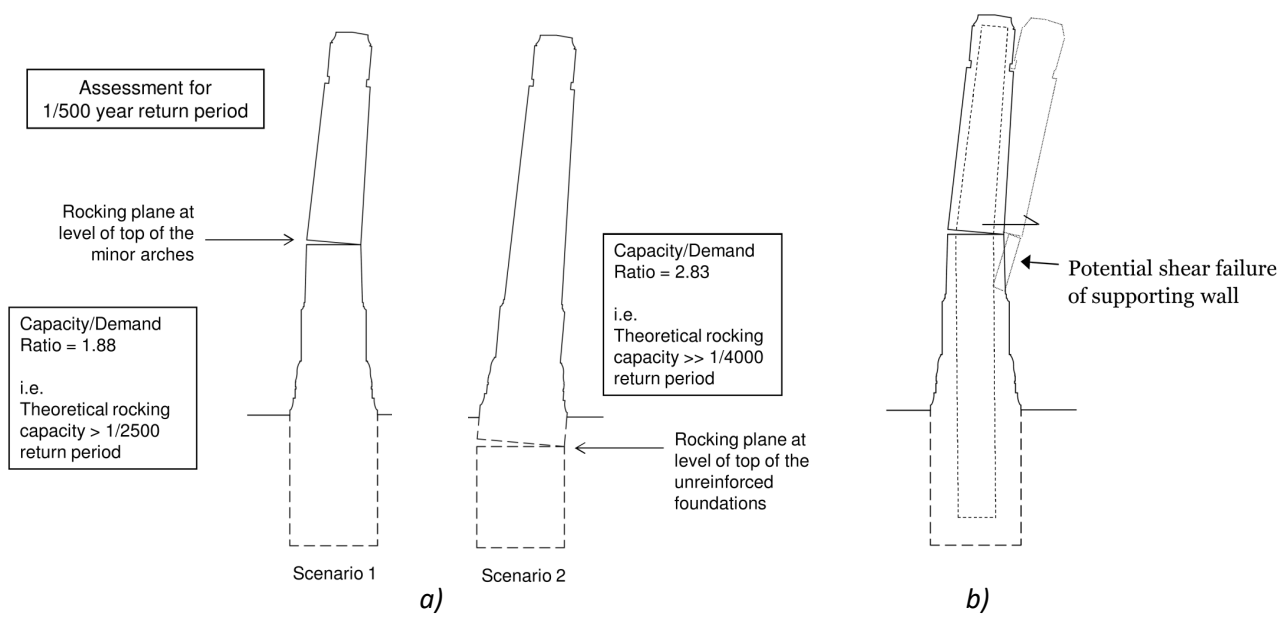
Figure 2: a) Rocking scenario's considered in the assessment; b) Potential brittle failure mechanism during rocking

- Integral wingwall only on the north side induces torsional effects (Fig. 5a)
- Inner columns are significantly wider than the outer columns preventing out-of-plane rocking at the base (Fig. 5a)
- Transfer of shear across the potential rocking plane relies on dubious shear friction interface
- Potential shear failure of supporting wall face due to minimal shear links in the columns and no reinforcement in the footings (Fig. 2b)

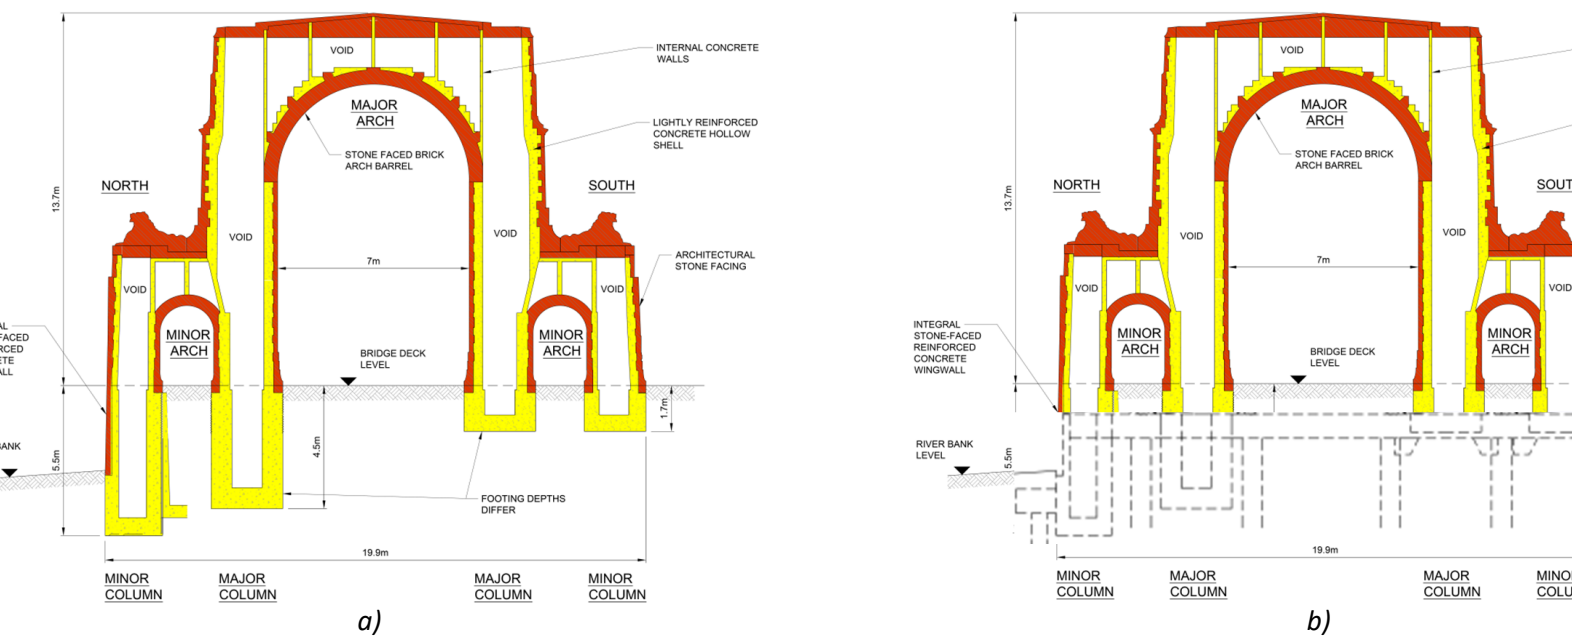
Figure 4: Cross section through existing structure indicating: a) varying existing foundation depths; b) new piled foundation

- Listed as Category 1 Heritage Structure with NZHTP and Group 1 with Council - significant restrictions on change to appearance and loss of heritage fabric
- Client wants to avoid/minimise future damage to heritage fabric
- Importance level 3 structure, 100 year design life - 1:2500 year design earthquake
- Perceived safety risk - internal access to the structure restricted requiring remote working practices
- Existing footings at different depths leading to torsional effects and differential settlement (Fig. 4a)
- Small voids within the structure - severe restrictions on size, location and access for placement of strengthening (Fig. 4a & 5a)

- Piles and pilecaps provide a solid foundation to rock on and allow for the increased dead loads from new concrete infill (Fig. 4b)
- Rocking collars provide a definite rocking interface and allow uniform out-of-plane rocking at the base (Fig. 5d, 5e & 5f)
