Bridge of Remembrance Seismic Strengthening – New Zealand Concrete Industry Conference 2015

BRIDGE OF REMEMBRANCE SEISMIC STRENGTHENING

This paper highlights some of the design and construction challenges that were overcome in the seismic strengthening of the Triumphal Arch in Christchurch, a listed category 1 Historic Place. The project involved a complete change to the dynamics of the structure to allow a rocking motion to be induced to dissipate energy during a significant earthquake. The delivery team used a number of simple but effective techniques to overcome the challenges..

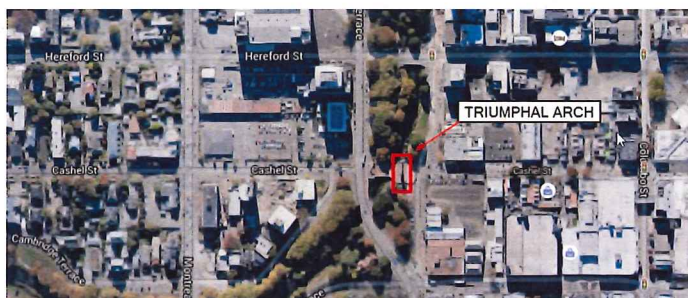
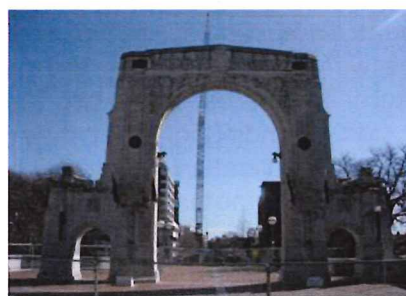
As a result of the 2010 and 2011 Christchurch Earthquake sequence, the Triumphal Arch experienced significant structural and non-structure (stone fabric) damage. Built in 1924 as a memorial for soldiers who fought for New Zealand, the Triumphal Arch stands on the east abutment of the Bridge of Remembrance crossing the Avon River. The resulting damage included; differential settlement across the four columns, horizontal displacement of the top half of the structure above the minor arches, cracking and spalling of stonework in a number of locations and damage to the ornate Lions. Structural assessments following the earthquakes deemed the structure to be earthquake prone, meaning strengthening work was required to meet the requirements of the Building Act 2014 and to once again provide safe public passage under the structure.

Figure 1. Location of Triumphal Arch and east elevation of the structure after the earthquake

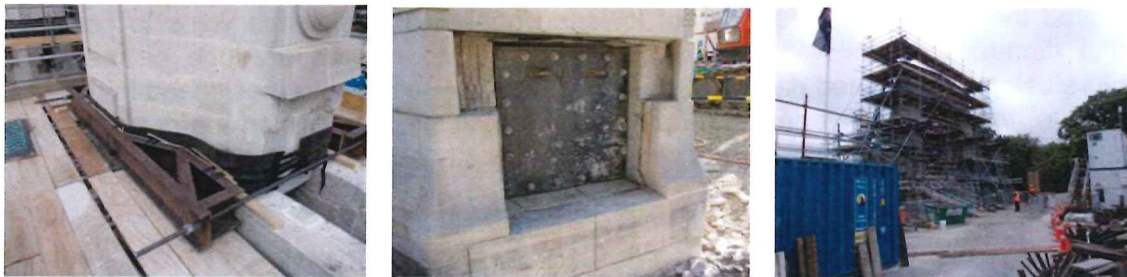
As a result of the damage sustained, the likely action of the main Arch under a seismic event was rocking about the existing crack line at the level of the Lions, midway up the major columns, but it was unlikely to topple as a result. However, uncertainties existed around the integrity of this hinge point, specifically the possibility of degradation of the rocking surfaces under prolonged seismic shaking. This issue was addressed by installing steel circumferential reinforcement clamps above and below the cracks on the major columns to reinforce the hinge point and provide residual capacity to the crack line. The clamps were

Figure 4. (L-R) Steel Column Clamp, Temporary Access Hatch in side of Column, Scaffolding

designed to fit the profile of the columns, then lifted into place and tensioned to provide the required circumferential confinement.

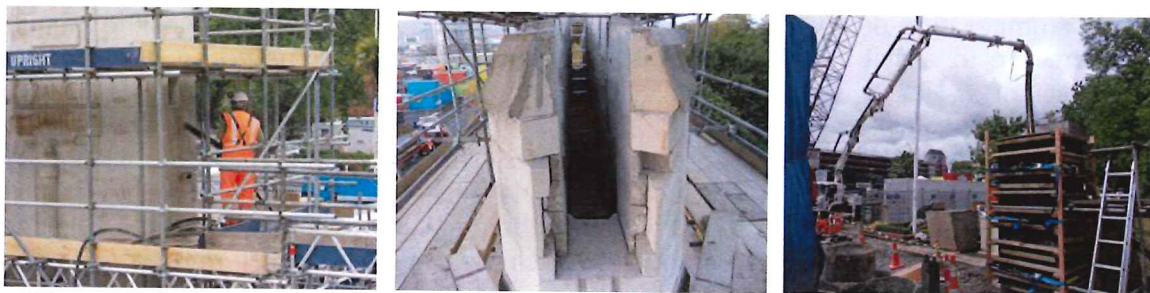
Figure 8. Stonemason working, Limited space inside Major Arch, Concrete Test Pour

A major portion of the works involved repairing the damaged Tasmanian Sand Stone cladding on the structure. In order to retain as much of the original stonework as possible, damaged stonework was repaired in-situ. In many places the stonework was too badly damaged to fix, in which case stones were removed and replaced with new stones. The original Quarry was located in Tasmania, Australia, and matching stone was shipped to New Zealand. To preserve the ornate Lions that sit on top of the minor arches, the delivery team removed them before any other work began. This gave the Stonemasons an opportunity to fix the damage off-site. The Lions were replaced at the completion of the strengthening work.

Stones were replaced on the structure using stainless steel threaded rods epoxied into the stone and structure. New mortar joints were pointed and the remaining gaps filled with grout. The new stones were roughly cut to size and then positioned in place on the structure in the same way as the original stones were replaced. Once in place, the face of the stone was cut to the correct profile and when an area had all the stones replaced, the face of the new stones were levigated to achieve a smooth transition between the new and old stones.
