Resilience Examples in Reservoirs, Pump Stations and Pipelines – Lessons Learned from the Canterbury Earthquakes

A paper prepared for the Water New Zealand 2014 conference which considers resilience lessons for: reservoirs, pump stations and pipelines.

RESILIENCE EXAMPLES IN RESERVOIRS, PUMP STATIONS AND PIPELINES – LESSONS LEARNED FROM THE CANTERBURY EARTHQUAKES

Dennis Hunt (CH2M Beca Ltd) and Gavin Hutchison (CH2M Beca Ltd)

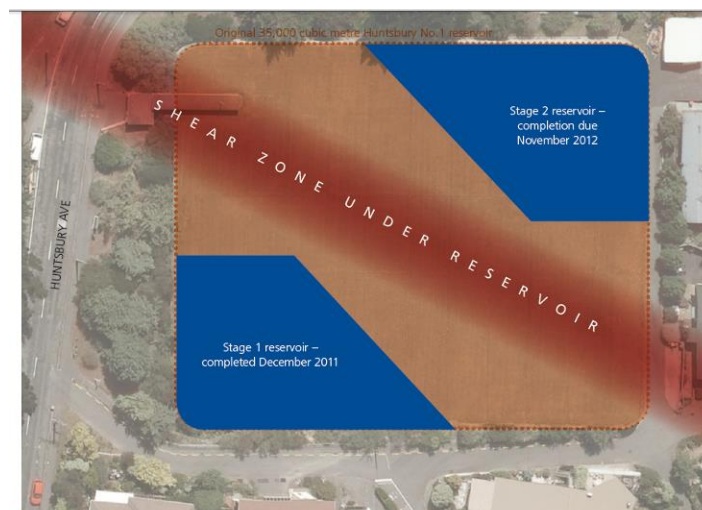
Photograph 1: Huntsbury No. 1 Reservoir Plan

A previously unidentified shear zone in the basalt under Huntsbury No 1 reservoir ruptured causing structure dislocation and loss of all stored water. It was estimated by the geologist who reviewed data from inclined boreholes done as part of a site investigation after the June 2011 earthquake that the last movement of this shear zone was in the order of 15,000 years ago.

The reinstatement of the reservoir was limited to sections each side of the shear zone as shown in photographs 1 and 2.

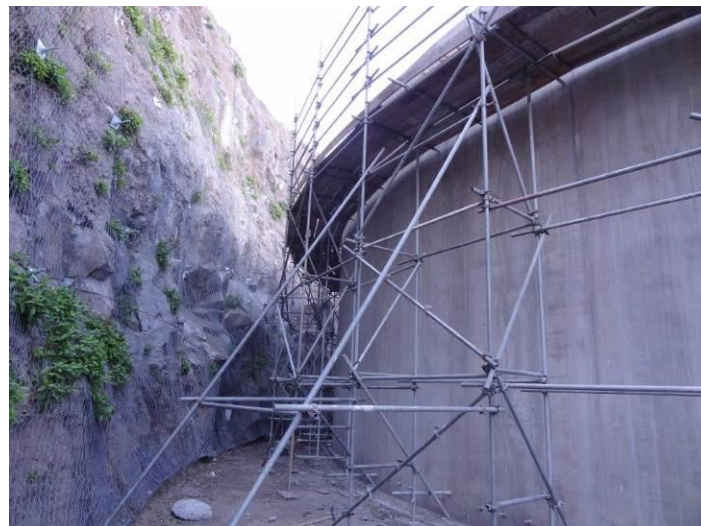
Photograph 3: McCormack's Bay Reservoir Rock Fall Protection

The McCormack's Bay reservoirs are located on a platform cut into a hillside. Rockfall and instability in the cut slope above the reservoirs presented a significant hazard which needed to be mitigated prior to external reservoir remediation works (Refer No. Photograph 3) and localised filled areas on the access road on the downhill side of the site required extensive retaining works and restricted access to the site.

The lessons from McCormack's Bay are the need to inspect and assess the geological conditions, and visualise the likely performance of cut and filled slopes during seismic events.

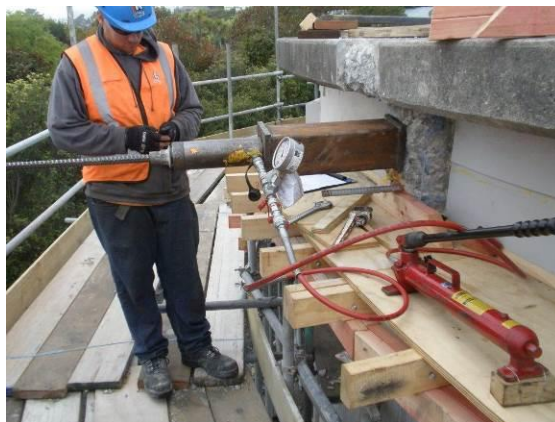
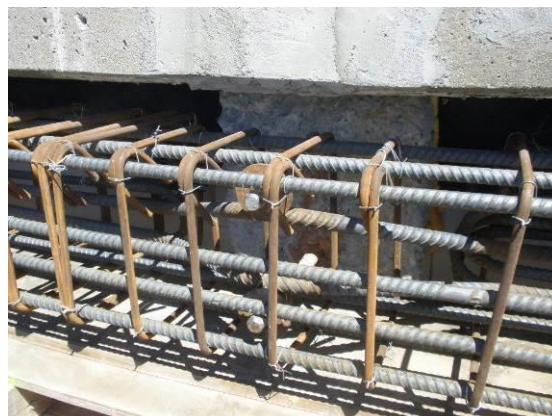
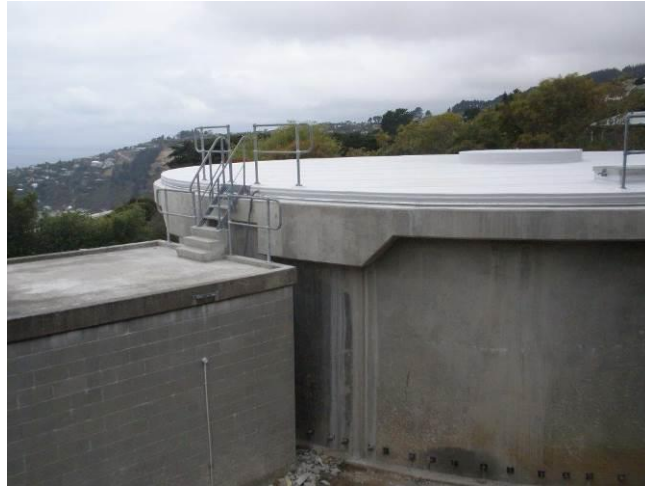
A similar method was used to reinstate the Upper Balmoral reservoir roof/wall connection where the failure mode was roof tee beams punching through the wall (Refer Photograph No's 4, 5 and. 6).

In both cases the retrofit design was made difficult due to the lack of sufficiently strong components in the perimeter of the roof and strength limitations in the top of the walls. At Upper Balmoral these difficulties were overcome by core drilling holes into the ends of the radial prestressed tee roof units and epoxy grouting Reidbars into them thereby providing anchorage for the ring beam. However the wall section was not strong enough to resist the horizontal seismic load from the ring beam in bearing against the wall, requiring the transfer of the load to the pilasters and from there via shear to the base of the wall.

Due to the difficulty of repairing the extensive cracking in roof toppings, membranes were installed on Upper Balmoral (refer Photograph No. 6) and McCormack's Bay reservoirs. Membranes were also installed on the Huntsbury Stage 1 and 2 reservoirs even though the topping was 200mm thick. In the case of Huntsbury this allowed the roof slabs to be poured in large pours which was critical to achieving the programme. If programme had not been a consideration extensive jointing with PVC waterstops could have been contemplated with the advantage of reduced maintenance.

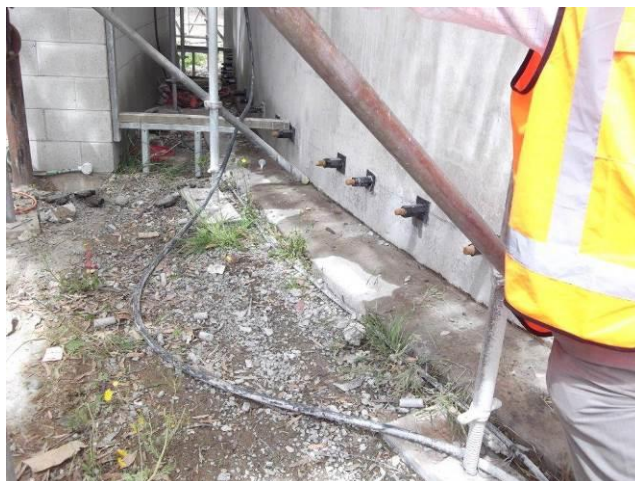
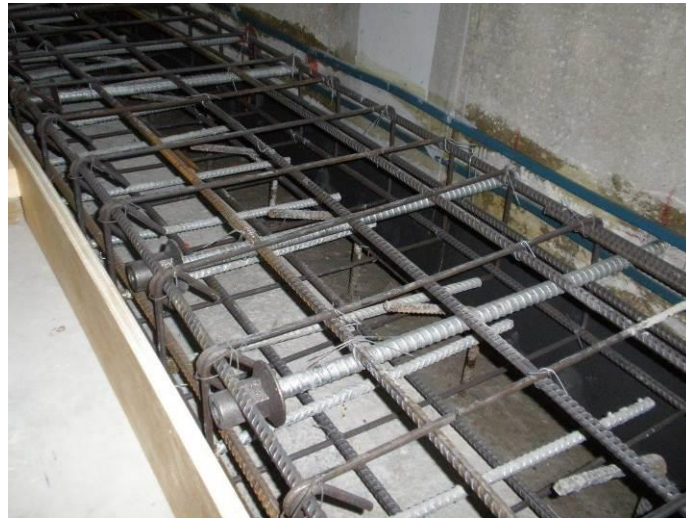
Calculations using 2011 seismic design loadings indicated a lack of shear connection strength at Huntsbury, McCormacks and Upper Balmoral. In each case there had been floor slab damage. The repair method adopted consisted of new reinforced concrete floor slabs (Huntsbury and McCormacks) and a shear connection between the floor slabs and the wall. This connection consisted of Reidbars installed through cored holes in the wall and anchored into a beam above (and connected into) the floor slab within the reservoir (Refer Photograph No's. 7 and 8).

The key lessons on connections are to resolve the seismic resistance philosophy for the structure at the outset, and to provide adequate strength and watertightness in the connections. The adequacy of these connections rely on detail and need to be considered at concept design stage to ensure the design of wall, roof and floor slab sections is compatible to accommodate them. The roof to wall detail has the added complexity of providing for temperature expansion and contraction.

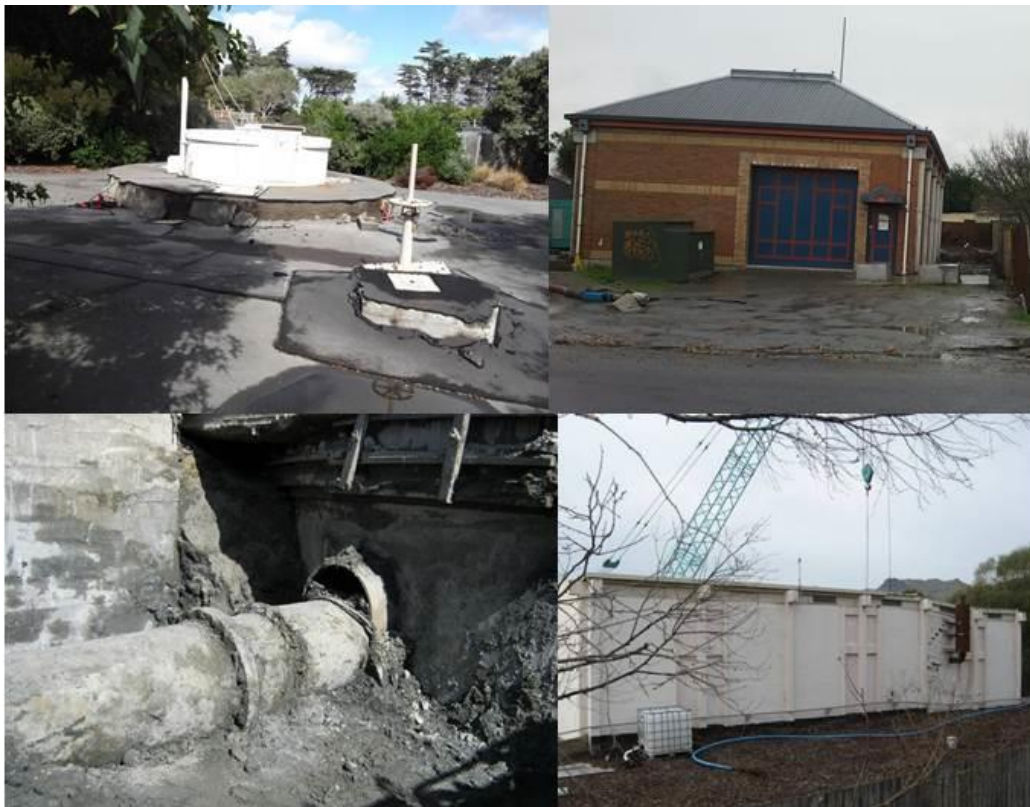
Photograph 9: Pump Station Earthquake Damage

Structural damage to the pump stations was generally a result of settlement, with some damage to above ground structures. There were some water pump stations buildings that suffered substantial structural damage requiring a full rebuild. Photograph 9 below shows typical damage to wastewater pump stations from top left, small pump station next to the Avon River, Pump Station 36, Pump Station 15 and pressure main connection PS15.

The most typical and troublesome were failures at the pipe connections to the structures. These failures were caused through ground settlement which also reversed the grade of some gravity inlet pipes. Repairs to the discharge pipes were often impeded due to the depth of the pipe requiring significant temporary works and dewatering.

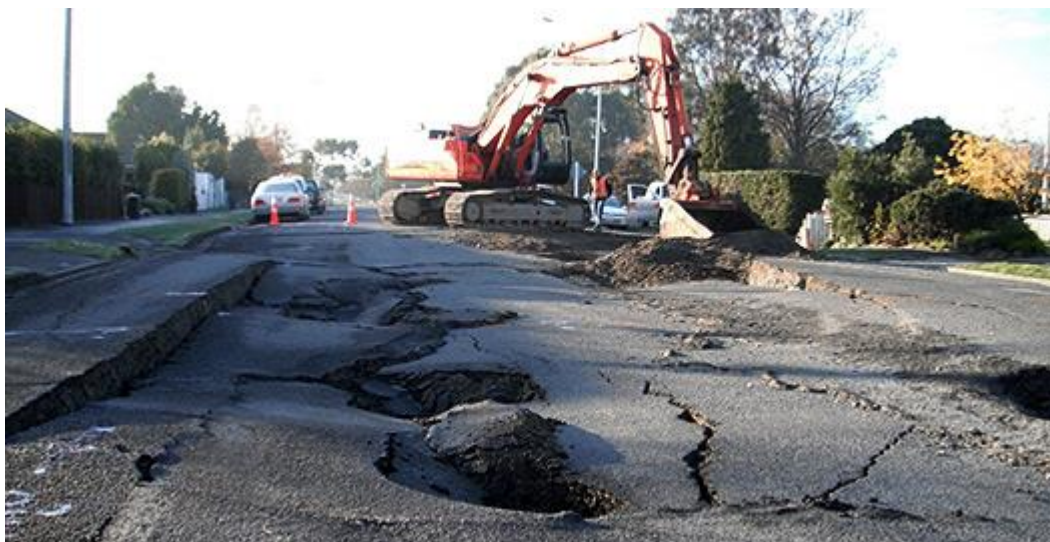
Photograph 12: Woodham Road Trunk Main Failure

The Trunk sewer immediately upstream of PS1 was a 1500mm x 1500mm box culvert. This failed in the 13th June 2011 earthquake resulting in the collapse of Woodham Road (Refer Photograph 12). Prior to the collapse assessment at the pump station had included the survey of the upstream trunk sewer, this indicated a severe dip

in the trunk main. On review of the as-built drawings (circa. 1957) the dip had existed since construction and survey indicated the dip had increased by approximately 400mm. It is assumed that all or the majority of the increase occurred in the February earthquake. This highlights the importance of the construction phase, and continued assessment over the lifetime of an asset. In this case a fault in construction had occurred, the trunk main functioned but the resilience had been compromised.
