Huntsbury Reservoir - Post Earthquake Reconstruction Ozwater 2013 conference presentation

A PowerPoint presentation prepared for the Ozwater 2013 conference detailing the story of the damage to, and subsequent repair of, Huntsbury Reservoir.

Huntsbury Reservoir

Post Earthquake Reconstruction

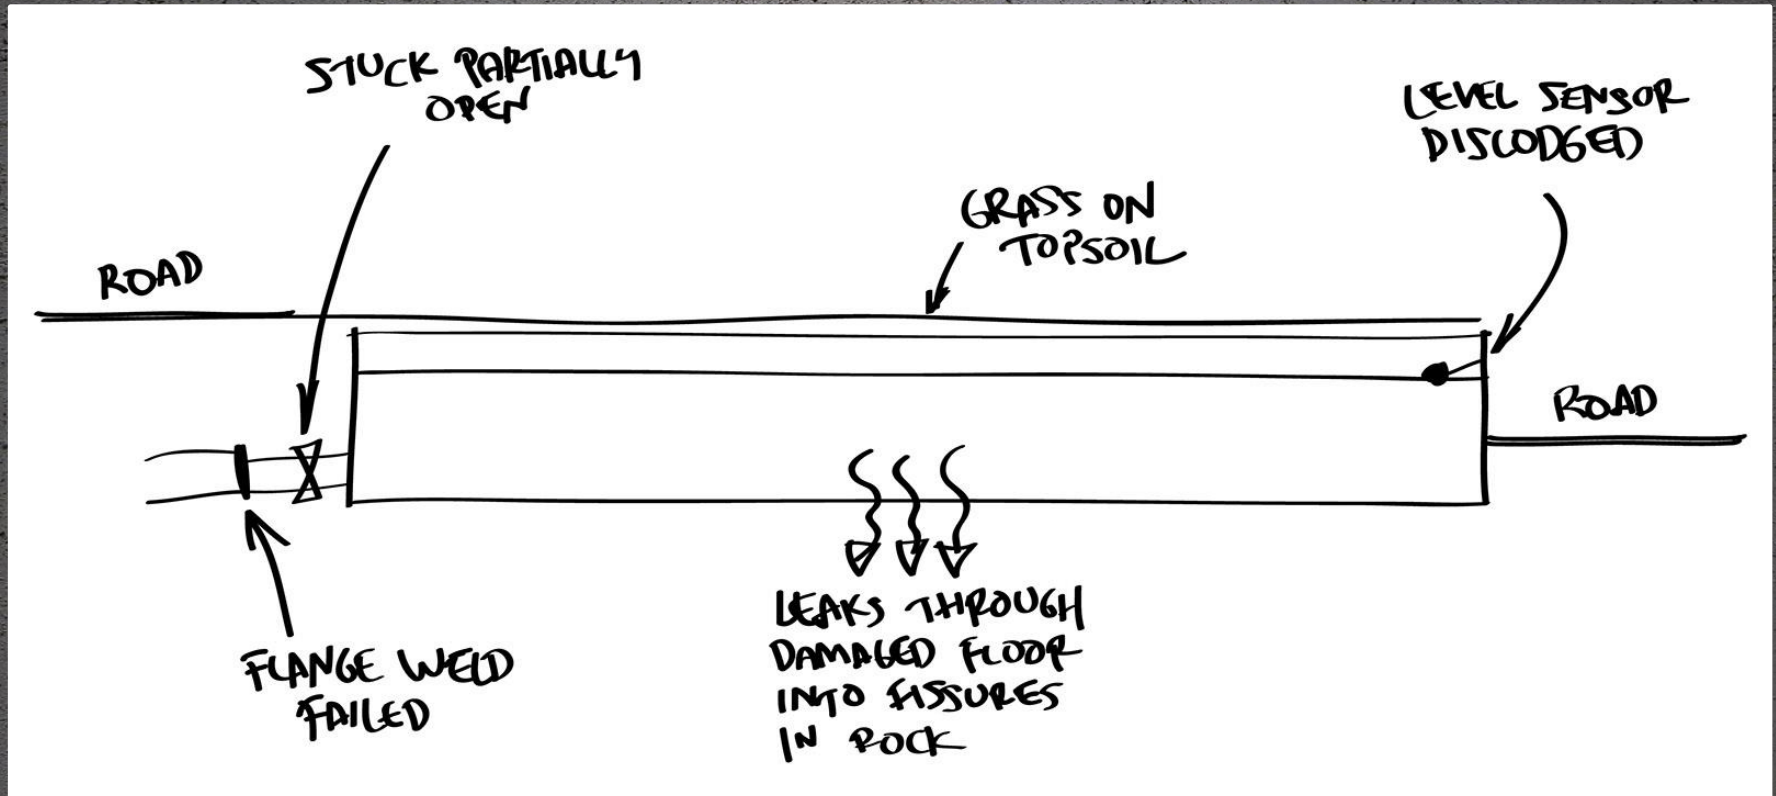
Water loss paths

Time to empty: Not known accurately but a few hours

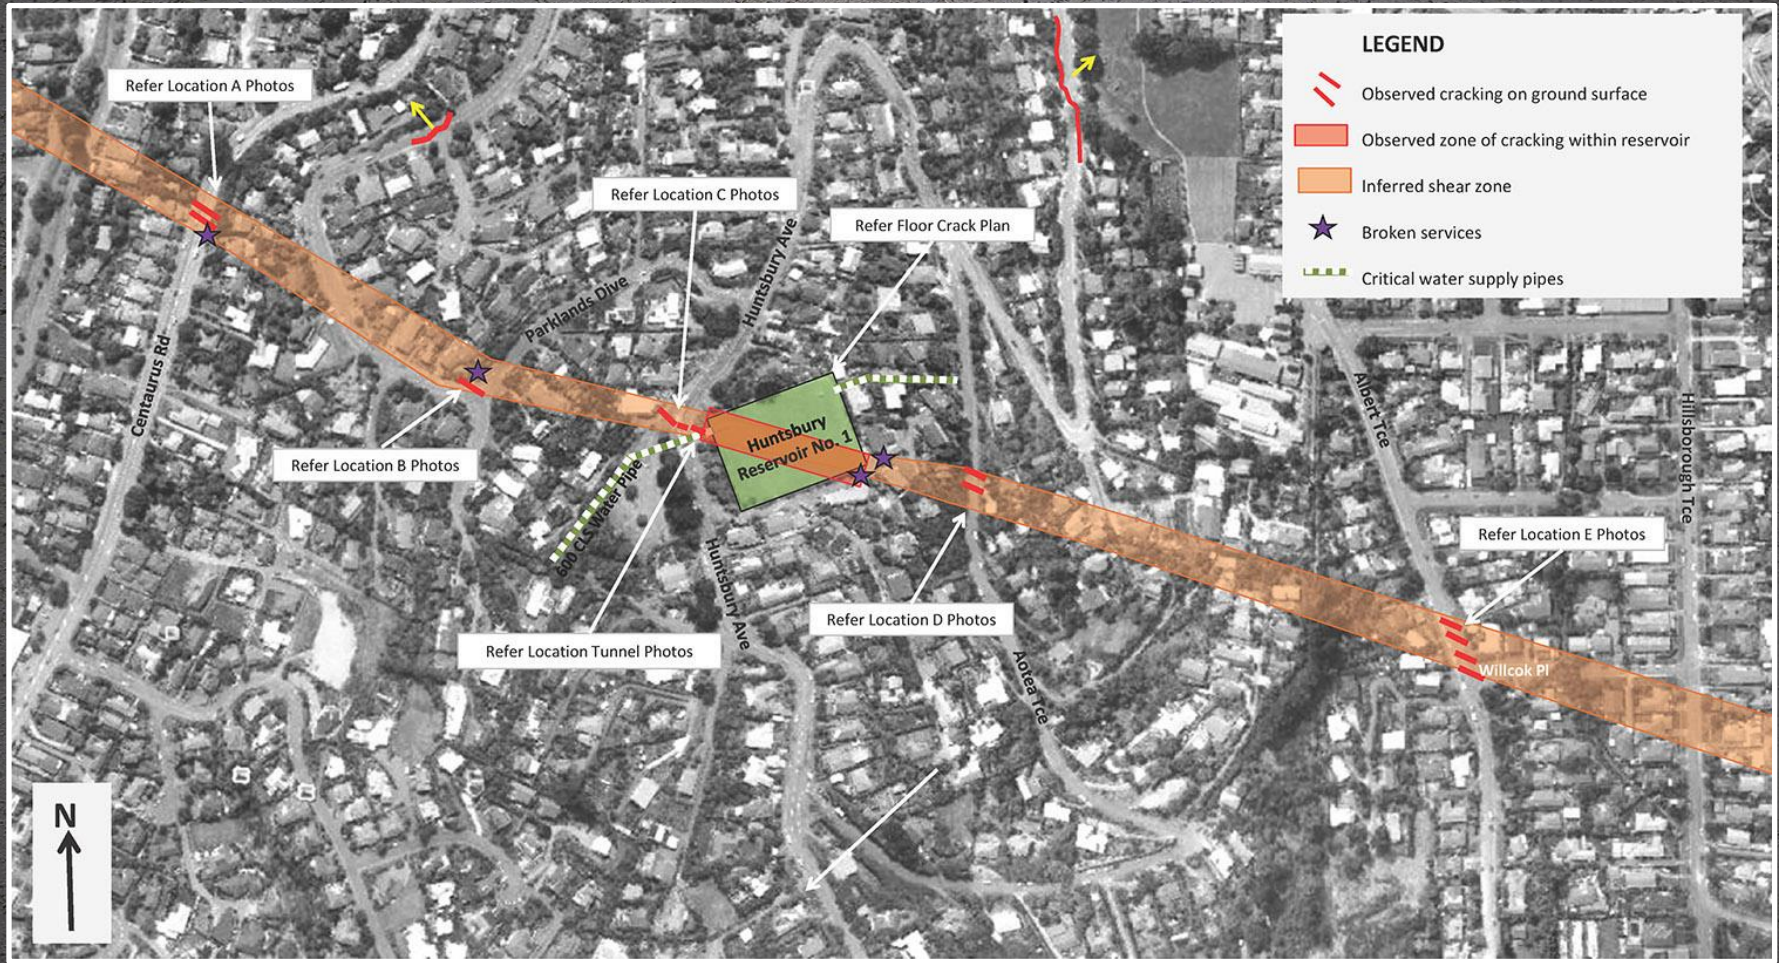
Inferred location of shear zone

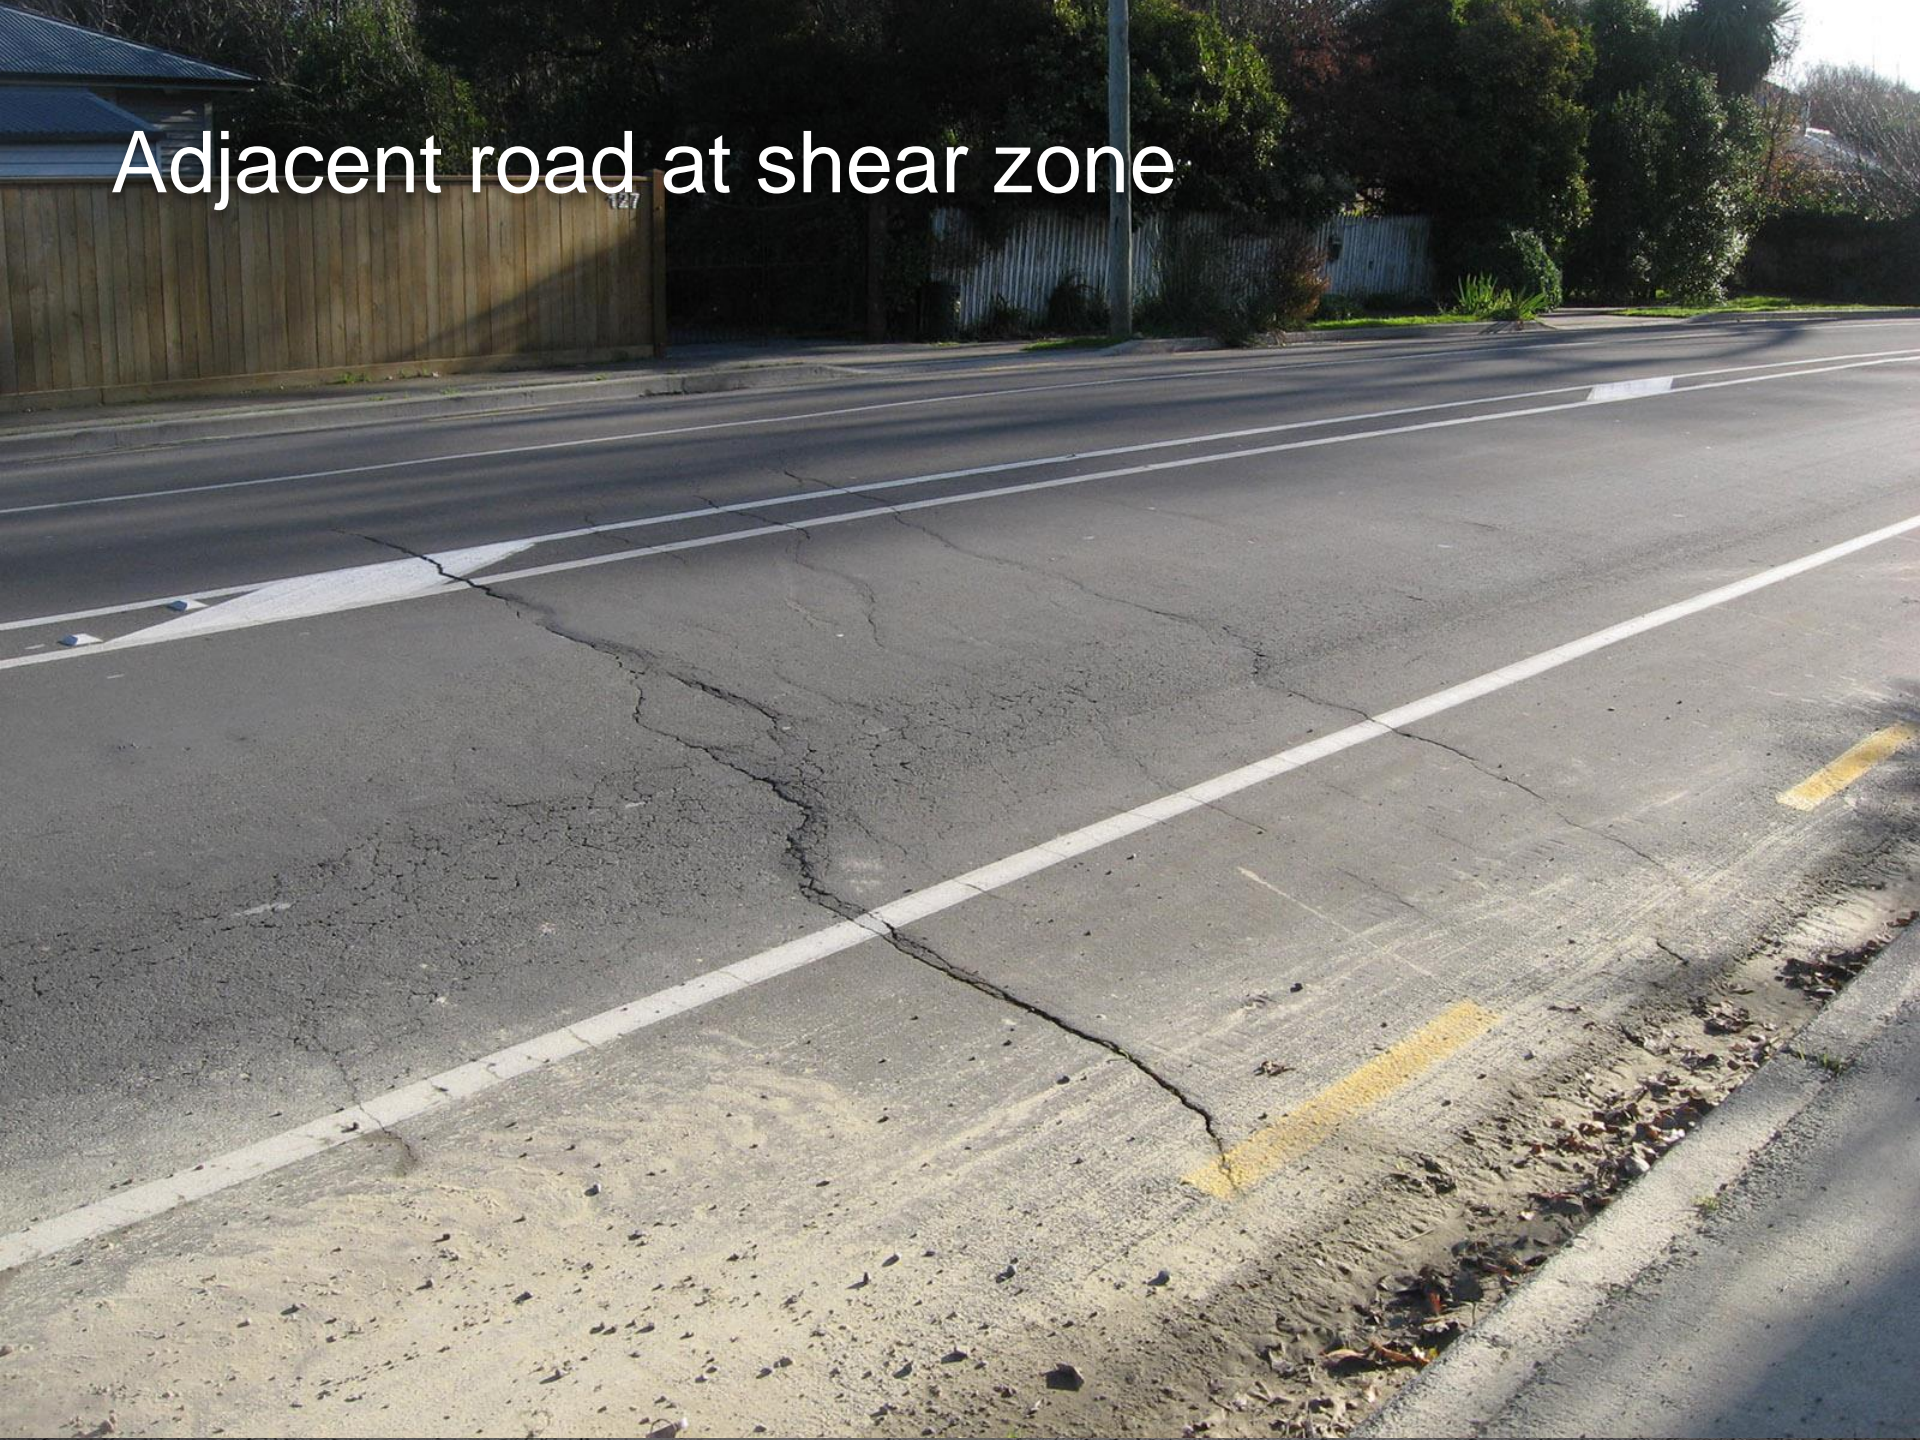
Adjacent road at shear zone

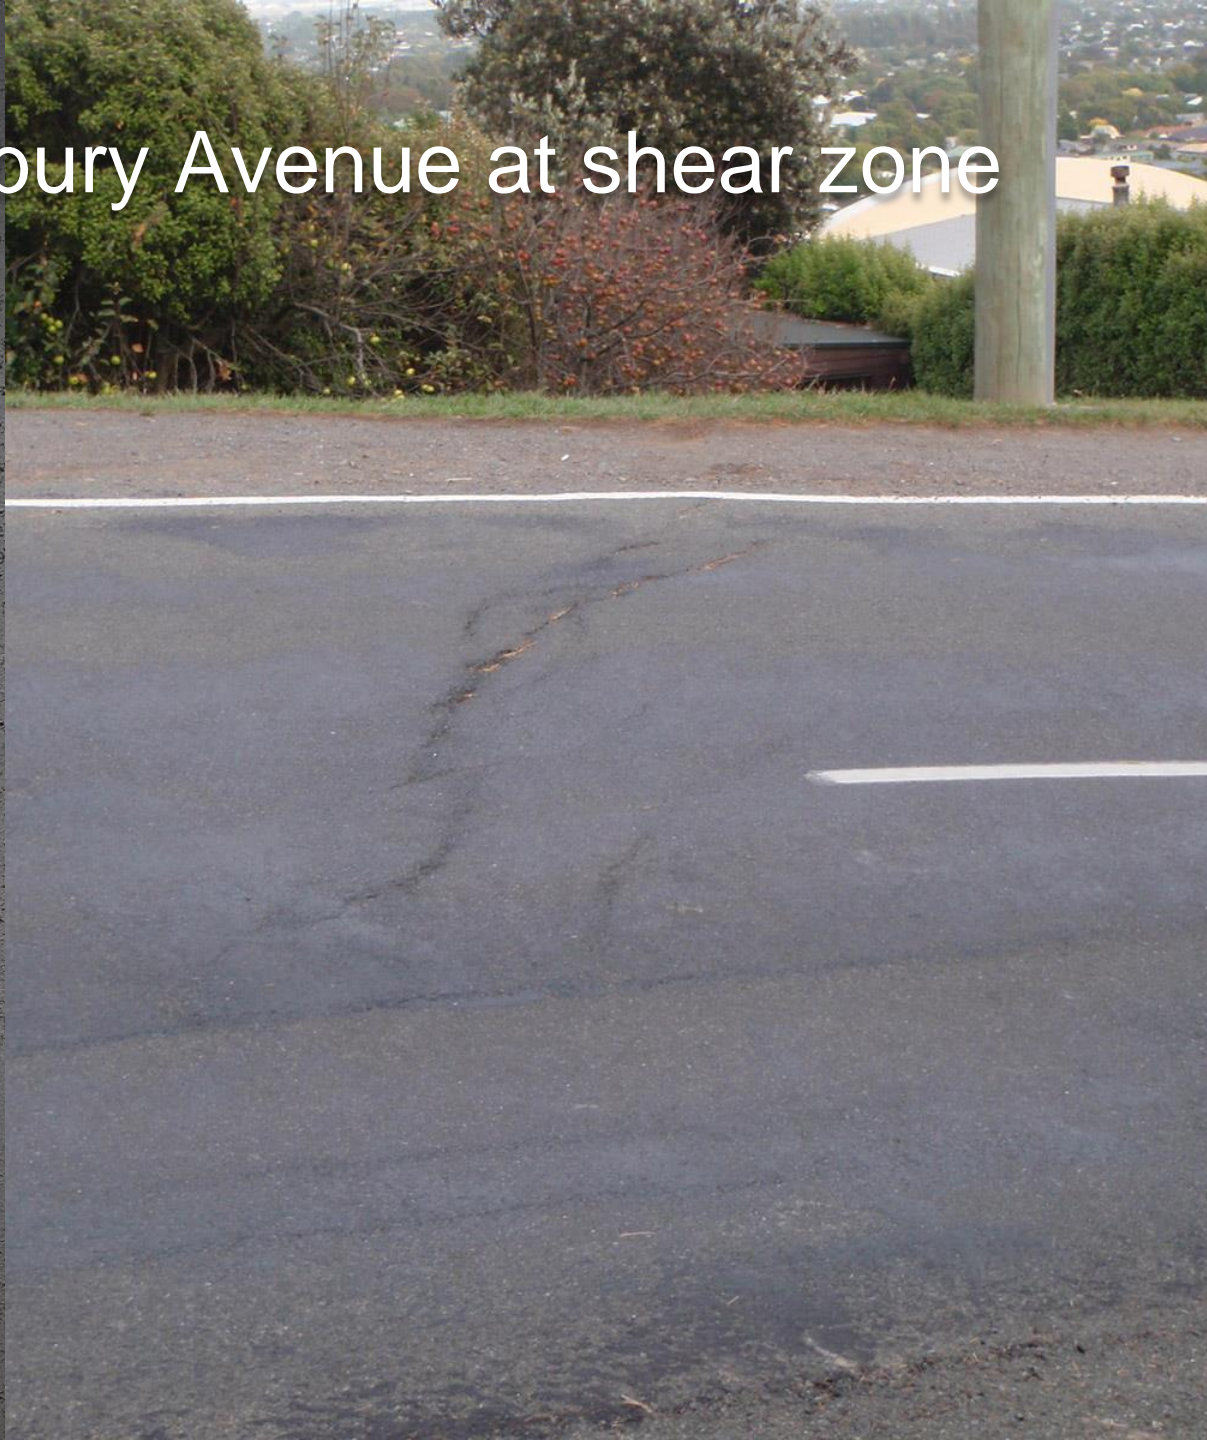
Huntsbury Avenue at shear zone

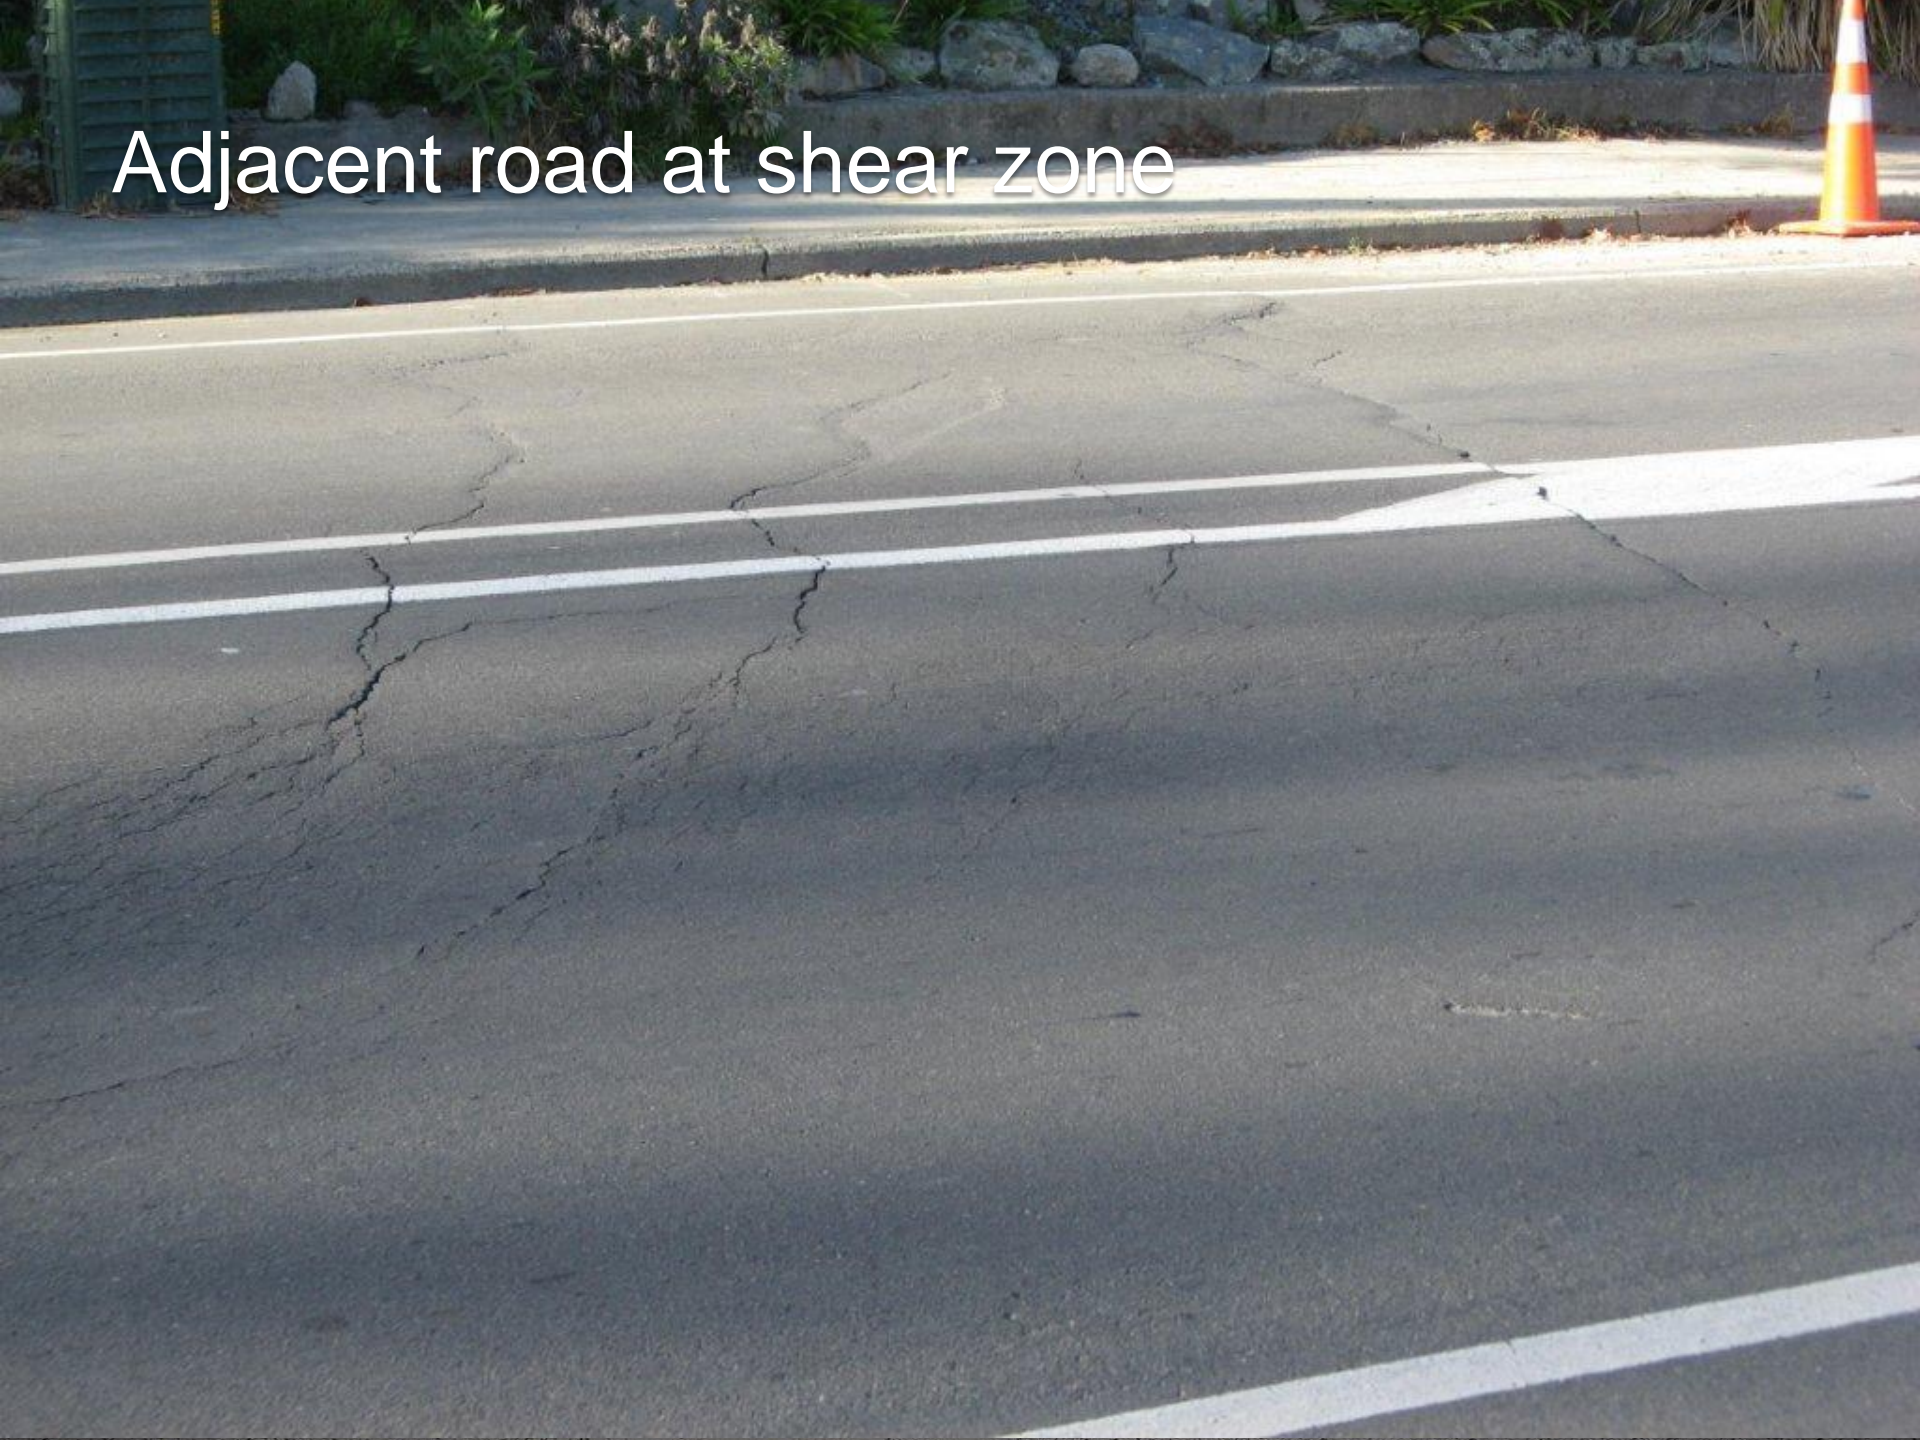
Adjacent road at shear zone

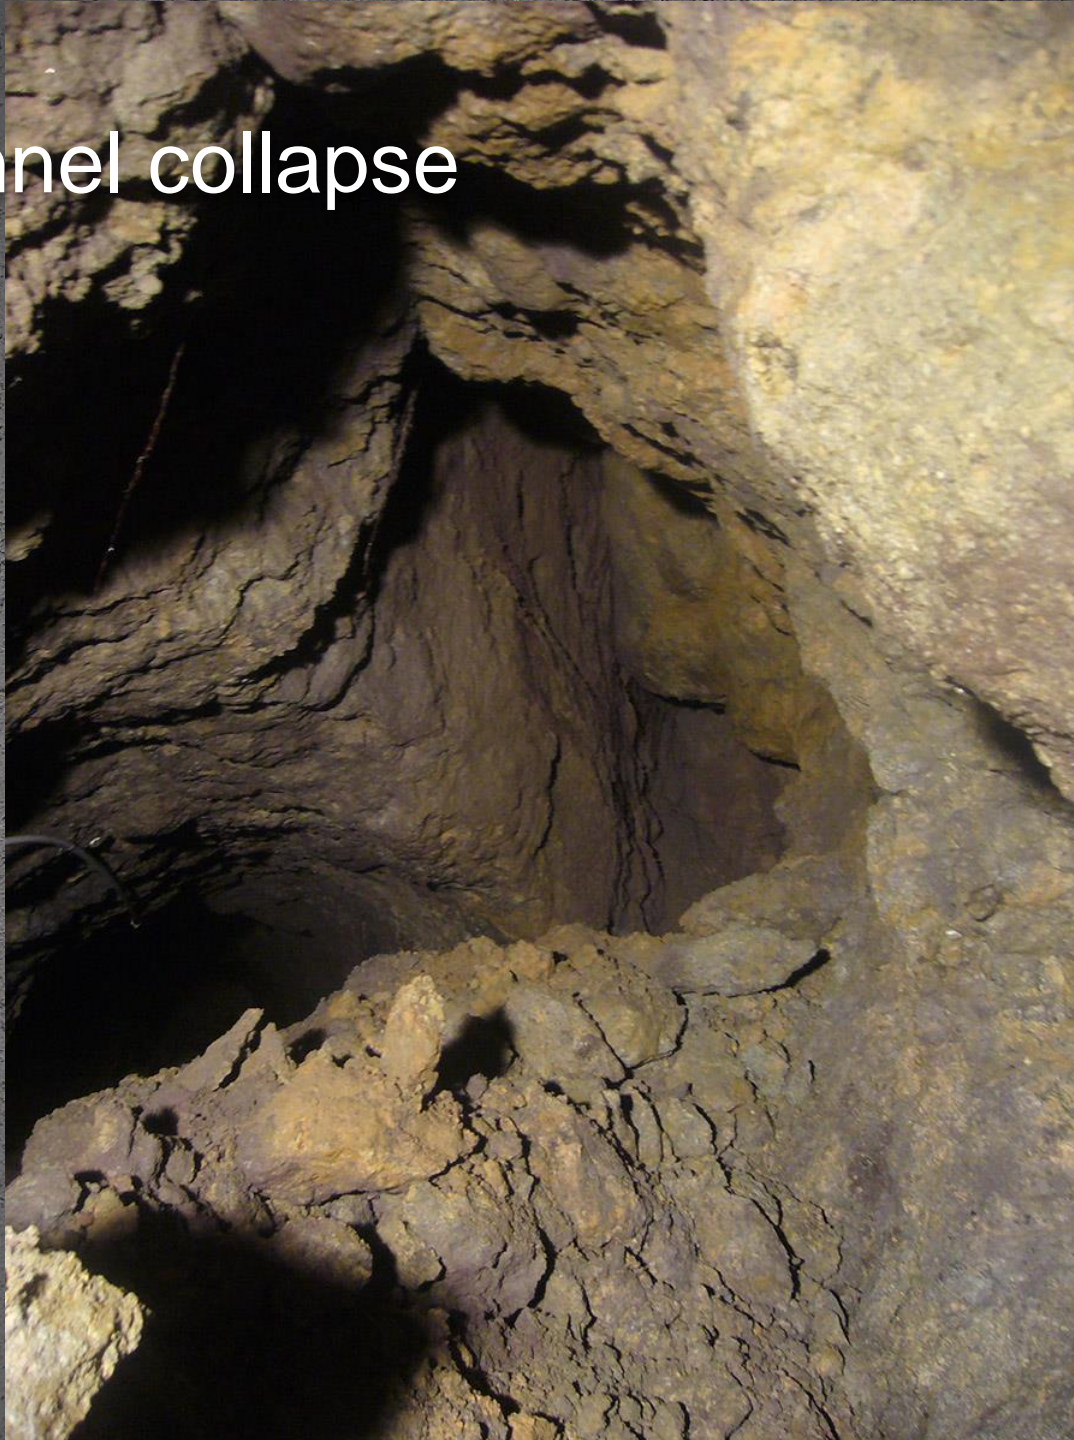
Pipe tunnel collapse

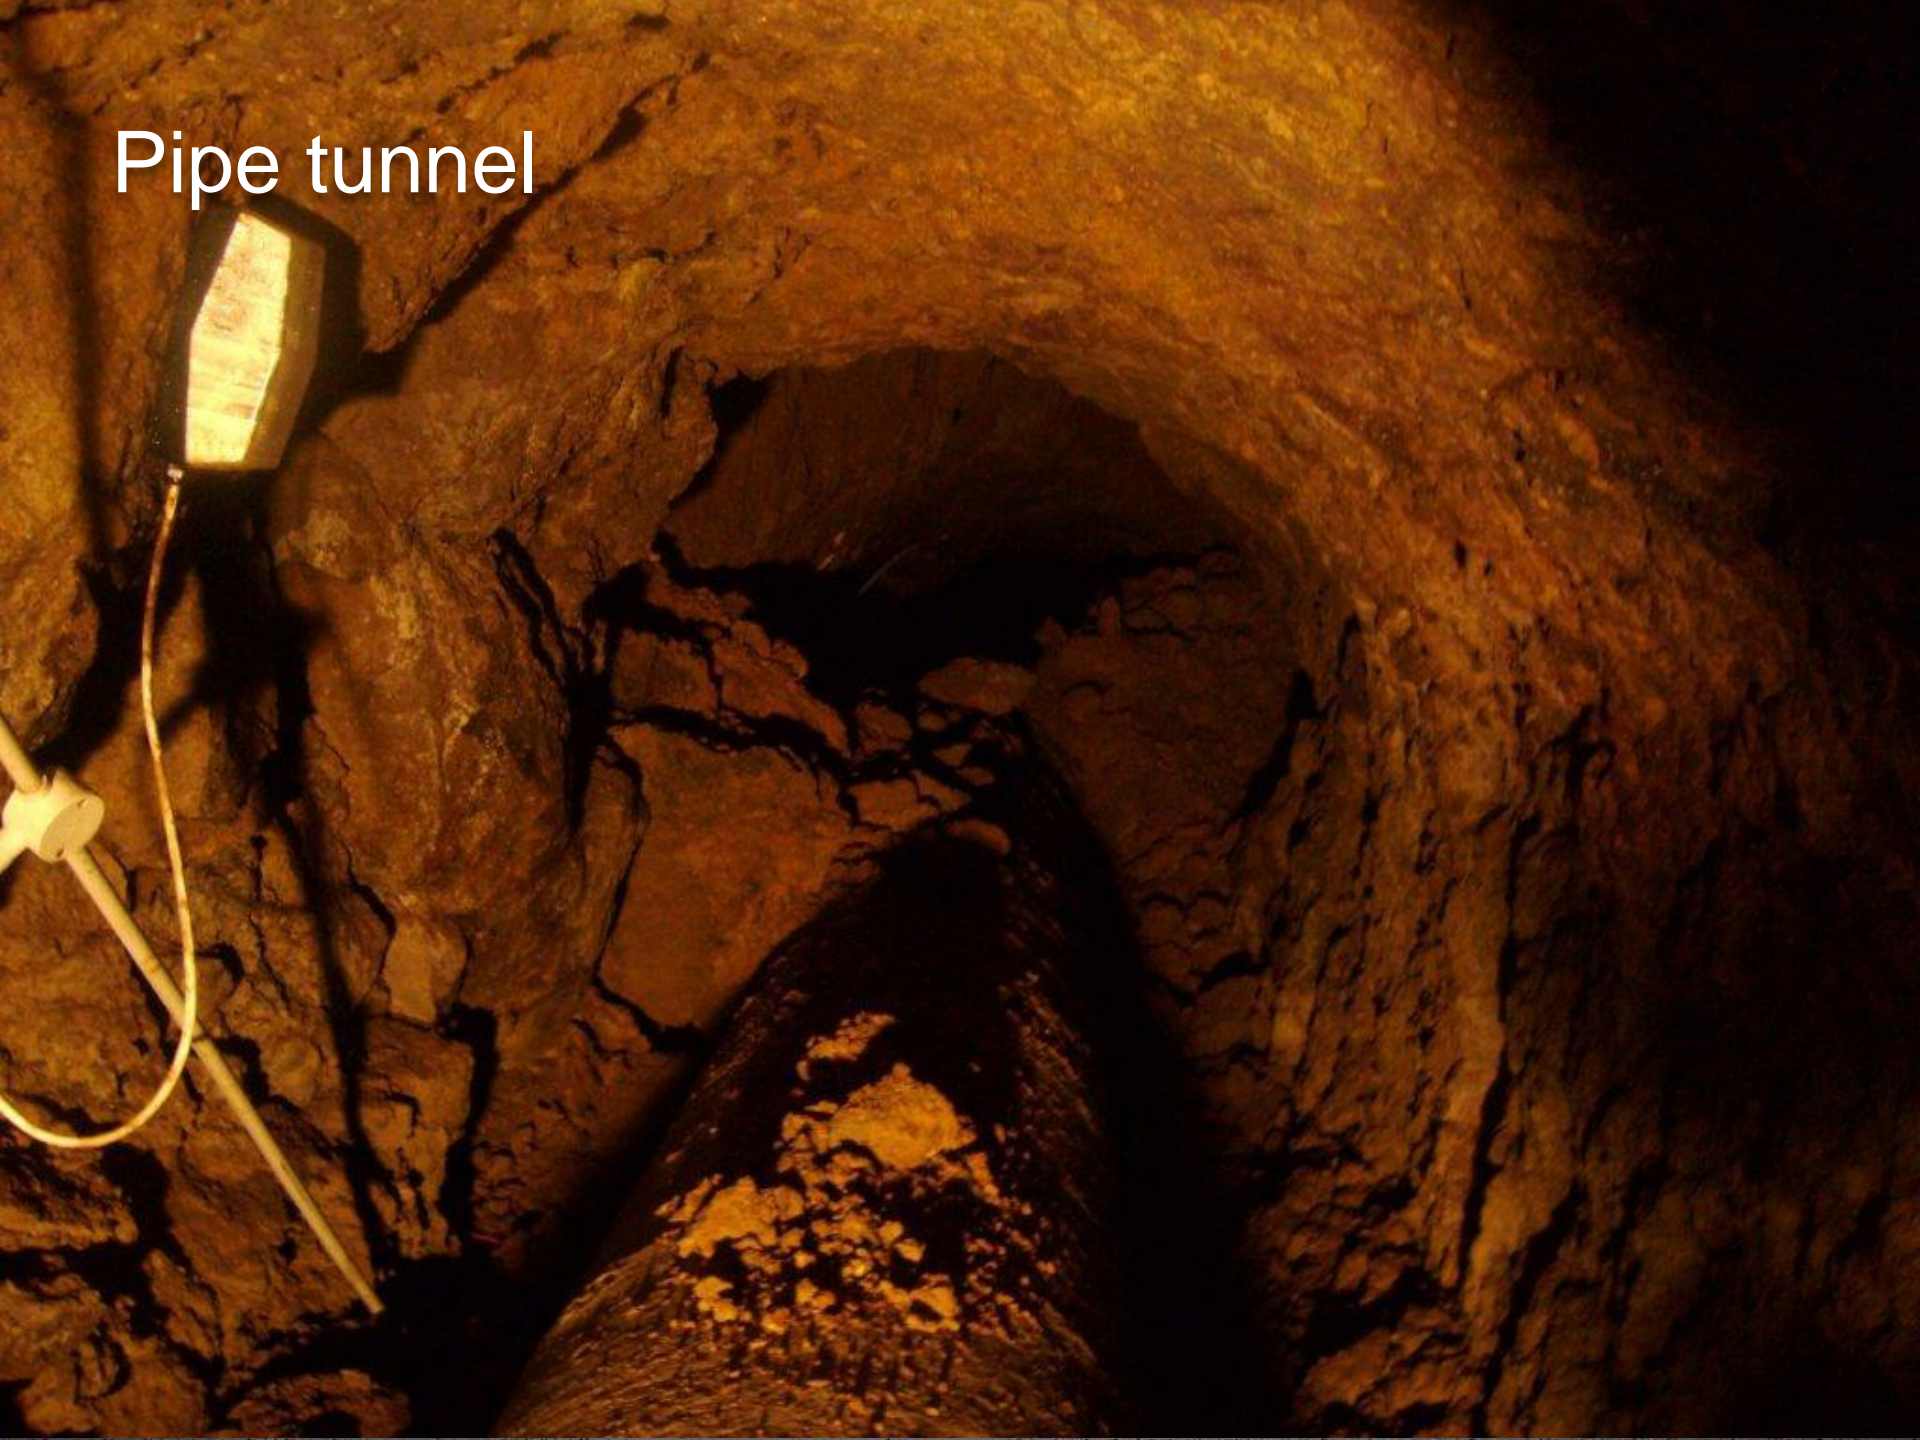
Pipe tunnel

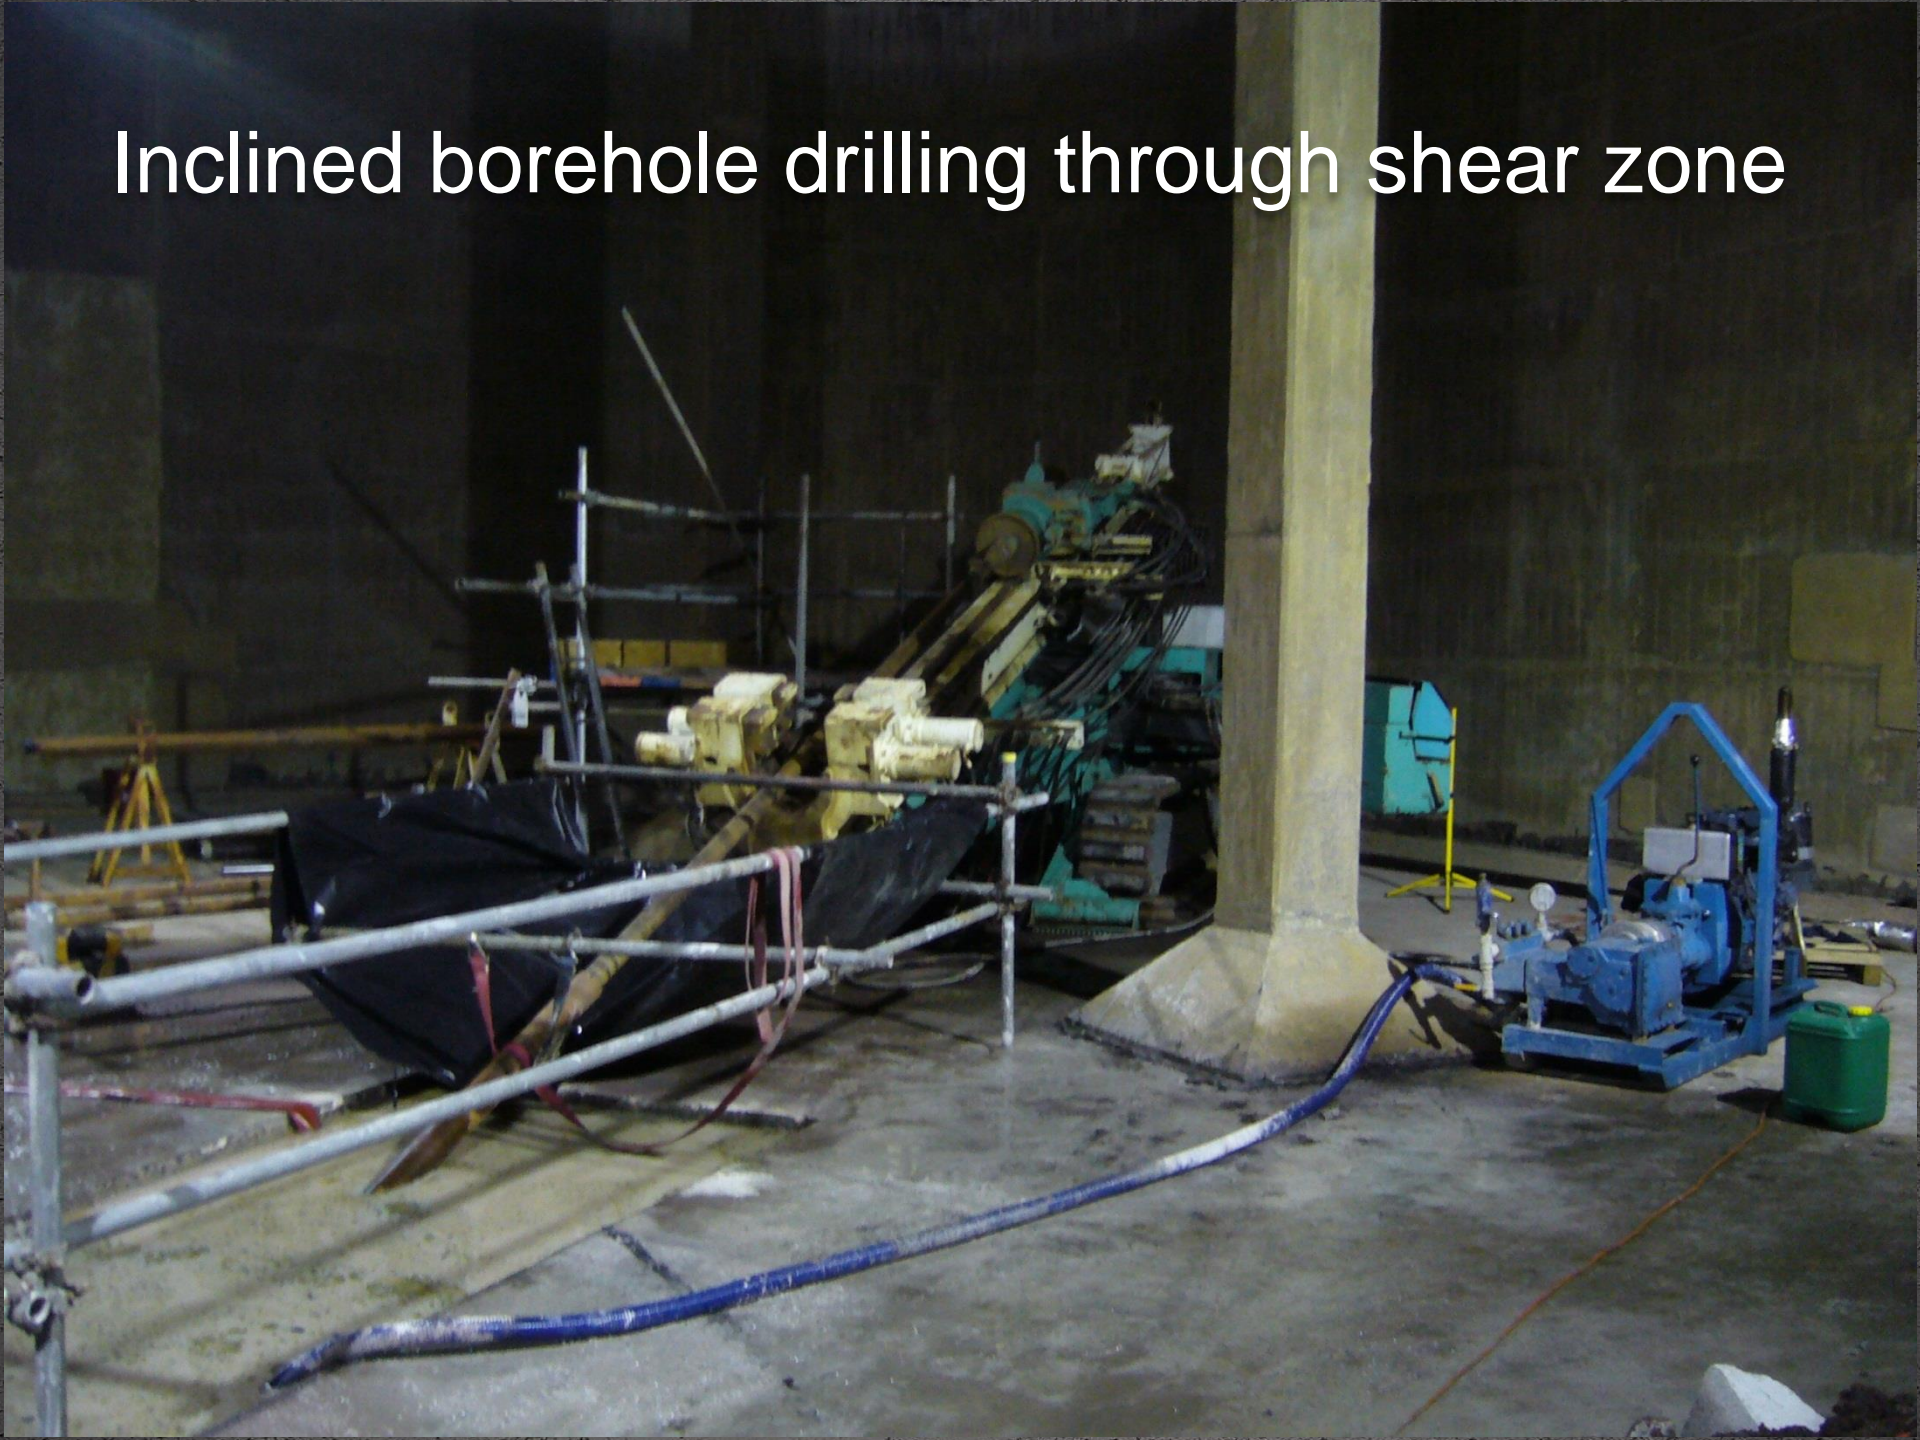
Inclined borehole drilling through shear zone

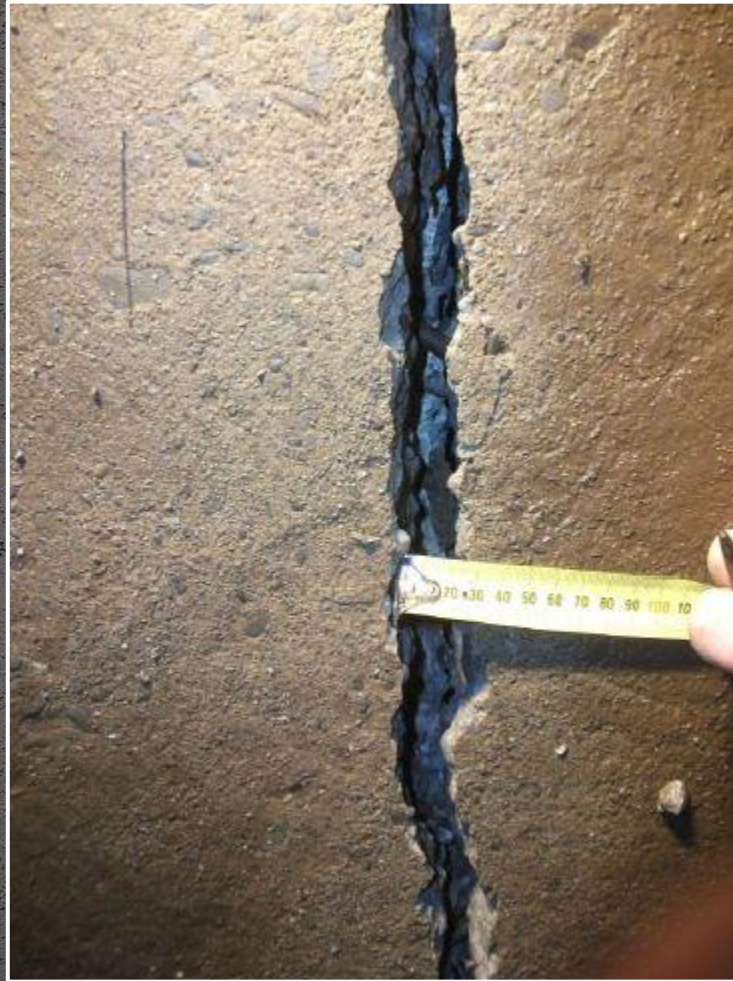
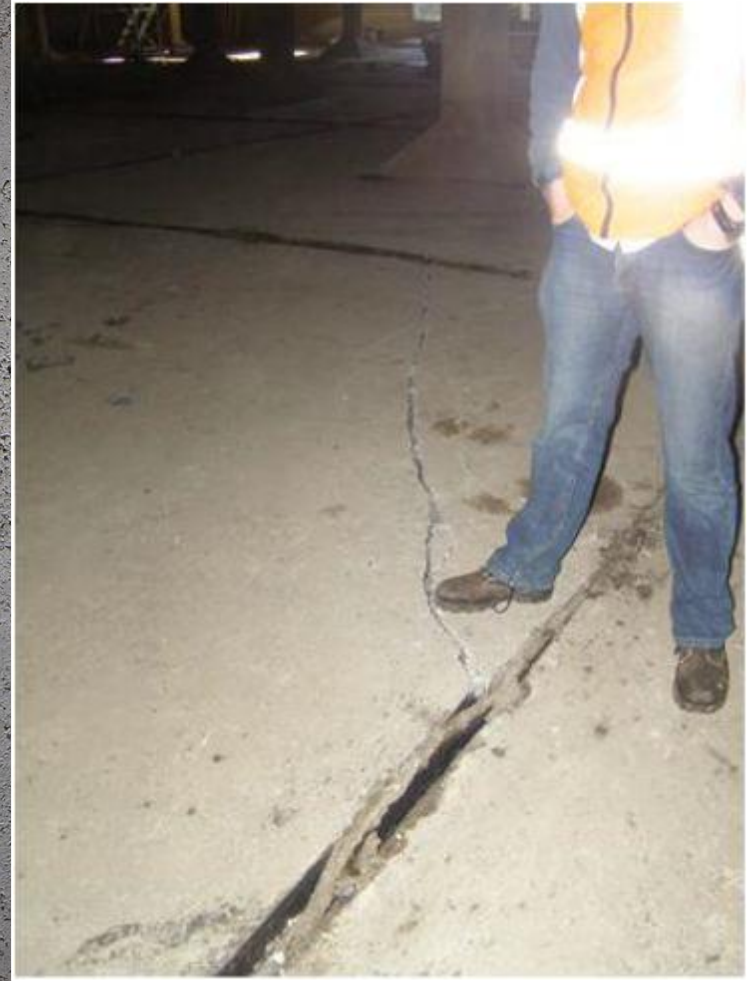
Floor slab damage

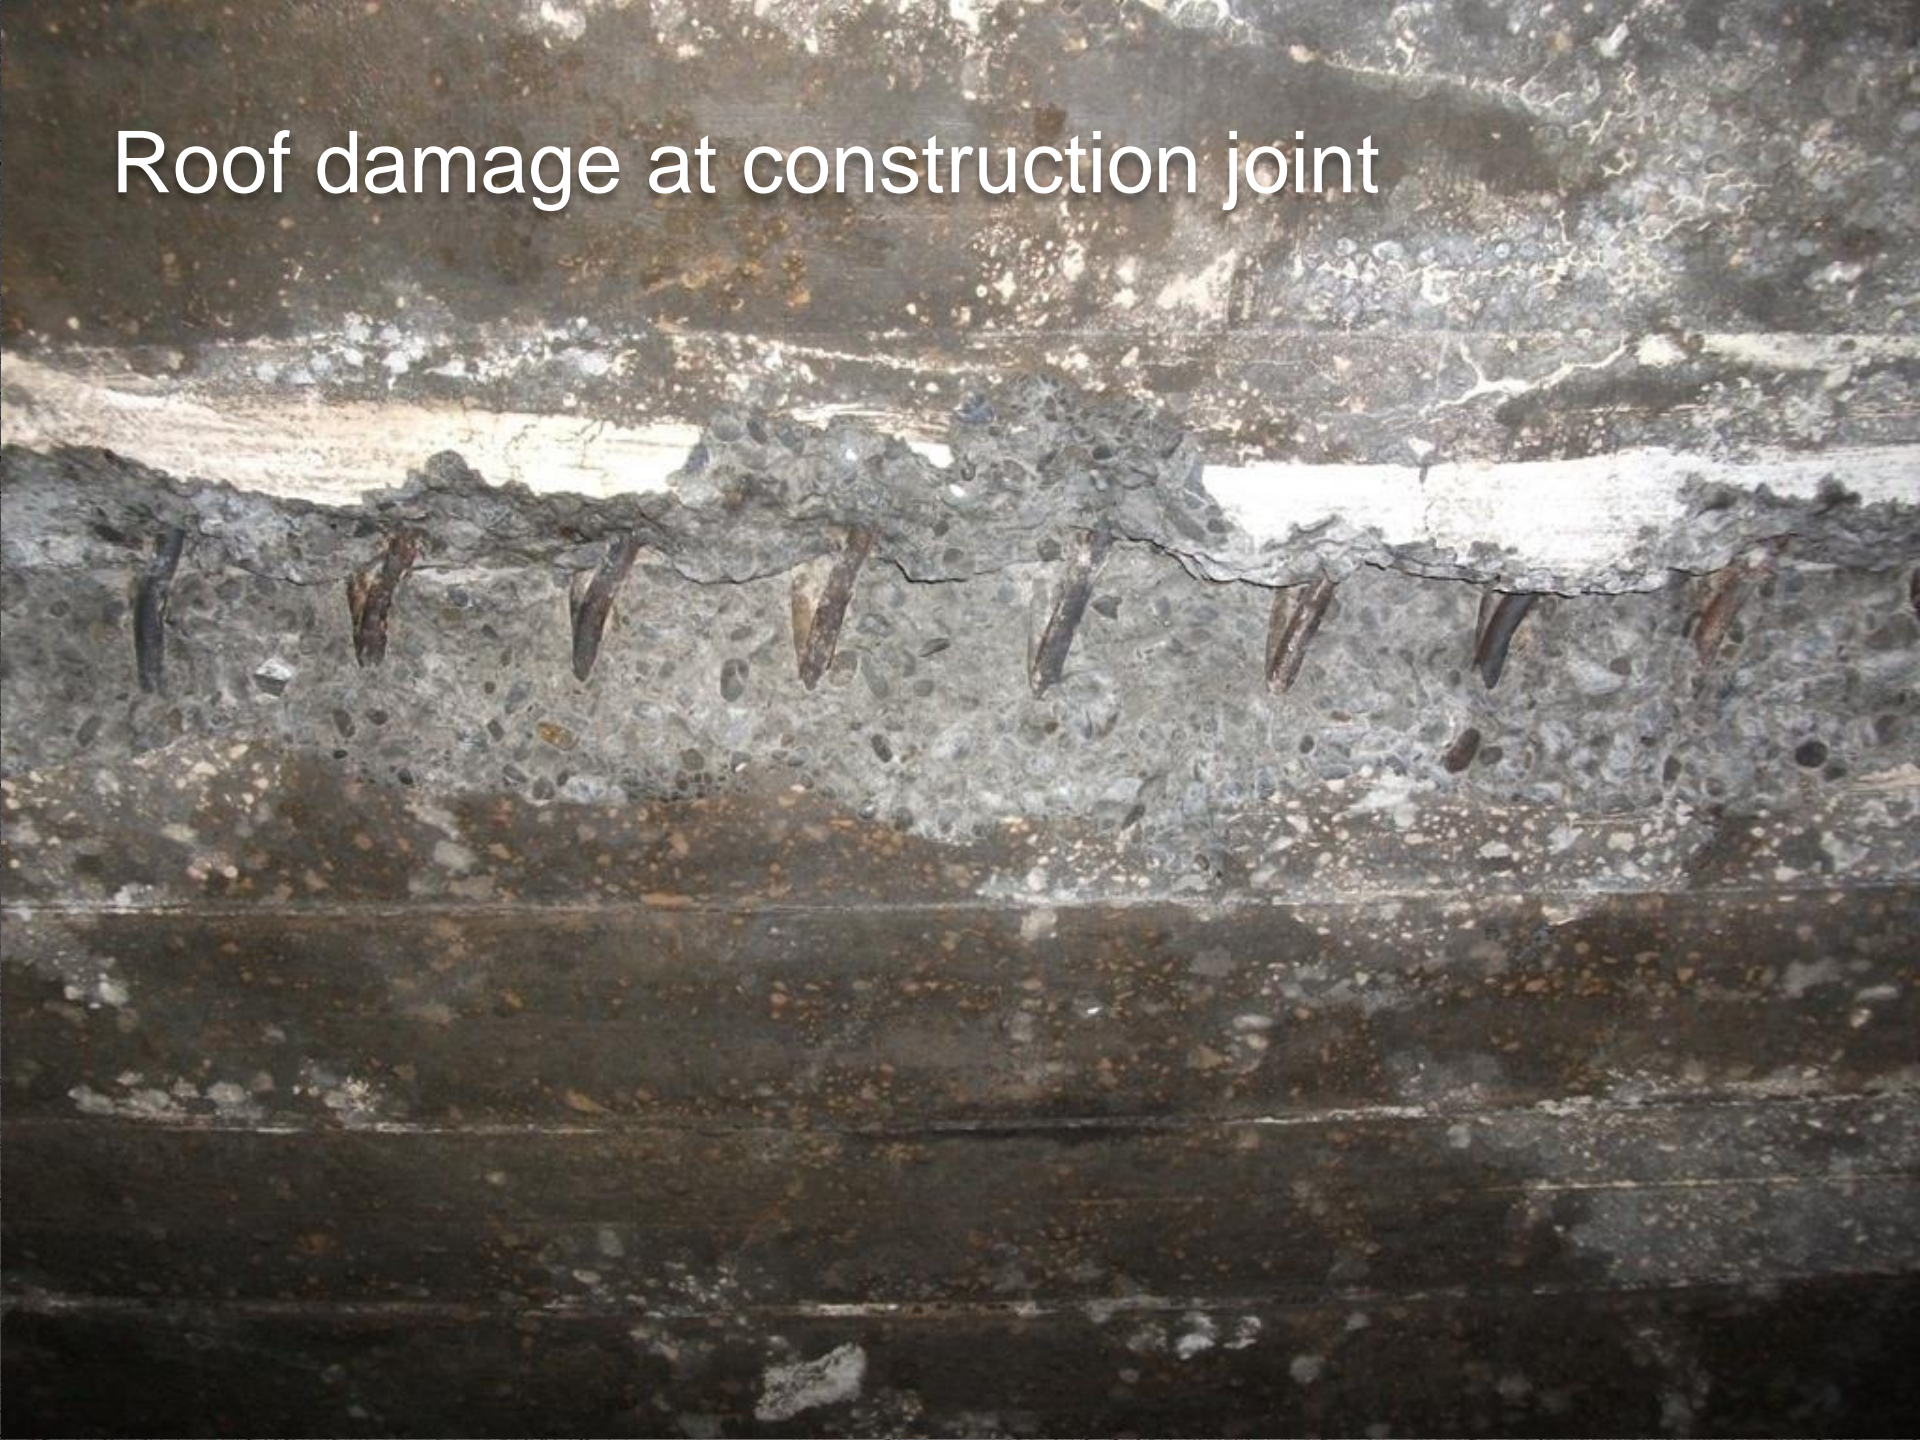
Roof damage at column head

Roof damage at construction joint
