## Huntsbury Reservoir - Post Earthquake Reconstruction Ozwater 2013 conference paper

A paper prepared for the Ozwater 2013 conference detailing the story of the damage to, and subsequent repair of, Huntsbury Reservoir.

# HUNTSBURY RESERVOIR POST EARTHQUAKE RECONSTRUCTION

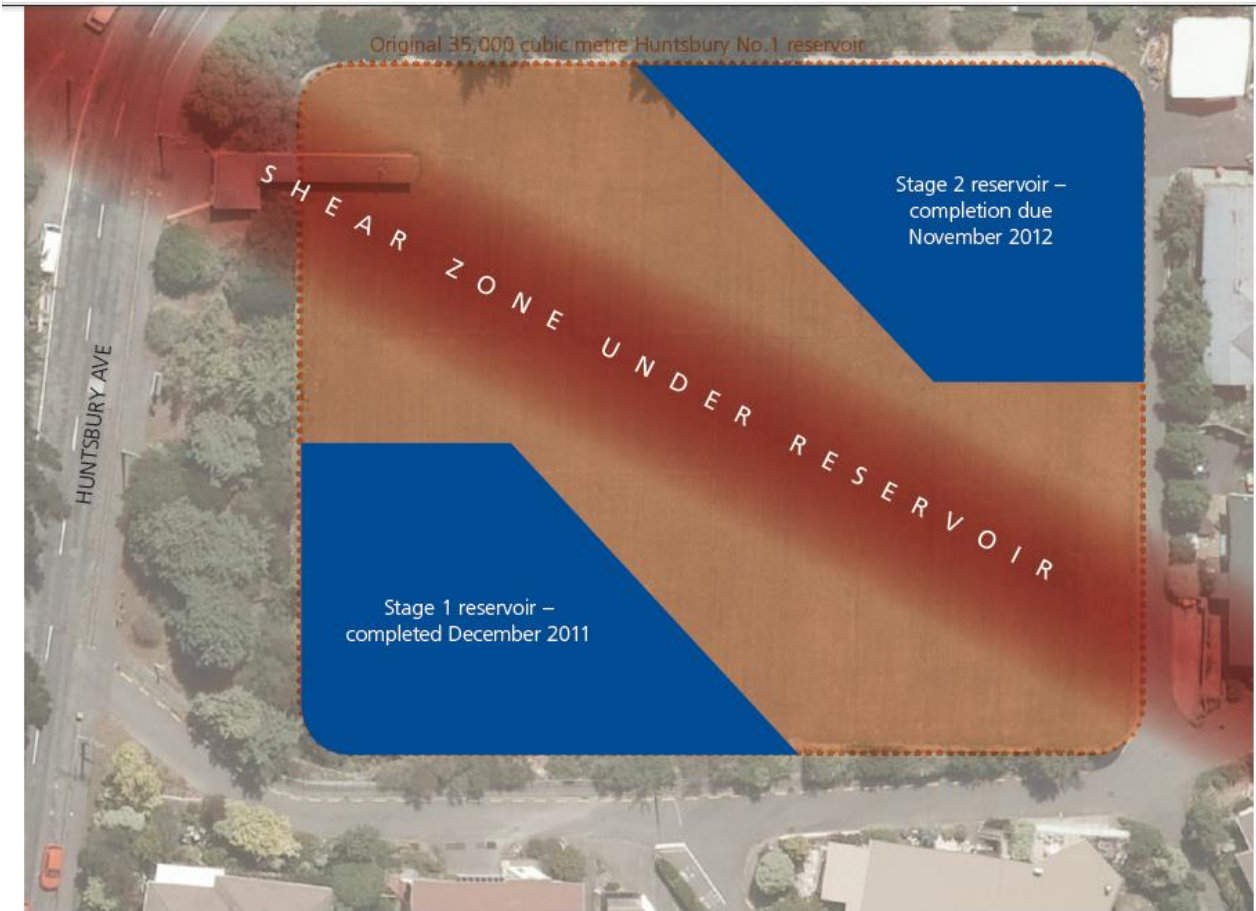
*Figure 1: Huntsbury No 1 reservoir plan*

Geological investigations were undertaken comprising inclined boreholes which confirmed the presence of the shear zone (refer to Figure 1). Inspection of the borehole material revealed interfaces where rock to rock faces had slid across each other and others where rock elements were separated by softer

The selected solution comprised two trapezoidal plan shaped reservoirs either side

of the shear zone (refer figure 1). The design required a new floor slab overlaid on the existing concrete slab, a new reinforced concrete foundation and walls adjacent the shear zone, re-use of the existing perimeter walls of the reservoir, and a new reinforced concrete roof. The existing roof column supports were also reused. The new roof slab was designed to allow a crane to operate on it during construction.

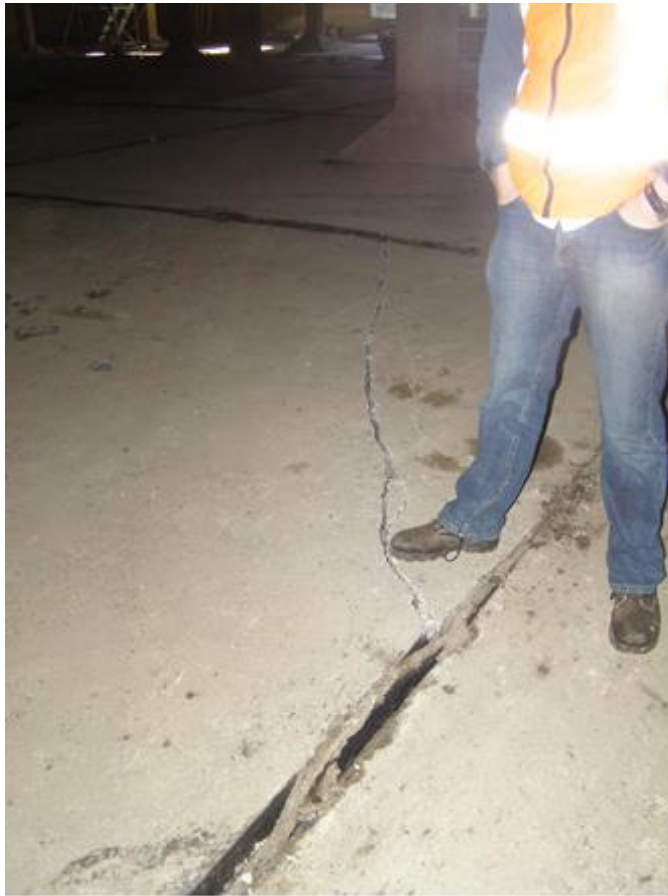
The floor consisted of two layers of reinforced concrete slabs. The construction joints in the upper slabs were offset from those in the lower slabs. The practice was followed in the 1950's with the design objective being to increase the potential leak path in the event of localised failure of the sealed joints in the upper slab. The slabs were reinforced but there was no continuity of reinforcement across the joints.

The slabs cracked extensively to the point of rupturing the reinforcing with the concentration

of damage being in an approximately 20 to 30 metre wide diagonal strip across the reservoir. Refer to Figures 3 and 4.

*Figure 3: Dislocated Floor Slab Joint*

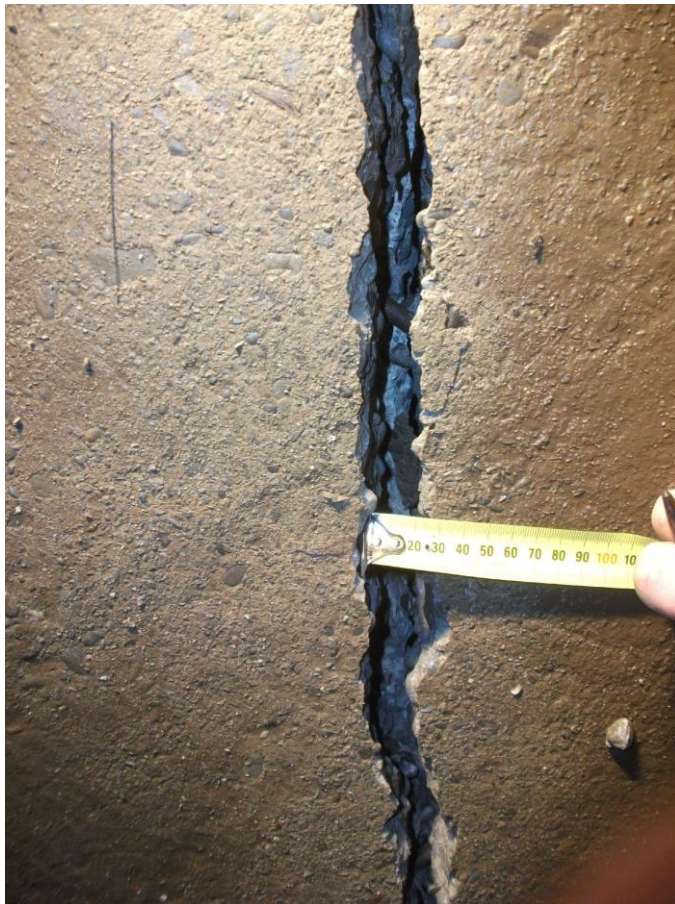
*Figure 4: Crack in Floor Slab*

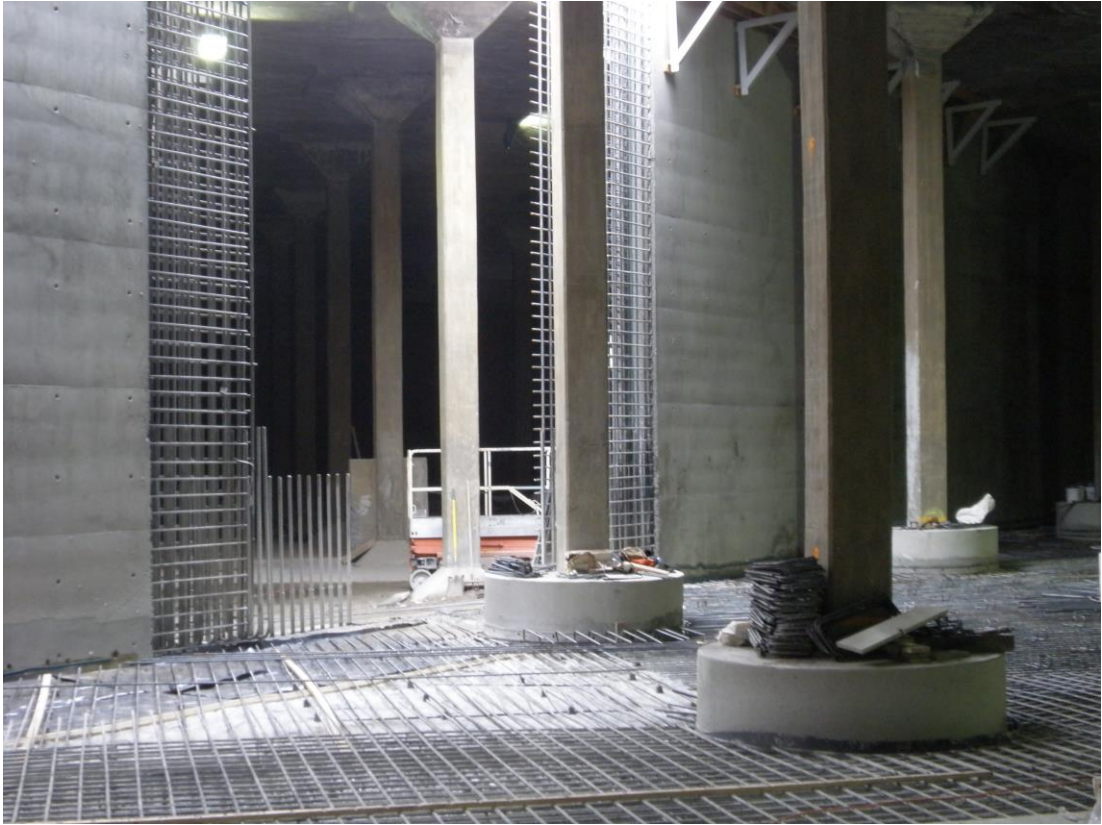
*Figure 5: New Floor and Wall Sections under construction*

The most challenging activity was the construction of the new wall at 8000mm high by 600mm thick. The chosen methodology involved designing and constructing a new roof overlaid on the existing roof so that a mobile crane could operate at this level. Progressive cutting of the existing roof slab was carried out to allow crane placement of reinforcement, formwork and concrete into the new wall section. This methodology maximised the work that could be done outside the reservoir and proved very successful. Refer to Figure 5.
