Seismically Induced Shear of a Concrete Reservoir in the February 2011 Christchurch Earthquake: Investigations and Response

ANZ 2015 // 22-25 February 2015

Marcus Gibson – Associate Geotechnical Engineer Beca Ltd / SCIRT

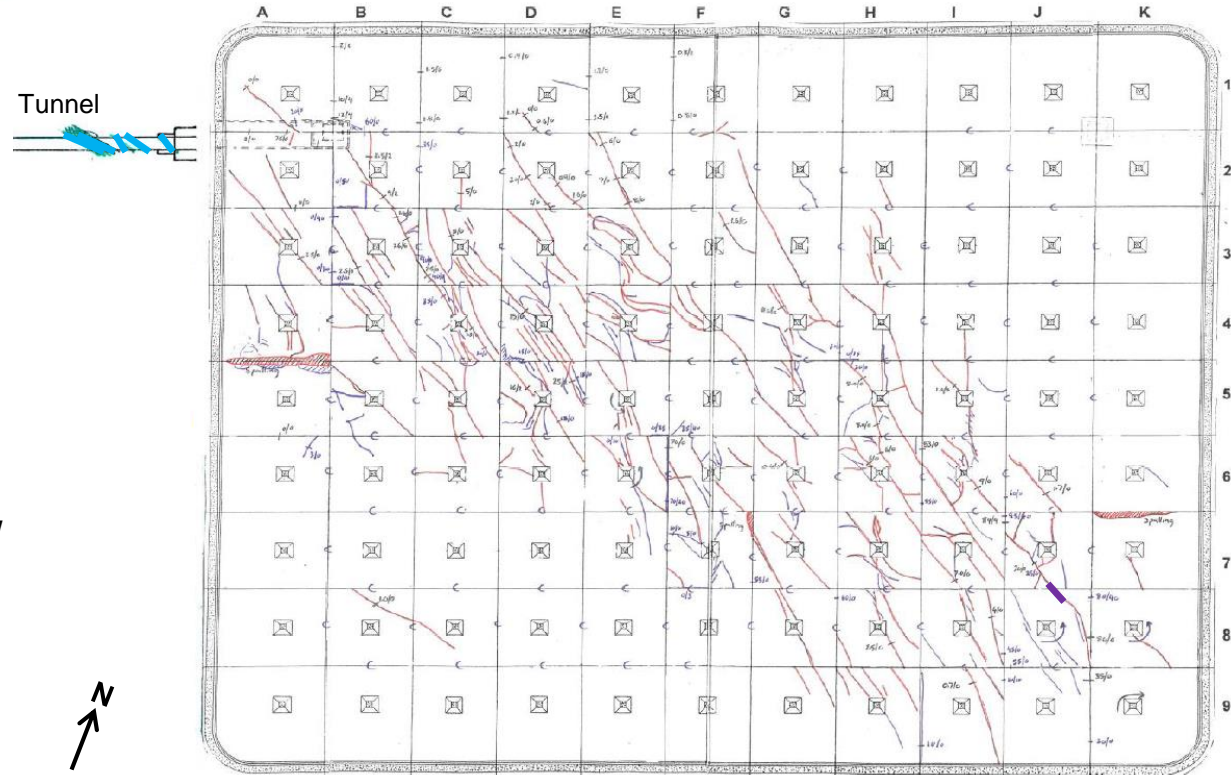
Crack Mapping

- Zone 20-25 m wide
- Oriented 280° - 300°
- Full depth of slab
- S moved ~ 50 mm NW

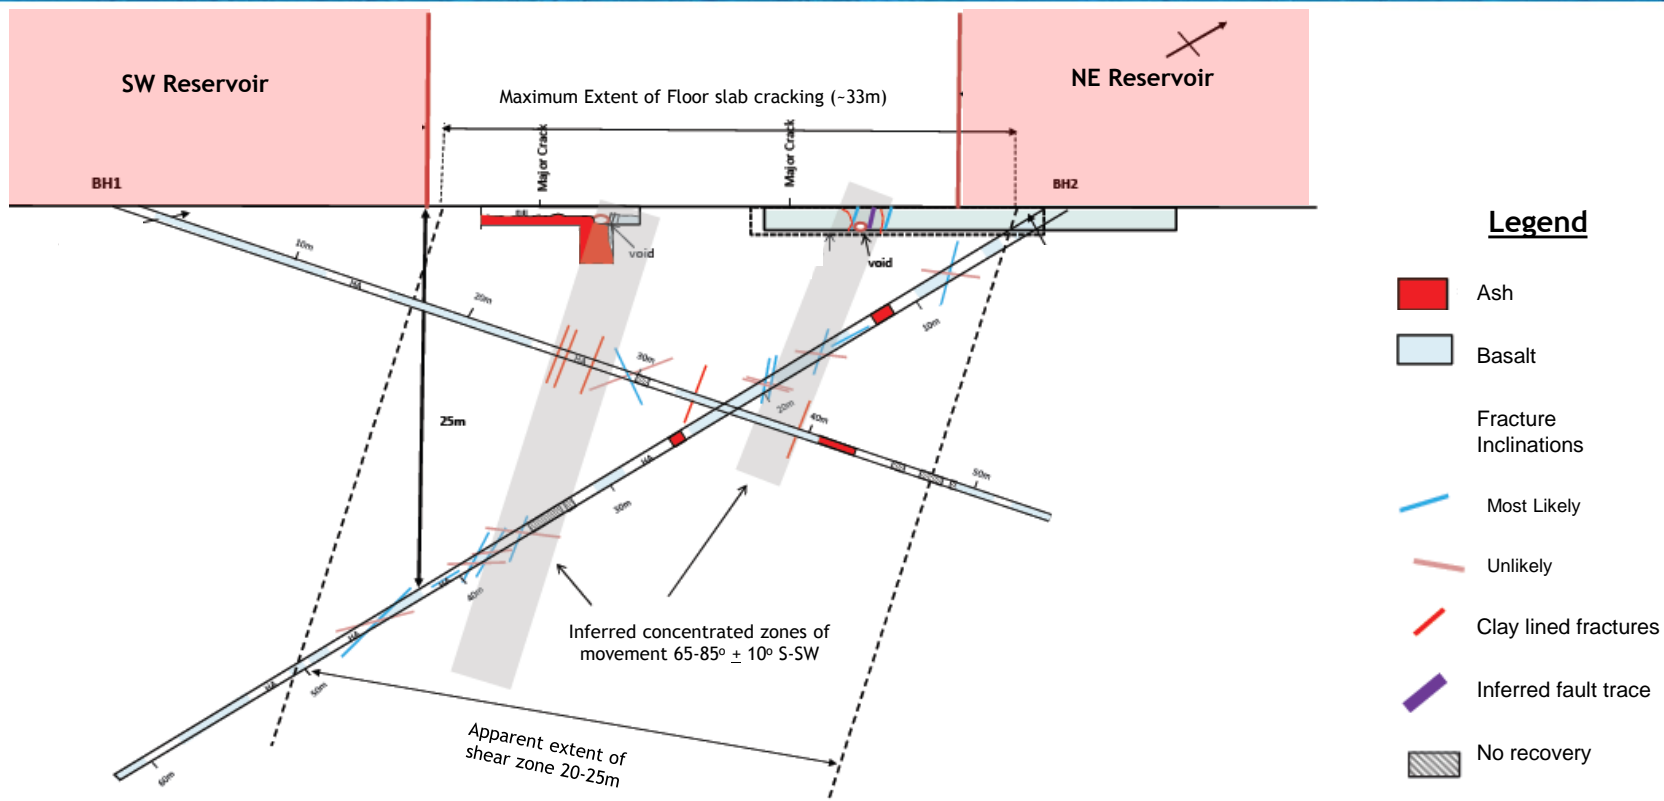
Interpreted cross-section of shear zone

- Expect further displacement during seismic events
- Not possible to forecast seismic events or movement.
- Potential 50-150mm of movement along shear zone over next 50 years
- Extent and width of shear zone 20-25m
- Principles of MfE 'Planning for Development of Land on or Close to Active Faults'
