Lessons learned from one of New Zealand's most challenging civil engineering projects: rebuilding the earthquake damaged pipes, roads, bridges and retaining walls in the city of Christchurch 2011 - 2016.

## Christchurch City lifelines – performance of concrete potable water reservoirs in the February 2011 Christchurch Earthquake

# CHRISTCHURCH CITY COUNCIL LIFELINES – PERFORMANCE OF CONCRETE POTABLE WATER RESERVOIRS IN THE FEBRUARY 2011 CHRISTCHURCH EARTHQUAKE

Ian Billings<sup>1</sup> and Nicholas Charman<sup>1</sup>

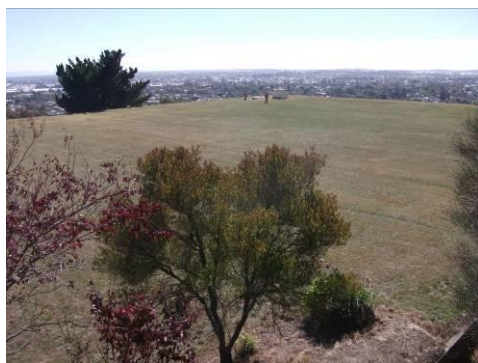
**Figure 1: Huntsbury No.1 Reservoir. Christchurch's largest reservoir (capacity 35,000 m<sup>3</sup>).**

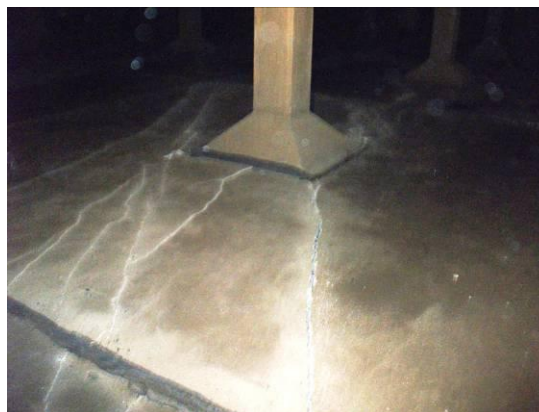
The main structural damage was cracking of the individual base-slabs with cracks of up to 35 mm width measured and movement of slabs both horizontally and vertically by up to 50 mm. This cracking had a distinctive pattern extending diagonally across the reservoir. A similar pattern of cracking was also observed in the roof and movement/slippage of up to 20 mm along construction joints measured. Discrete localised cracking was observed in the walls and the central, low height, dividing wall was severely damaged at one location consistent with the base-slab diagonal cracking pattern. The adjoining pump station was also significantly damaged plus the main 600 diameter inlet / outlet pipe. Refer figures 2 and 3.

Figure 2: Huntsbury No.1 Reservoir – base-slab cracking.

Extensive geotechnical investigation, including GPR surveying and inclined boreholes, indicated the likely presence of an underlying shear zone in the underlying rock extending diagonally across the reservoir footprint. This shear zone was considered the main reason for the observed pattern of structural damage. Following completion of a site viability report and detailed risk assessments of various concepts, the impact of the shear zone was assessed as being too high a risk for long term reliability of any structure constructed over it. Two significantly smaller reservoirs have therefore been proposed which will be constructed in the corners of the current reservoir footprint. The first replacement reservoir is currently under construction and due for completion in December 2011. The final configuration of the second replacement reservoir is still being assessed with construction completion anticipated around mid-2012. The estimated storage volume at the completion of reconstruction is about 12,000 m<sup>3</sup>, providing only approximately one-third of the reservoir's original capacity.

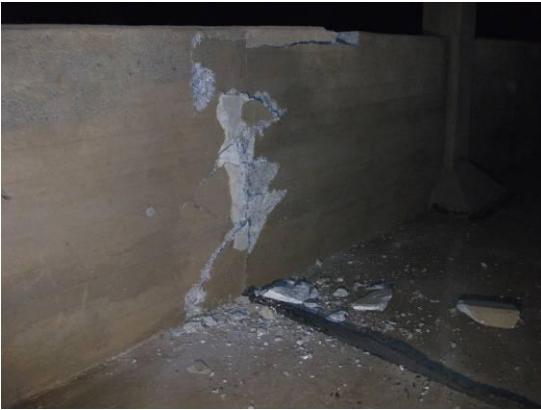
**Figure 3:** *Huntsbury No.1 Reservoir – dividing wall failure.*

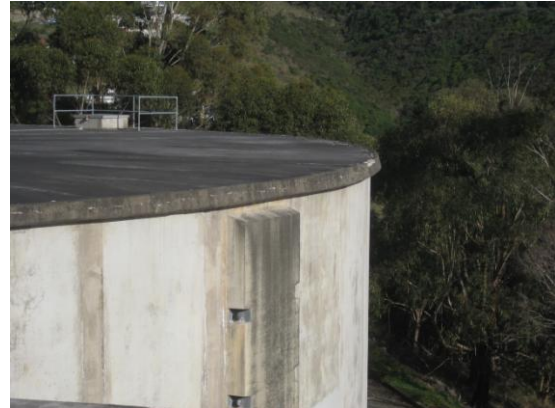
Damage noted to Reservoir No.1 is very similar to No.2 but its roof is more severely damaged due to extensive failure of roof-wall connections, and water appears to be leaking through the circumferential post-tensioning tendons.

**Figure 4:** *McCormacks Bay No.1 Reservoir – significant roof damage.*

The detailed seismic assessment identified vulnerabilities with the roof-wall connection, the wall to base connection, the wall circumferentially and a potential deficiency in resistance to sliding. The damage observed is generally consistent with the seismic assessment.

Repair and retrofit requirements are extensive and costly including; construction of a full base-slab overlay and internal ring beam to tie the wall in to the base-slab and to provide a direct seismic shear transfer mechanism, a ring beam around the top of the wall tied to the roof (No.2 reservoir) and bandaging of all wall vertical construction joints full height. Reservoir No.1 repairs are still being developed at the time of writing but expected to be similar, with the impact of water leaking through the tendons still to be assessed.

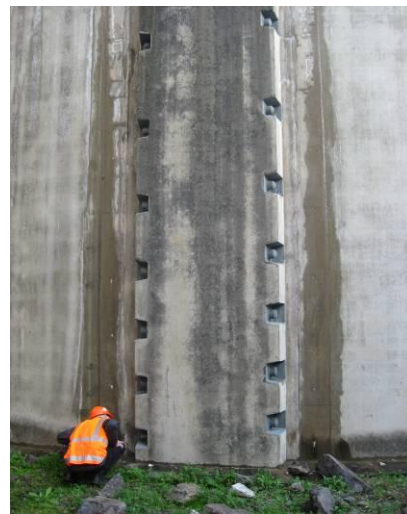
**Figure 5:** *McCormacks Bay No.1 Reservoir – leaking vertical construction joints.*

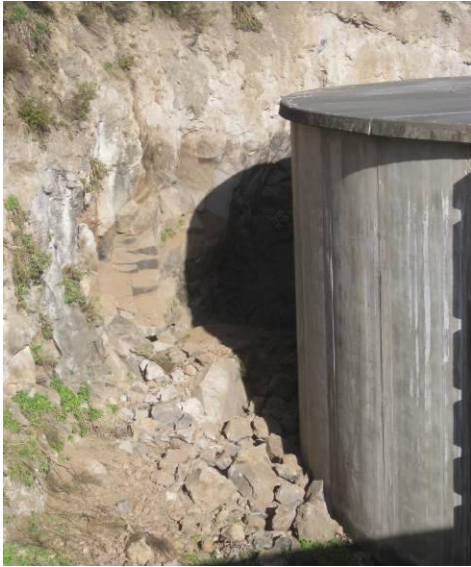
**Figure 6:** *McCormacks Bay No.1 Reservoir – rock fall behind reservoir.*

The McCormacks Bay site requires extensive, and costly, stabilisation. The access road to the reservoirs has significant cracking, settlement (up to 500 mm) and slumping towards the slope below the reservoirs. The stacked basalt block gravity wall supporting this road partially collapsed resulting in rockfall hazards to the road and residents below. Emergency temporary rockfall fences were installed to mitigate short term rockfall risks. A permanent piled replacement retaining wall is currently proposed along the edge of the road. The construction platform for the reservoirs was cut into rock and there is a near vertical face (up to around 21 m high) behind the reservoirs. The large ground accelerations that were experienced at the site on 22 February and 13 June led to significant loosening and dislodgement of material from the rock face. Rock and material has piled up behind the reservoirs and some rocks may have impacted the reservoir wall. It is currently proposed that reinforced steel mesh and a grid of rock anchors and soil nails be installed over the full extent of the cut face.

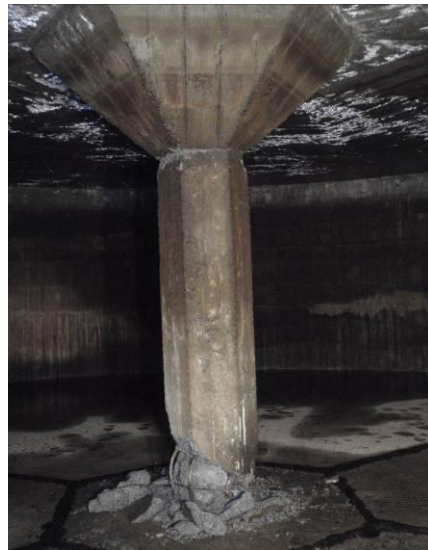
Damage noted includes failure of the internal column, sagging of the roof and shearing of the roof overhang at the roof-wall joint.

The roof has an overhanging nib with only a small overlap with the top of the reservoir wall. Under horizontal earthquake loading the roof has impacted the top of the wall and resulted in the overhanging nib shearing off. Excessive translation of the roof has subsequently occurred and resulted in the column failing due to only limited shear and flexural capacity. Refer to figures 7 and 8.

**Figure 7:** *Clifton 3 – internal column failure.*

Repair and retrofit includes break-out and reconstruction of the damaged top and bottom of the column, jacking of the roof vertically and fitting of a reinforced concrete ring beam at the top of the wall to restrain the roof against lateral movement. A kerb is also being constructed at the base of the column to provide additional restraint. Minor repairs to floor sealants and wall cracking are also required.

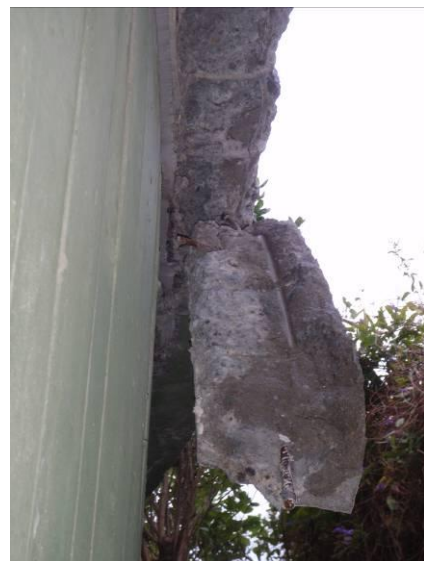
**Figure 8:** *Clifton 3 – failure of roof overhanging nib (repaired nib shown).*

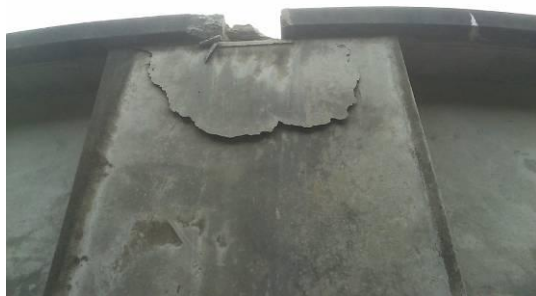
The roof comprises precast roof beams that are slotted into the reservoir wall and pilasters. Under horizontal earthquake loading the roof beams have impacted the wall and resulted in major cracking and damage to the top of the wall. At pilaster locations, the beams have punched off the wall concrete at the ends of the beams. The excessive roof movement has also resulted in damage to the top of the internal column. Refer figures 9 and 10.

**Figure 9:** *Upper Balmoral Reservoir –concrete shear failure at pilaster locations due to roof beam (concealed) impact.*

The detailed seismic assessment identified vulnerabilities in the roof-wall connections, the internal column and the wall to base connection.

Repair and retrofit includes break-out and reconstruction of the damaged top of the column, and fitting of a reinforced concrete ring beam at the top of the wall (tied to the roof beams). An internal ring beam is to be constructed to tie the wall into the base-slab and to provide a direct seismic shear transfer mechanism.

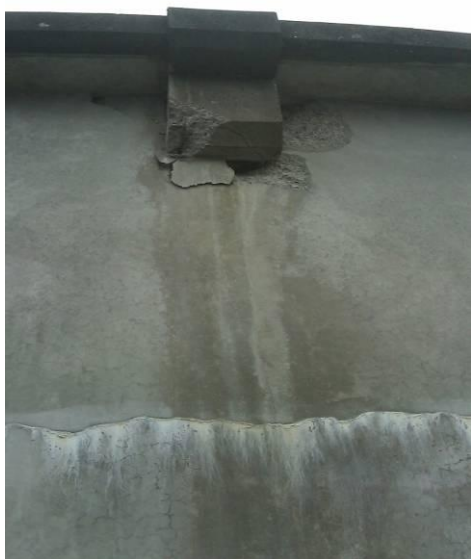
**Figure 10:** *Upper Balmoral Reservoir – concrete damage at roof beam wall support.*
