Lessons learned from one of New Zealand's most challenging civil engineering projects: rebuilding the earthquake damaged pipes, roads, bridges and retaining walls in the city of Christchurch 2011 - 2016.

SCIRT Safety Alert – SCIRT Critical Risk #3 powered plant and tools – first aid injury

SCIRT CRITICAL RISK #3: “Powered Plant & Tools”

First Aid Injury

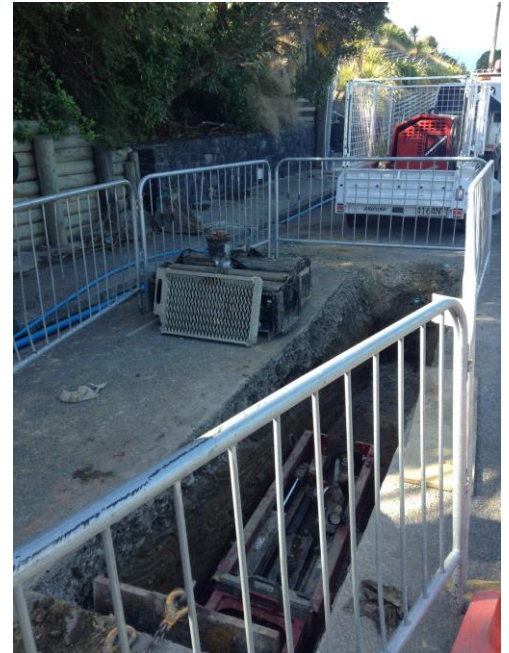
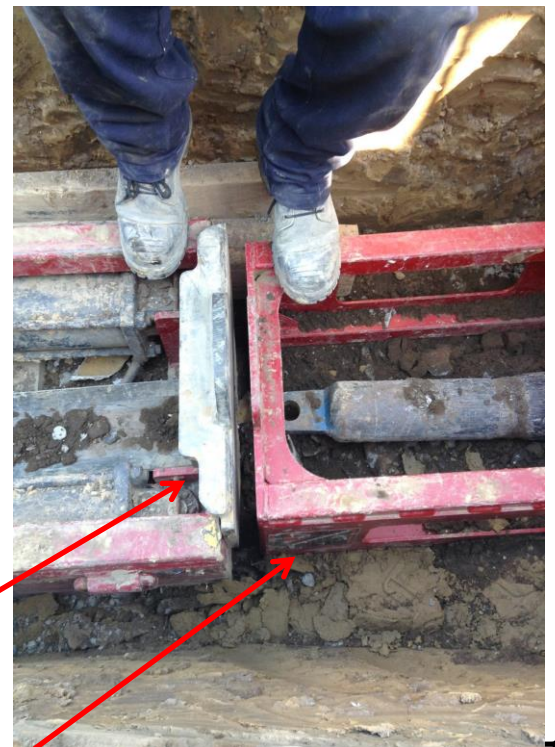
On Wednesday 14th October a crew member was putting a steel frame in the pit for the pipe burster, when his hand became stuck between the steel frame and the steel plate on the burster side. This caused an injury to his fingers. Gloves were worn at the time.

The machine was not operating at the time. The burster machine had been jacked back and the frame/spacer was lowered into the pit. The gap between the lifting lugs on the spacer and the bursting plate was not wide enough – the hand was caught by the downward motion. As the frame was lowered into the pit his fingers were caught.

Bursting plate

Frame of spacer

- Keep all body parts away from pinch points when using equipment.
- Remove bursting plate first.

Consider what the risk is, even when completing small tasks. Following this incident, a job methodology will be written up detailing steps to prevent any repeat incident. Lifting lugs should be repositioned so pinch points are removed.
