The Strengthening of Heritage Bridges - Construction Challenges

A conference paper prepared for the 4th Australasian Engineering Heritage Conference which outlines the challenges faced by SCIRT when repairing the Armagh Bridge, Colombo Bridge and Antigua Bridge.

The Strengthening of Heritage Bridges – Construction Challenges

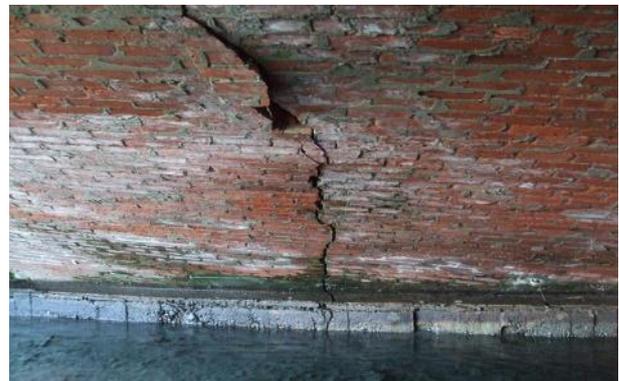
The Feb 2011 seismic event caused a longitudinal crack in the arch soffit measuring up to 20 mm in width. The crack was visible in the soffit but did not present through the layers of basecourse and sealing to the road surface.

Figure 2. Longitudinal crack in the soffit

The repairs specified included investigation and reporting on the extent of the crack, repairs to the crack itself, refurbishment of the cast iron balustrading and repairs to the footpaths and road surface.

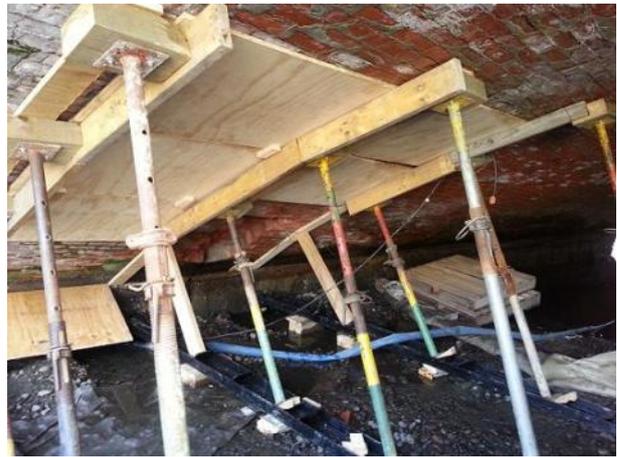
Figure 5. The temporary works in place.

An ingenious bearer member, fabricated from a steel channel section and hinged to a plate bolted to the abutment was designed to rest on the river bed. The hinge allowed the bearer to rotate to the angle of the existing river bed and assured a reliable load path. A series of ‘chock plates’ were pre-welded into the channel so that readily available ‘Acrow Props’ could be placed with their bases fitting squarely in the channel and their tops set tangentially to the curved soffit.

Effectively, this provided a series of props to the soffit at spacings of 1.5m in each direction for the

area to be repaired. Removable plywood panels were placed in the spaces between the props so that small areas could be sequentially opened up for repair whilst the remaining areas had temporary supports in place.

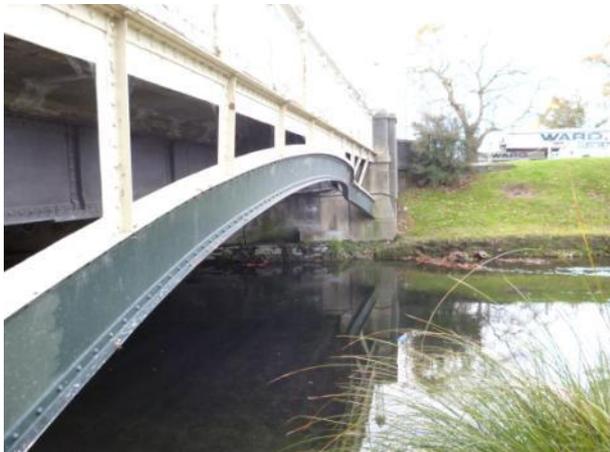
The unreinforced concrete abutments are founded just 1m below river bed level and both suffered cracking from rotational movement of up to 30 degrees. This was caused by liquefaction and lateral spreading during the February 2011 earthquake. Further repercussions of this saw the two outer-arch girders and the cast iron handrails on each side of the bridge buckle under the sudden axial load which occurred when the abutments rotated towards each other.

Figure 7. Warped arch girder prior to grit blast and painting works

- Remediate the ground adjacent to each abutment and install inclined anchors from the abutments into the strengthened ground.
- Lift the bridge clear of its abutments, rebuild the top part of the abutments, install new bearings and set the bridge back down on the strengthened abutments
- Remove the cast iron handrails, repair off site and reinstate onto the bridge
- Grit blast and paint the outer-arch girders
- Repair cracks and spalls to the abutments and pilasters and re-point the stonework wall to match existing

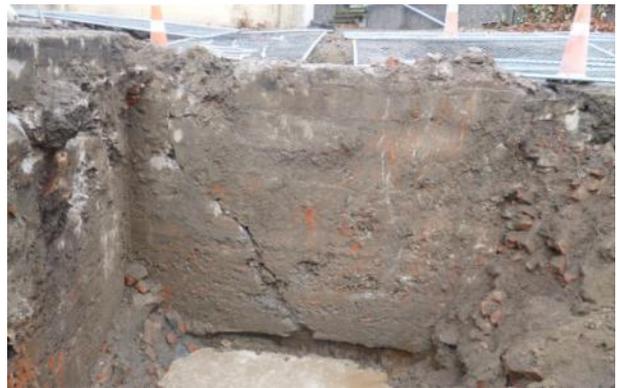
Historical drawings indicated that the wingwalls of the 1901 structure had been removed during the widening of the bridge. This was not the case as can be seen in Figure 8 where the original

wingwalls remained in-situ. This effectively precluded the installation of DSM columns in that local area.

Figure 8. Original 1901 wingwalls found in-situ

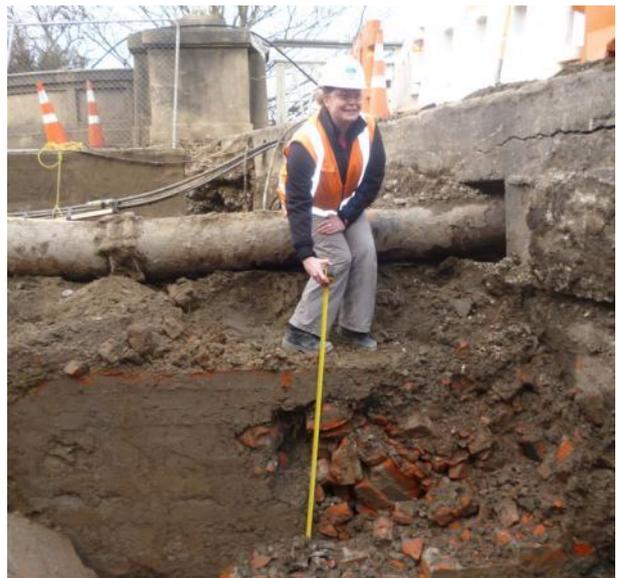
In addition to the aforementioned discovery, a more significant archaeological find was the unearthing of the remains of the 1858 brickwork wingwalls. Since historical data for this structure was scarce, excavation proceeded with caution so that a qualified archaeologist could conduct an accurate as-built record of the structure.

Figure 9. Emma Clifford of Underground Overground Archaeology Ltd recording as-built dimensions of the 1858 brickwork wingwalls

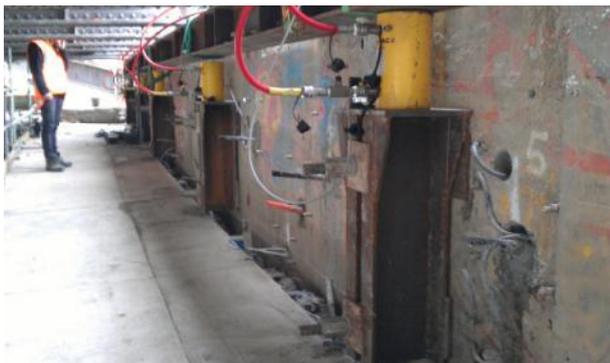
Figure 11. Jacking the bridge

An economical and innovative method was adopted to lift the bridge and support it so that strengthening work could take place on the abutments. This involved clamping a number of jacking pedestals to the lower part of the concrete abutments. A continuous beam was installed above the row of pedestals such that jacks could be placed in the space between the pedestals and the beam to jack the bridge up. The pedestals were fabricated with a widened top portion so that a pair of packers could be fitted, one each side of the hydraulic jacks. This allowed the jacks to be removed until the time came to lower the bridge back down on to the abutments.

Jacking of the bridge was carried out with all 7 jacks operated from a panel which could instantly report jack loads and displacements. The jacking was carefully monitored by engineers to ensure that the bridge was raised evenly and that none of the temporary works pedestals were overloaded. Packing members consisting of short heavy walled steel RHS sections were cut to length on the day and welded in place.

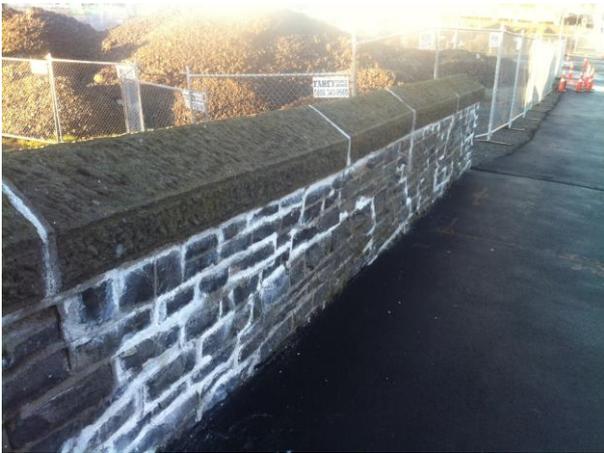
Figure 14 Repointing of the Stone Wall

Topcoat, a specialist coating contractor, were engaged to identify the existing materials and to propose suitable replacements acceptable to the Christchurch City Council and their Heritage Advisors. The existing material was found to be a lime based plaster and mortar. The evidence for this conclusion was the observation of hairline micro cracks that had self-healed over time, retaining the integrity of the plaster. The plaster used today is based on Ordinary Portland Cement (OPC) and is hard, non-breathable and does not self-heal. The stone wall, repointed as illustrated in Figure 14, benefits from a lime mortar which is more forgiving than OPC and allows the wall to “move” minutely and still retain its integrity. Due to the scarcity and substantial lead times for lime based plaster, the contractor formulated an alternative product made by mixing quicklime with water. The water was sat an inch or so above the quicklime to eradicate exposure to carbon dioxide and left to cure for a minimum of 6 weeks

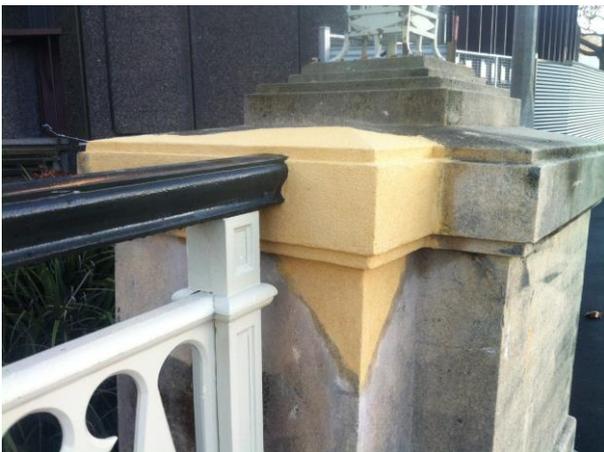
Figure 15 Rendering of repaired pilaster corner spall

Unfortunately, the immediate visual appearance of the new rendering is different to that of the existing. However, it is expected that the colour of the lime putty will fade over time and together with age and moss growth, the contrast will gradually become less apparent. In time, it is hoped that the repair work will blend seamlessly with the existing fabric and to aid with the aging process, a milk spray was applied at all rendered locations to encourage the growth of microorganisms.

The final challenge was to colour match the repaired cracks and spalls to the existing fabric. Yellow oxide was used at a reduced dose of half a

teaspoon per kg of putty as today's oxides are five times more potent than those available in 1930.

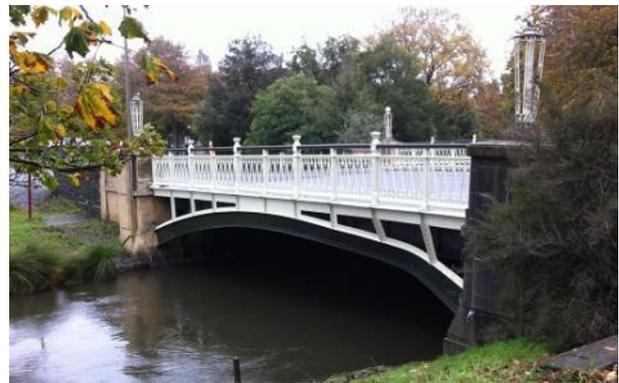
Repair works were completed in 2014 with the tilted piers and buckled side girders left in their deformed shape as a reminder of the earthquakes.

Figure 16. The buckled side girders were retained.

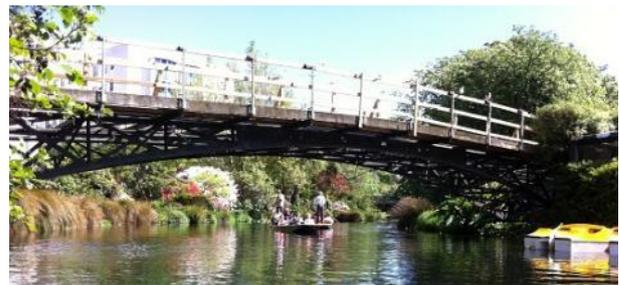
Built in 1901 the Antigua Footbridge was damaged in the 2011 earthquake when lateral spreading caused the concrete abutments to rotate and move towards each other. The bridge is adjacent to the Category 1 Historic Antigua Boat Sheds.

Figure 17. . Antigua Footbridge

The structure consisted of a pair of trusses fabricated from rolled steel (or possibly wrought iron) angle and tee section members. The two trusses were braced together and anchored into the concrete abutments. The structure had a timber deck and timber handrails. Lateral spreading caused the trusses to hog in the centre by approximately 400mm. Furthermore, the structure had fallen into a state of disrepair prior to the earthquake and several of the riveted joints and members had rusted and failed either before or during the earthquake.

- Removal and refurbishment of the steel structure
- Demolition of the existing abutments and construction of new abutments
- Re-installation of the steel structure with a new precast concrete deck.

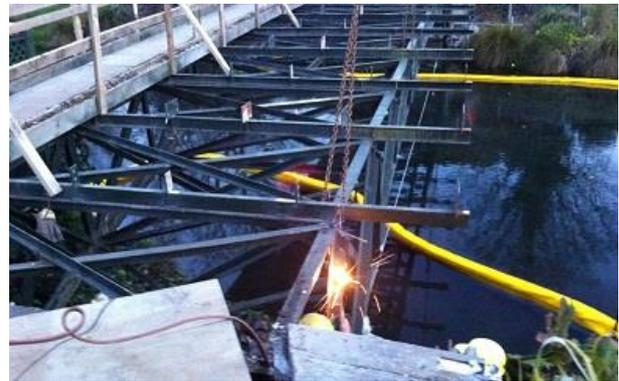
Final gas cutting of the bottom chords commenced when the crane and rigging were set up for the lift. As cutting commenced, the bridge attempted to straighten from the pre-camber induced by the earthquake.

Figure 20. Cutting the bottom chord & diagonal braces

The removal of the bridge from its abutments was thus carried out incrementally with careful monitoring and gradual release of the tension in the bowstrings. Small bites of steel were cut from the bottom chords as the remainder of the structure straightened itself, gradually relieving the built-up compression forces.
