Lessons learned from one of New Zealand's most challenging civil engineering projects: rebuilding the earthquake damaged pipes, roads, bridges and retaining walls in the city of Christchurch 2011 - 2016.

Armagh Street bridge – award application

An award application for the Civil Contractors NZ Hirepool Construction Excellence Awards 2015 which details Downer's approach to repairing the Armagh Street bridge.

Armagh Street Bridge Repairs

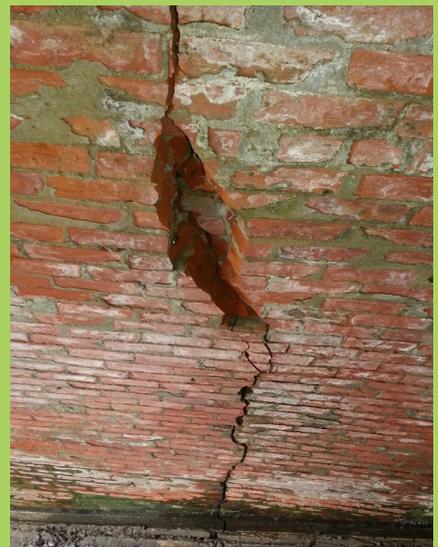
The February 2011 earthquakes caused significant damage to the brick barrel and the bridge was thereafter closed to vehicles (including the trams). The damage included a 20mm wide crack extending from the western abutment and spreading $\frac{3}{4}$ the length of the arch. It was believed that this crack may have split through all 6 layers of brick.

The main crack to the brick barrel

The core structural repairs to the crack were completed by crack stitching and cross pinning. This work involved using 12mm stainless steel threaded rods drilled into the brick at a 45° angle.

Stage 3, grout filling the crack, occurred once the outer layer of brick had been removed. A specific grout mix was designed to match the strength of the brick. Once injected, we cored holes for the cross pinning and mortar joints cut for the stitching bars. In conjunction with this we took 2.8m deep cores to complete the abutment stitching repairs.

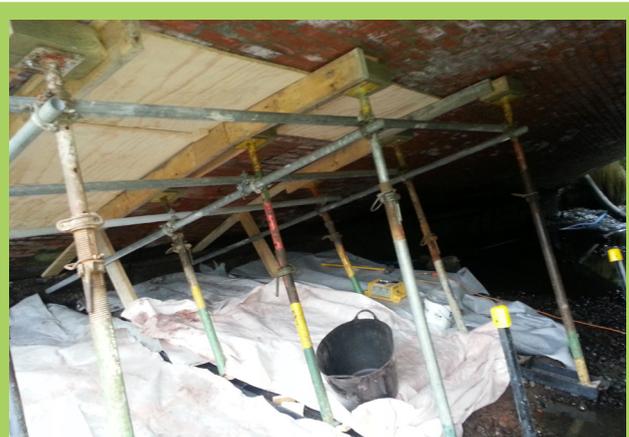
Our propping structure designed to protect workers from falling debris

As the repairs were to be completed from underneath the bridge, a key health and safety risk was bricks and debris falling onto workers. To prevent this we developed a propping structure, designed to support ‘a tonne of bricks’. This structure involved anchoring three channel supports into the concrete abutments and using Acrow props on different angles to account for the shape of the brick barrel. Each channel held three props and a plywood sheeting system was placed on top of these props. As work progressed, sections of plywood were removed to enable us to move along the crack.

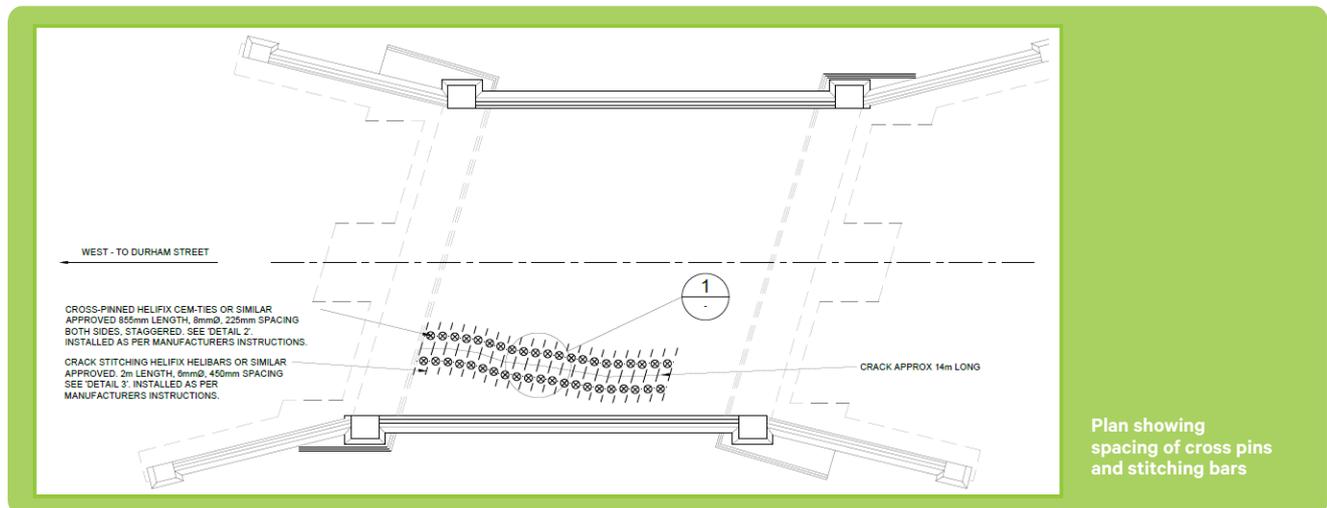
Plan showing spacing of cross pins and stitching bars

The cross pinning work involved coring 48 880mm long holes on a 45° angle crossing the crack. The brick barrel is only 750mm thick (confirmed by two core samples taking during the design stage). Mapping out the direction of the core holes put the core direction straight into the outer 66kV. This meant an increased and significant risk of electrocution to operatives whilst performing repairs which, at that voltage, would almost certainly mean fatalities. It would also mean significant outages for consumers and issues for asset owner Orion. Switching off the power and removing the cables simply wasn't an option. The network could not sustain these cables being out of service due to loading issues.

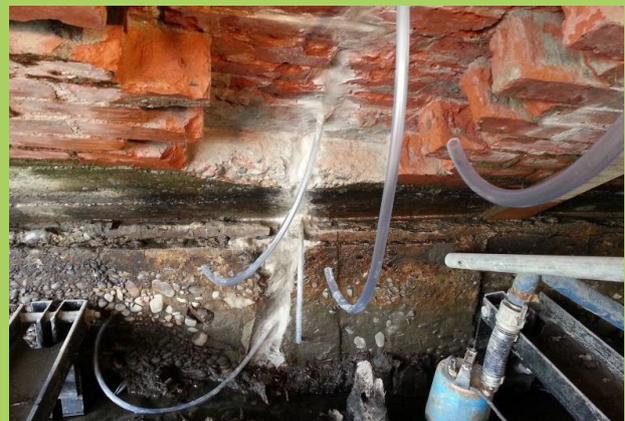
Installation of grout tubes ready for injection

BBR Contech completed all crack injections, abutment repairs and grout injections in the brick arch and under the tram tracks. Working on a heritage site was a challenge for BBR, but one in which they excelled. Together with Downer they ensured all products used would not stain or mark the heritage fabric of the bridge. The low strength grout mix for the brick injection worked well and the strength rating and methodology was approved by the designer, client and heritage consultant.

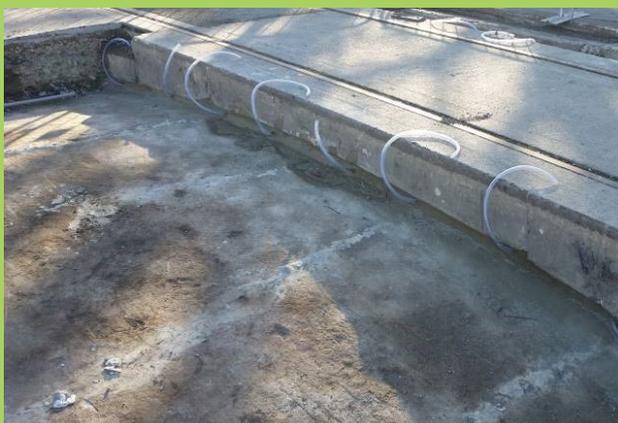
Grout tubes placed around tram tracks

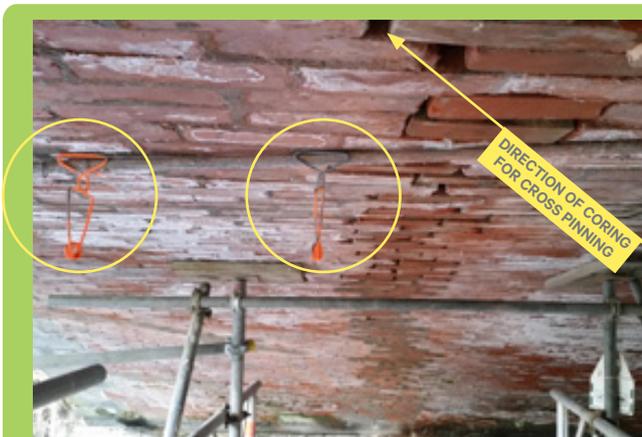
The main physical hazard on this project was the two 66kv cables that crossed the bridge. The location of these cables proved difficult as they were directly on the path of the cross pinning works.

The two 66kv cables and pilots

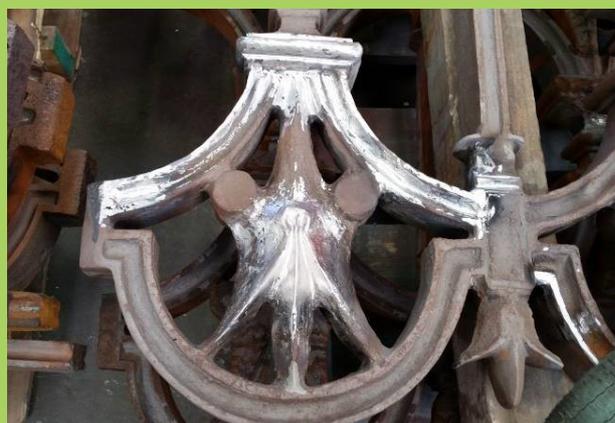
Sample of an Eutectic repaired balustrade panel.

Another complex risk was around the repairs to the cast iron balustrade. As this would always be in the public eye we wanted to complete repairs so they were imperceptible. A common technique generally used was brazing and was favoured by the consultant initially. However, with the number of repairs required this would have been extremely costly for the client. SCE submitted another product for review which was a Eutectic system (metal powder spray), which was faster and more cost effective. SCE repaired a section using each method for heritage review and it was decided to use the Eutectic system. This innovation saved time and money for the client.

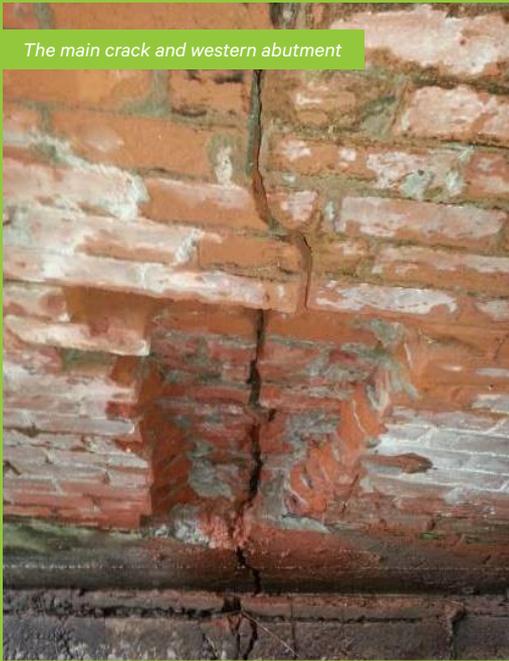
The main crack and western abutment

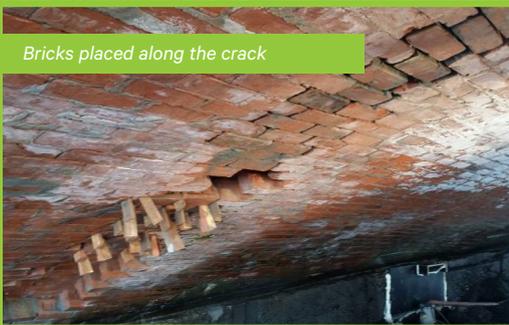
Bricks placed along the crack

From here we started replacing bricks and filled mortar joints. In order for bricks to stay in place we drilled a threaded rod into the brick above and a tie placed between the two, timber wedges then secured them in place and allowed for remortaring to occur. This completed repairs of the main crack.

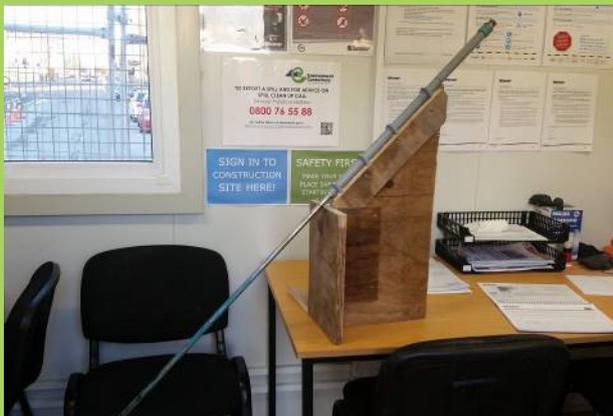
Drill guide created to ensure angle of drilling was accurate, and prevent service strikes

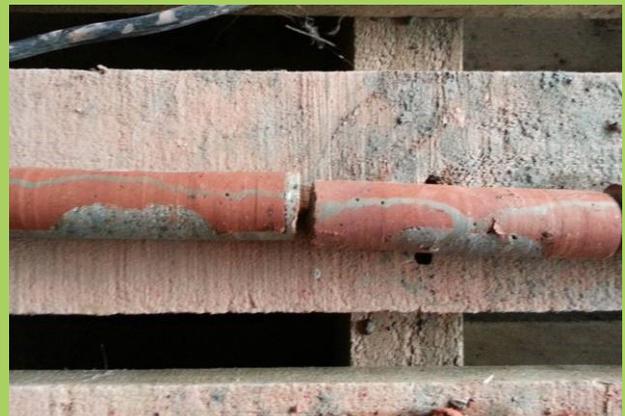
A section of core sample showing grout filling the crack through two brick layers.

Whilst completing grouting works, to ensure all possible areas were sealed, water was injected first. This allowed us to check for leaks around the brickwork and seal up areas before grout was used.
