Lessons learned from one of New Zealand's most challenging civil engineering projects: rebuilding the earthquake damaged pipes, roads, bridges and retaining walls in the city of Christchurch 2011 - 2016.

## Protecting the past – Restoring heritage bridges

A document which describes the processes that SCIRT took when repairing some of Christchurch's heritage bridges.

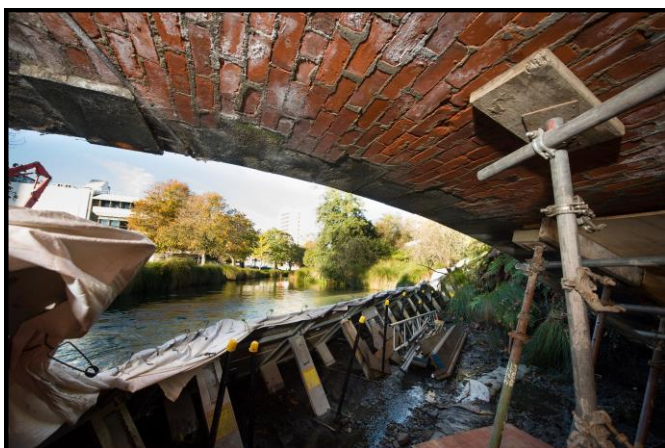
*Brick by brick: Work gets underway on the Armagh Street Bridge.*

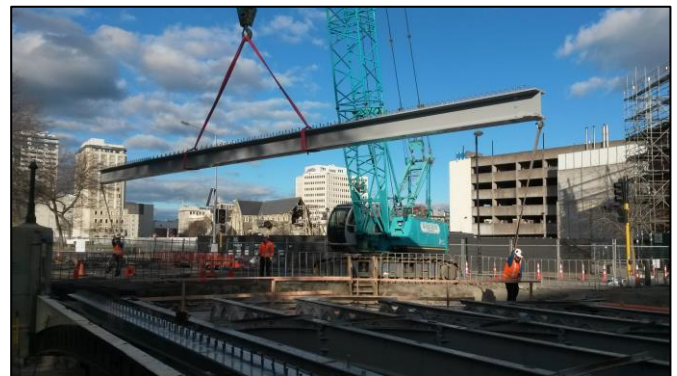
*Beam up: A section of the Gloucester Street Bridge is hoisted into place*

SCIRT proposed – and heritage authorities agreed – that an “invisible” support structure be installed to strengthen the bridge. To do so, the bridge was partially deconstructed.

Eight new steel beams, hidden from view, were installed between the old girders and connected to the new, reinforced concrete panel deck. Parts of the railings were broken and damaged, but these were carefully welded and repaired off-site.

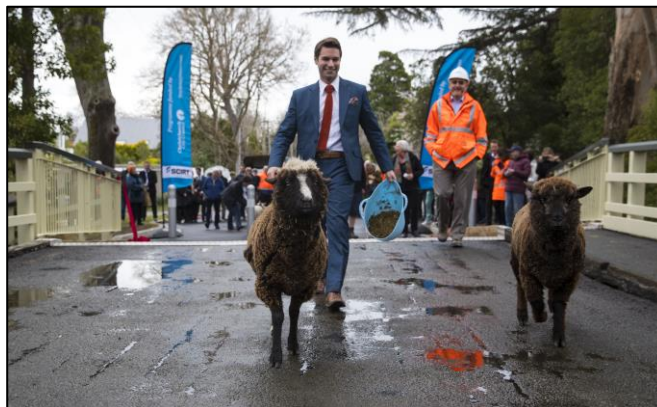
*Flock of onlookers: The Helmores Lane Bridge is reopened to pedestrian and animal traffic.*

In consultation with the council heritage team, it was decided to build two five-metre-long "land spans", like ramps, at each end of the original 17-metre-long bridge for access. That allowed the soil under each end to be removed, reducing the load on the old timber frame.

The ramps were clearly a modern addition where timber with preservatives was used because it was just as durable as the original Australian hardwood, and stainless steel fixings were used instead of iron. The ramps and handrails were built to modern building codes, so the new handrails were a different height. The land spans move independently of the old bridge to protect it in any future earthquakes.

For the repair of the original bridge, recycled Australian hardwood timber was sourced from two dismantled bridges over the Waitaki River in North Otago, and the hardwood was made into new cross beams, handrails and posts, with the original mortise and tenon joints incorporated into the design. This was in keeping with the conservation practice of using material as close as possible to the original.

One of the tricky tasks was to cut out a rotten part of a beam. That required a careful jacking of the bridge and then cutting out half of the degraded beam at a time, and replacing it.

As a result, it was decided that the bridge would only be open to pedestrians and cyclists. The bridge reopened on September 5, 2016, after five months of repair work.

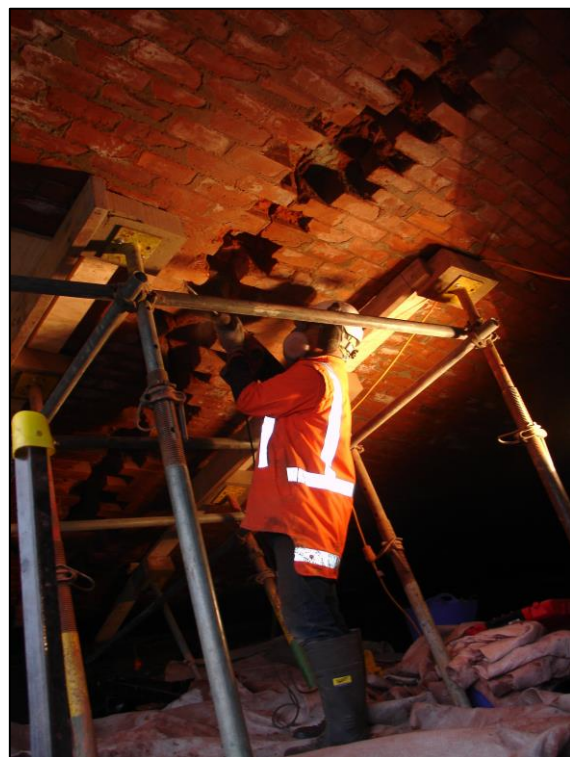
*Brick up: A worker fills the gaps under the Armagh Street Bridge*

The main repairs to the arched bridge, which was built with six layers of bricks, focused on a 20-millimetre-wide and 14-metre-long crack through the brick barrel – penetrating all six layers – and five others cracks.

The damaged outer layer of bricks was removed. Recycled bricks of the same type and size were sourced from a demolished building and used as replacements. The cracks were injected with grout, and holes were drilled for fine-threaded stainless steel rods to be grouted into the bricks in a “cross-stitch” pattern to repair the cracks. A crack in the unreinforced concrete foundation was tackled in a similar way but employing bigger steel reinforcing bars.

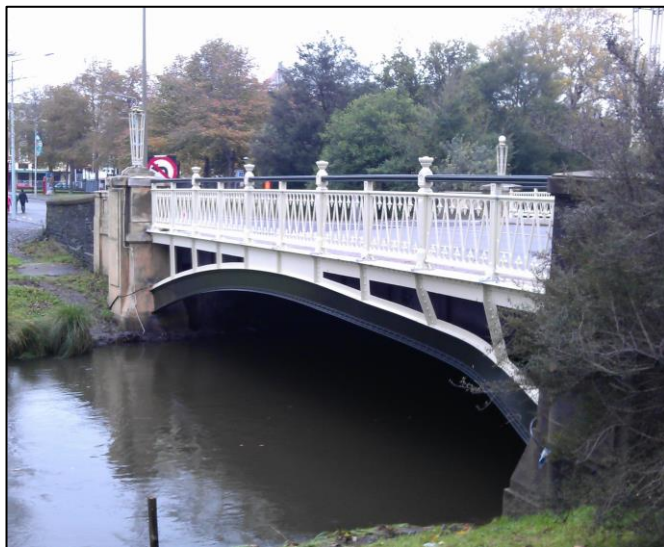
*Side warp: A warped girder on the Colombo Street Bridge.*

Seismic forces buckled its arched girders and twisted the abutments about 30 degrees, causing the handrails to bend and pull out of the pilasters.

At the request of the council, SCIRT designed the bridge repairs to keep the buckled arch-edge girders as a visual reminder of the February 2011 earthquake.
