## Repairing Christchurch City Council Owned Retaining Walls Damaged by the Christchurch and Canterbury Earthquakes

A paper which outlines SCIRT's approach to asset assessment, design and repair of damaged retaining walls, and presents a case study of a retaining wall rebuild, on Cunningham Terrace, Lyttelton.

# Repairing Christchurch City Council Owned Retaining Walls Damaged by the Christchurch and Canterbury Earthquakes

## **3 CUNNINGHAM TERRACE RETAINING WALL CASE STUDY**

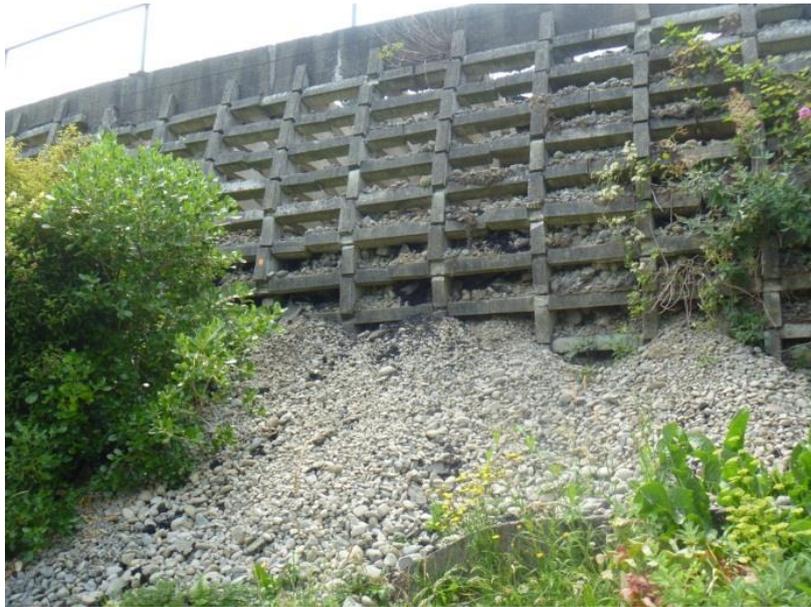
The wall is 75m long and up to 4.8m high. The existing wall consisted of two sections of crib wall and three sections of mass concrete wall. The crib lost more fill with each aftershock and was badly deformed. The mass concrete sections were propped with railway irons prior to the earthquake. The road above the wall was closed due to the degree of deformation and loss of stability (Figure 1).

Figure 1 The damaged Cunningham Terrace retaining wall

The solution was an anchored steel kingpost wall with concrete panels (Figure 2). This gave the wall a 100 year design life. The king posts are I-sections, embedded in concrete sockets below ground level. Walings run across the I-sections and are anchored. The anchor heads can also be seen in Figure 2. The anchors are distal plate anchors with double corrosion protection. They are typically 10 metres long and have a working load of 100kN. The wall under construction can be seen in Figure 3.

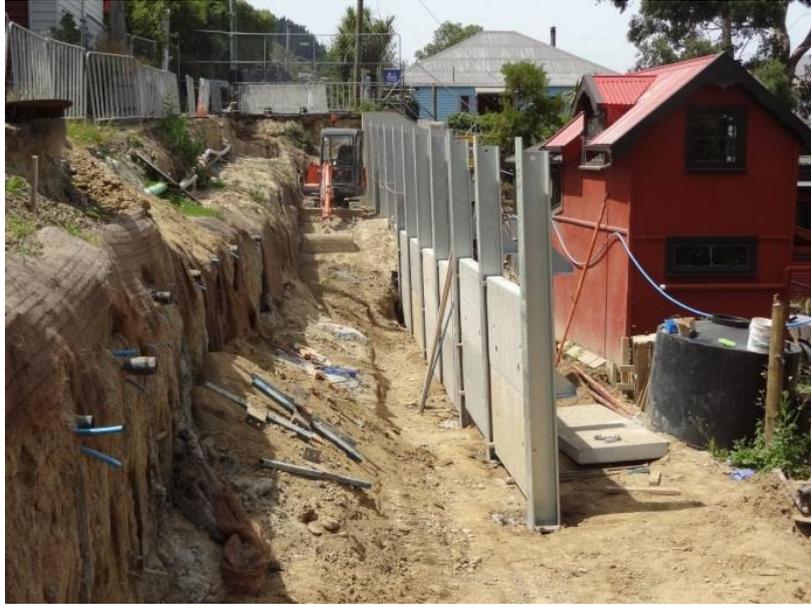
*Figure 3 The partially constructed Cunningham Terrace retaining wall*

The site was underlain entirely by loess, as is typical for this area of the Port Hills. The loess soils were typically dry and would stand vertically in excavated faces. However in places the loess had been reworked and was moist to wet. These areas displayed much weaker soil properties and the loess was significantly less stable. These different properties had to be accommodated for both permanent wall design, by locally increasing the length of the anchors, and temporary works design when maintaining stable excavations. Rock was not encountered at the site. This allowed the kingposts and the anchors to be embedded in relatively consistent material. Had rock have been encountered the anchors and posts could have been reduced in length, but construction would have been considerably more complex to allow for rock coring.

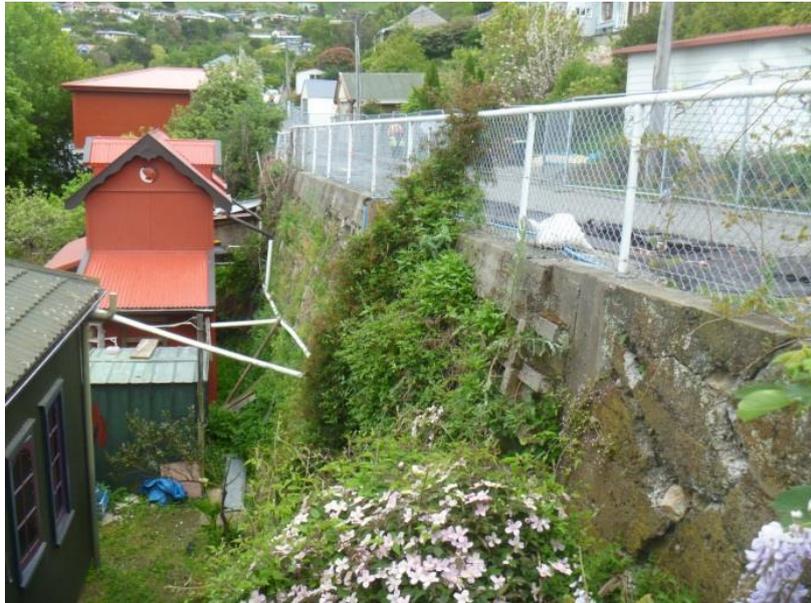
*Figure 4 Cunningham Terrace retaining wall before demolition showing the confined site*

As can be seen in Figure 4 the site was particularly narrow. This is not uncommon in these hillside residential areas. The wall on the right of the photograph was demolished and replaced without removing any of the buildings which can be seen on the left of the photograph. In addition the road

behind the wall contains water infrastructure and other buried utilities. Overhead cables also travel along this road.

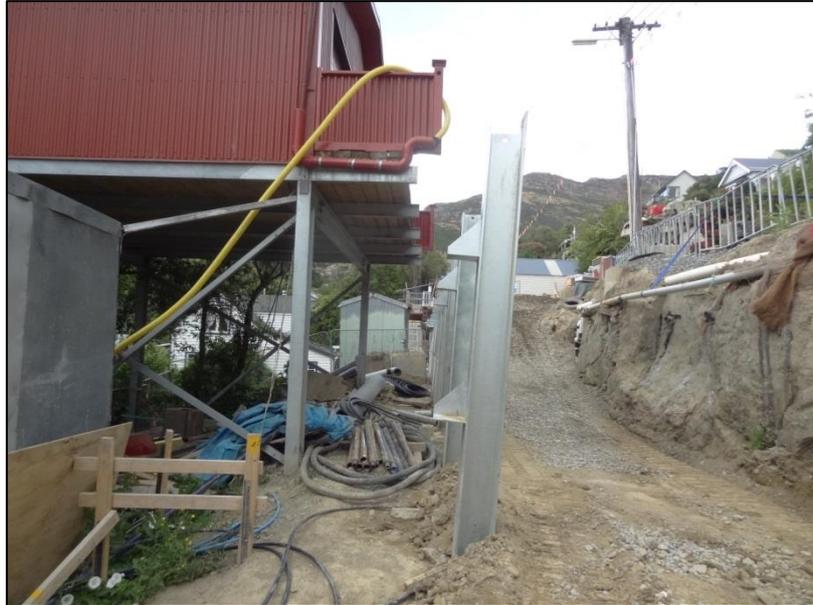
The alignment of the top of the wall is slightly different to what was there before due to the reduced rake of the wall. There is a garage on stilts on the low side of the wall and the new wall alignment would result in a 0.5m gap between the garage and the road. This can be seen in Figure 6. To remedy this access had to be provided without relying on the private structure for support. Therefore a cantilever access was built from the top of the wall as part of the capping beam.

*Figure 6 The gap created by the new wall alignment*
