Best in show: Retain and gain for Sumner Road

Story: Sumner Road Retaining Wall – Stage 4

A document which describes the process that SCIRT took to repair the Sumner Road retaining wall – stage 4.

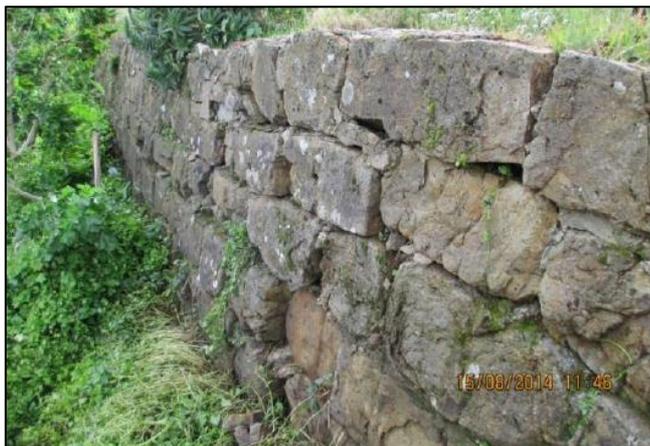
Stress fracture: cracks in the wall of retaining structures.

In the stage four project, the damage to the retaining wall included the failure of sections of the gravity stone facing and horizontal and vertical displacement of the footpath and roadway behind the wall.

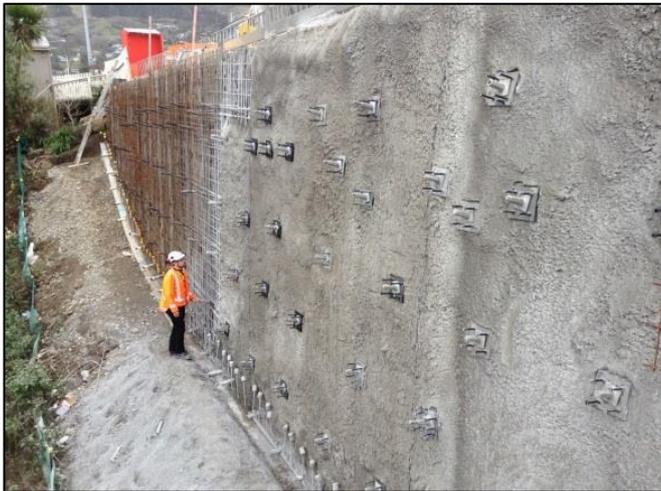
Concrete solution: An engineer checks the repairs.

SCIRT opted for the soil nail strengthening approach and an innovative access method. The SCIRT delivery team developed a method to install the nails and construct the concrete footing beam and shotcrete facing that was safe, cost effective and allowed Holcim to remain open. Drilling from a crane-lifted work access platform was deemed to be the safest and most cost-effective way of installing the nails. No additional load would be placed on the wall or downhill slope.

The retaining walls consisted of 100-year-old stone walls up to six metres high. Under SCIRT's design, 180 new soil nails were drilled through the existing blocks and grouted into place up to eight metres long and 180 millimetres in diameter. Once the soil nails were in place, drainage was installed, a footing was dug and poured and a reinforced shotcrete facing was applied in two 150mm layers. A handrail and repairs to the damaged kerb and channel and footpath completed the project. Work was under way by January 2015 and wrapped up by September 2015.

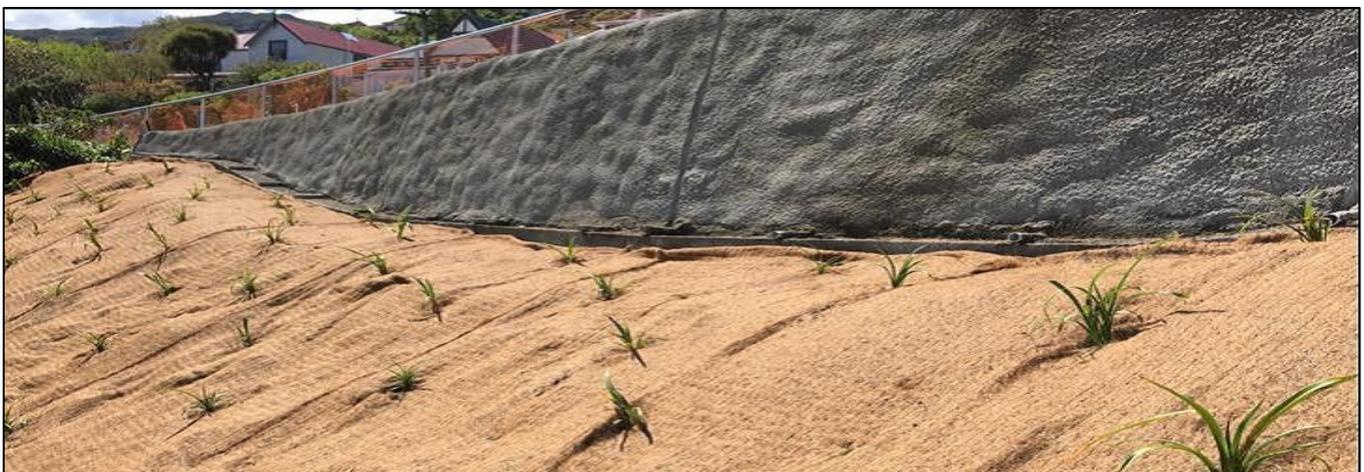
Protect and preserve: The rebuilt retaining wall in Lyttelton, Christchurch
