Trial Anchors through Existing Gabions

Story: Refurbishment of Gabion Walls with Anchors – a Trial

A paper describing the procedure and challenges associated with installing anchors through gabion baskets.

SCIRT Yellow Team

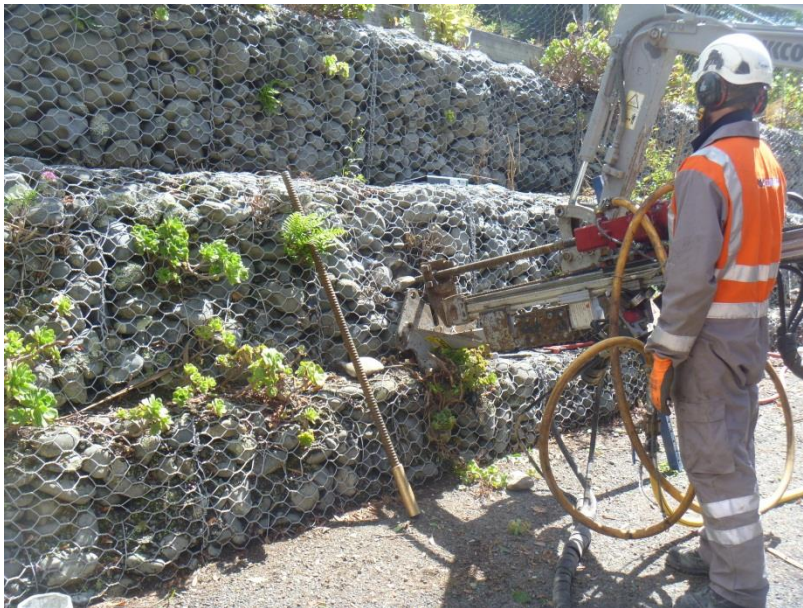
The anchors were drilled on 6th March using self-drilling anchors and sacrificial drill heads.

Figure 1 Anchor drilling through an existing gabion basket

Two anchors were installed. The first was 25mm diameter with a 70mm diameter anchor head. The other was 32mm diameter with a 90mm diameter drill head.

- Drilling of the anchors was possible and while the basket mesh at the rear of the basket was awkward to penetrate, it could be done.
- During grouting there is no grout recovery and therefore there is less certainty regarding how complete the grout is. Therefore all anchors must be load tested.

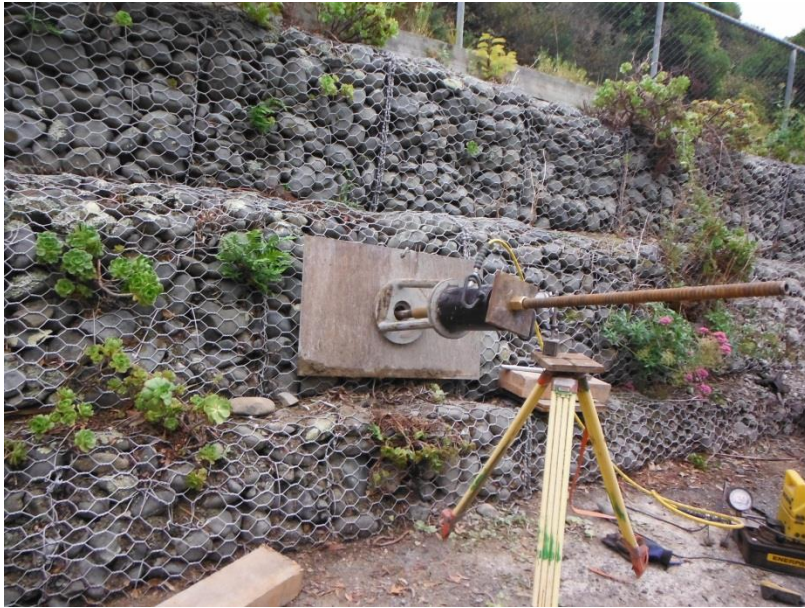
Anchor testing was against a plate 1.0m wide and 0.6m high. This was not packed against the basket because packing it could cause additional deformation to the basket once the load is applied.

Figure 2 Anchor testing equipment

The testing was conducted and deflection measured. As the load increased the gabion deformed further so as the plate used for measuring moved. This caused the anchor angle to change and at 70kN the gauge slipped off apparatus due to the deformation.

The anchor was then unloaded and loaded to 125kN with no measurements taken. The load reduced when held because of ongoing deformation of the basket. The load was held at 125kN and deflection measured:

- Galvanising and sacrificial steel are the only corrosion protection measures for self-drilling anchors.
- The testing regime needs consideration because measuring deflection may prove challenging. Therefore to load an anchor and only measuring deflection while holding the load may be appropriate if this will satisfy the designers testing requirements.

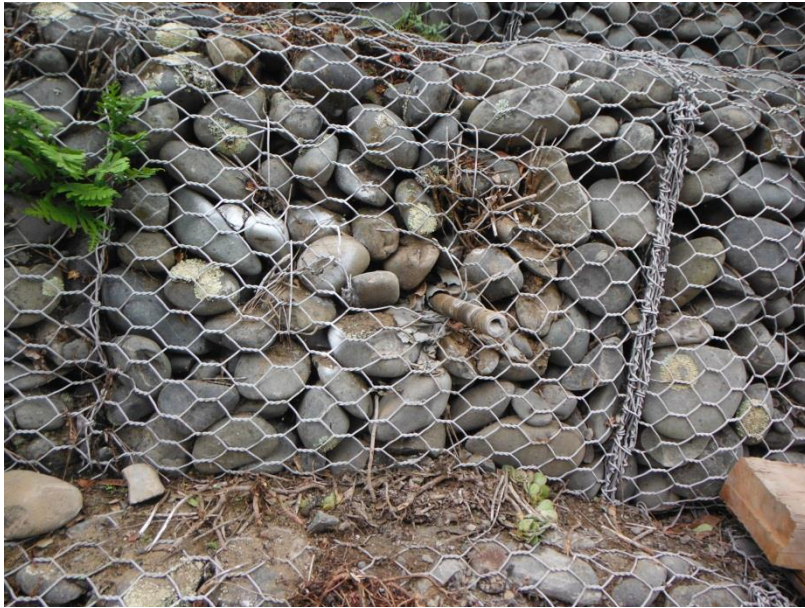
The load was released and the basket 'relaxed' and returned to shape.

Figure 3 Resulting anchor head showing basket damage

- The gabion baskets were damaged by the plate used in testing. Therefore using a textile layer or other protection under the plate may be advisable. Alternatively the basket may need to be patch repaired.

- Anchors should be installed in the middle of baskets to allow sufficient space for the plate to span.
