Lessons learned from one of New Zealand's most challenging civil engineering projects: rebuilding the earthquake damaged pipes, roads, bridges and retaining walls in the city of Christchurch 2011 - 2016.

Story: Sumner Road Retaining Wall – Stage 4

An award application submitted for the IPWEA Annual Excellence Awards 2016, detailing Fulton Hogan's work repairing the repair methodology for the Sumner Road retaining wall – stage 4.

SCIRT Delivery Team Fulton Hogan
Sumner Road Retaining Wall Stage 4

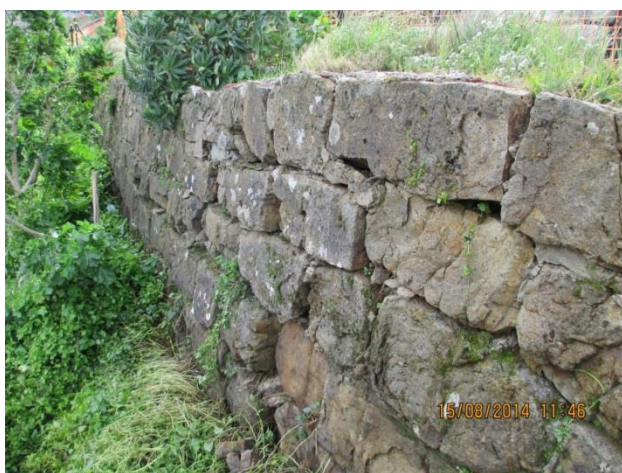
Figure 1: Pre-construction Sumner Road Stage 4

Sumner Road is an arterial road that links Lyttelton to Sumner, partially closed due to rock fall risk as a result of the earthquakes. The road also provides access to a number of residential properties in the area. The retaining wall retains sections of fill which support the Sumner Road carriageway and services. The damage suffered to the retaining wall included failure of sections of the gravity stone facing and horizontal and vertical displacement of the footpath and roadway behind the retaining wall.

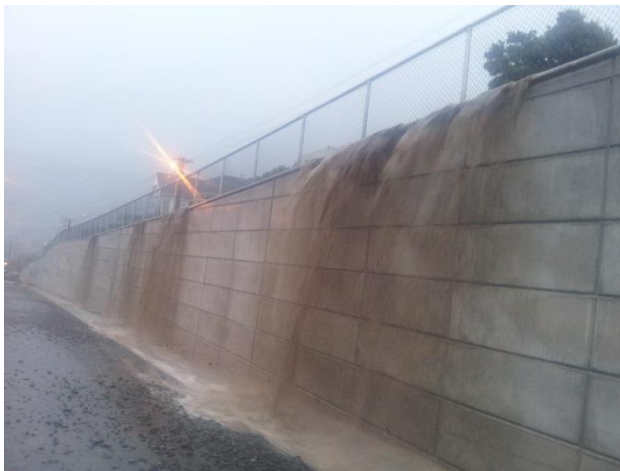
Figure 3: Flooding on Sumner Road

The SCIRT design team deemed Sumner Road stage 4 a more critical project than stages 3 and 5 after the March 2014 floods. Geotech engineers warned that the bank was in further danger of collapsing following the floods. There was a high risk of loose rocks and tree material situated above the Holcim tanks and the road was also at risk of collapsing so repairing the wall was vital.

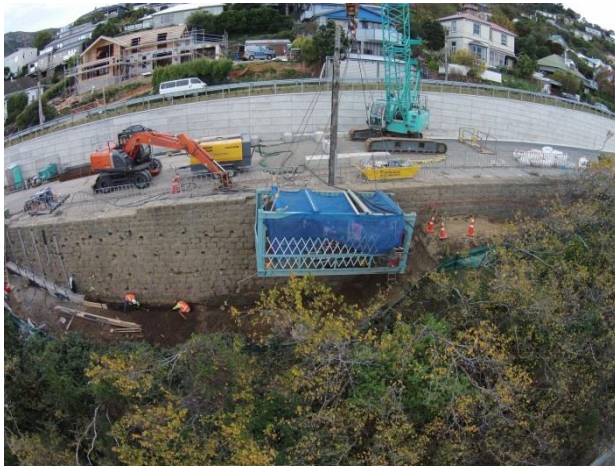
Figure 6: Soil nail getting inserted into Sumner Road retaining wall

When opting for this container configuration a number of obstacles had to be overcome to allow the drill rig to be moved in the container. A gantry crane was designed to move the drill mast along the container; however when the drill mast is moved along the container when suspended, the containers balance moves and the drill mast could run downhill without a suitable control in place. A chain block was attached to the gantry crane, mounted at 90 degrees to allow for controlled movement of the gantry crane without the risk of the drill mast running downhill. Additionally a tior lever hoist was used at one end of the container to level the container due to the weight shift of the drill mast.

Wall that required earthquake repair and strengthening consisted of three existing 100 year old stone walls up to 6 meters high. The design called for 180 new soil nails to be drilled through the existing block and grouted into place up to 8 meters long and 180mm in diameter. Once the soil nails were completed, drainage was installed, a footing was dug and poured and a reinforced shotcrete facing was applied in two layers of 150mm. A new handrail and repairs to damaged kerb and channel and footpath complete the project.

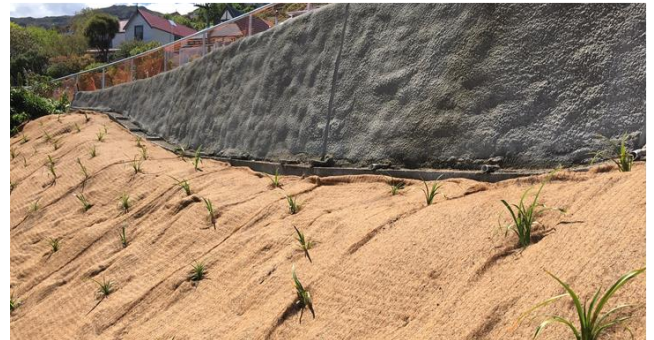
Figure 10: Retaining wall on Sumner Road complete

The final walkover with the asset owner to hand over the project identified no significant issues and the client provided positive feedback on the quality of the work, and excellent engagement with the local community. Stakeholders were also pleased to have had regular contact and update throughout the project; positive feedback was received from the community throughout the construction.

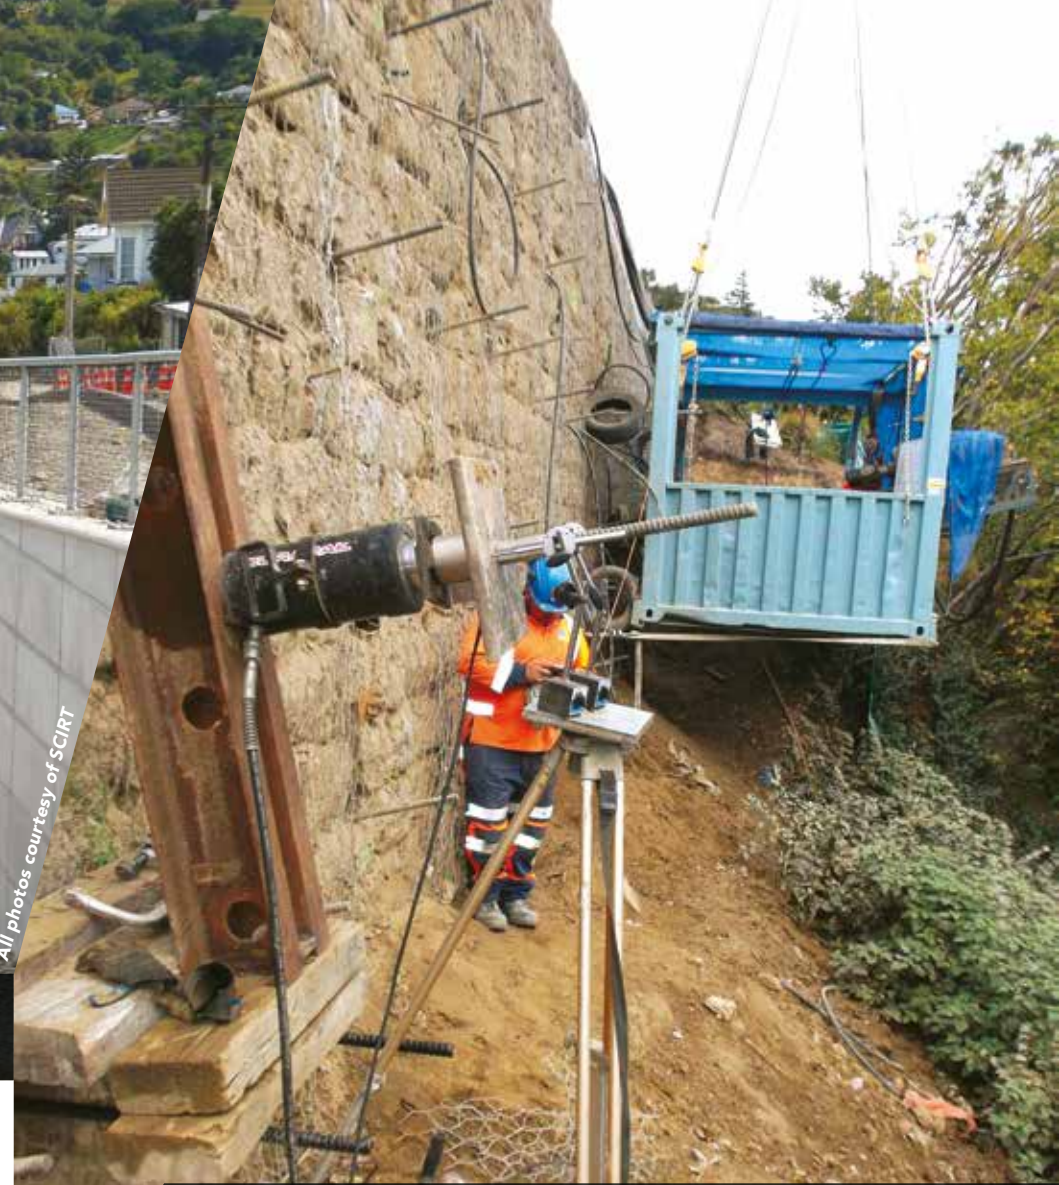
Testing the soil nails on stage four of the Sumner Road retaining wall repairs – a crane-suspended drilling platform was used to provide a safe working area

The site was steep, narrow, unstable and difficult to access. SCIRT has a strong safety culture so a way had to be found to minimise risks. In the end, the solution was to use a crane-suspended drilling platform.

"This method was chosen because the crane would sit back from the edge of the existing wall without placing any additional weight on the damaged retaining wall that could cause it to fail," Mr Oliver says. "The platform gave the guys an area to work and safely operate the drilling machinery. As some of the soil nails took up to nine hours to drill and install, it was important that the guys had an adequate working environment."
