Lessons learned from one of New Zealand's most challenging civil engineering projects: rebuilding the earthquake damaged pipes, roads, bridges and retaining walls in the city of Christchurch 2011 - 2016.

Having a blast in the past

Story: Archaeology

A document which describes SCIRT's discoveries and processes regarding archaeological finds on worksites.

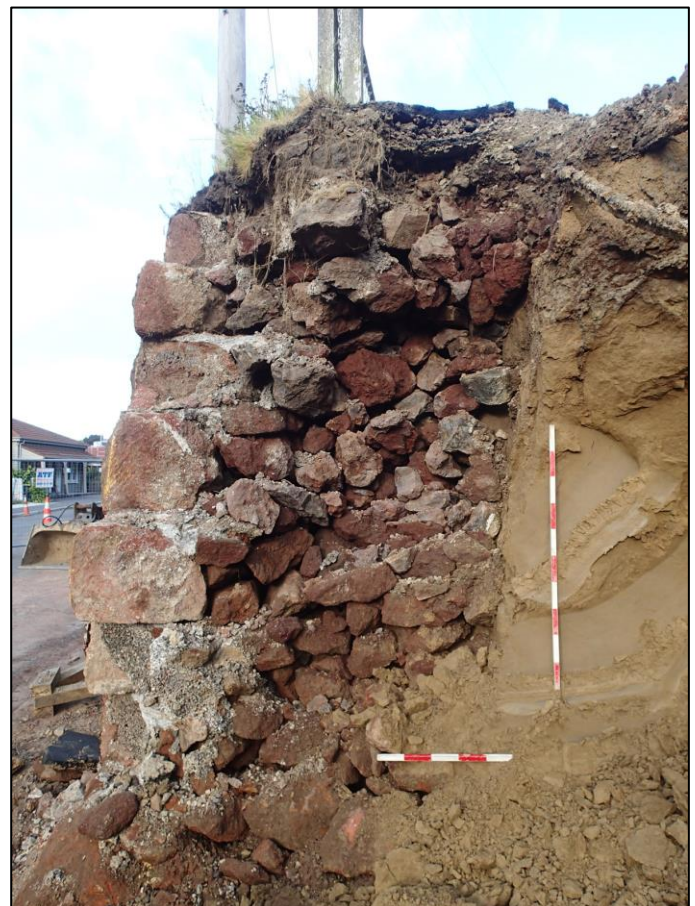
Another brick in the wall: A “red rock” retaining wall in Lyttelton reveals several crumbling layers.

“Lyttelton was of particular interest because of its retaining walls,” Watson said.

“In particular, the red volcanic retaining walls constructed during this period have been described as a distinctive part of the townscape.

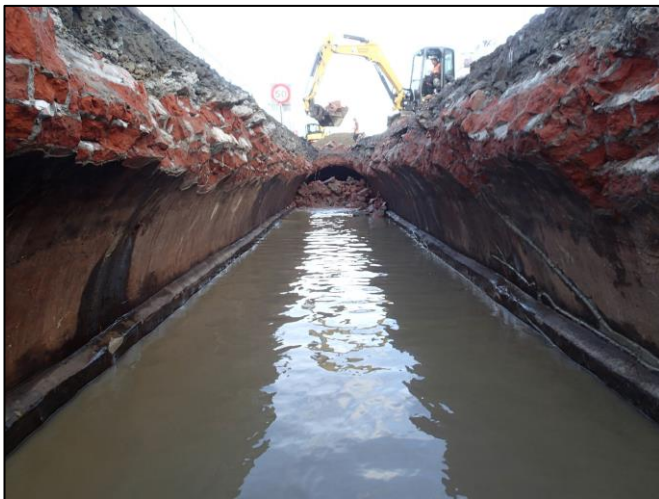
Down the barrel: Repairs get under way on a storm water brick barrel pipe in Christchurch.

"The way the city's drainage infrastructure was designed and built more than 130 years ago had a direct impact on how to approach repairs in the present day. Cracked sewers were relined. The non-invasive technique ensured the historical sewers could remain operational for perhaps another 130 years or more."

A significant proportion of the central city's wastewater (5.2 kilometres) and storm water (6.9km) network was made up of the "brick barrels". These beautifully crafted pipes often were located at depths more than 2.5 metres below ground level. Remarkably, they could be repaired and continued to be used. The wastewater barrels were oval or egg shaped, and the storm water barrels were circular, ranging from 600 millimetres to 1300mm in diameter. The arched form of some of these brick barrels was achieved by using special tapered bricks. The earthquakes of 2010 and 2011 broke or loosened the mortar joints between the bricks, allowing sand and silt to enter.

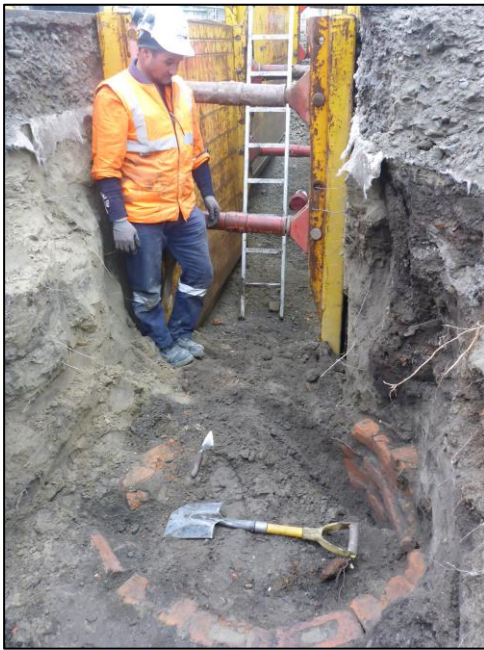
Well-disposed to discovery: A brick-lined well in Richmond reveals archaeological treasures.

Out in the suburbs, numerous items were discovered. Quality 19th century ceramics and glassware – including the uranium glass – were found more than 1.5m underground in Richmond. Deep inside a brick-lined well a SCIRT crew preparing to build a manhole found ceramics and glass bottles, ash, charcoal and the bones of animals. The selection of ceramics – including tea and tableware and elaborate serving dishes – displayed decorative styles popular about the mid-19th century.
