Sorensens Place, Christchurch: report on Archaeological Monitoring

A report which details the archaeological investigations carried out during the course of SCIRT project 11232, wastewater renewal work in Sorensens Place.

SORENSENS PLACE, CHRISTCHURCH (M35/1440): REPORT ON ARCHAEOLOGICAL MONITORING

SCIRT 11232

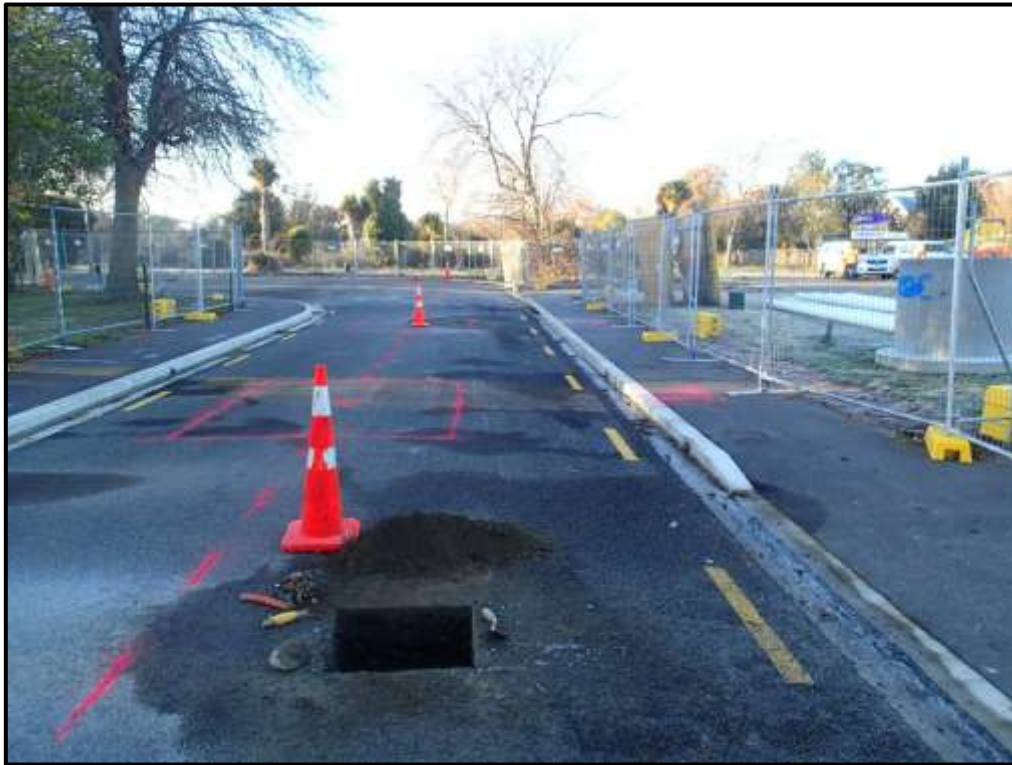
Figure 7. Looking south east along Sorensens Place prior to the commencement of trenching. The open excavation in the foreground is the test pit in which Feature 1 was first uncovered.

Feature 1 was a domestic rubbish pit (Butcher and Smith 2010: 55) that was first exposed on 26 July 2016 in a small test pit dug to investigate an anomaly detected by ground radar during a pre-works services location survey (Figure 7 and Figure 8). This test pit measured 560 mm by 500 mm in size, with the top of the feature exposed at a depth of 440 mm. These artefacts were found mixed throughout an ash stained grey sandy matrix that contained charcoal flecks, and a 40 mm thick layer of broken red brick was exposed at a depth of 780 mm. The hand excavation investigation of this feature was terminated at a depth of 900 mm as the limited size of the test pit restricted any further hand excavation beyond this depth (though at this depth the bottom of the feature was not yet reached).

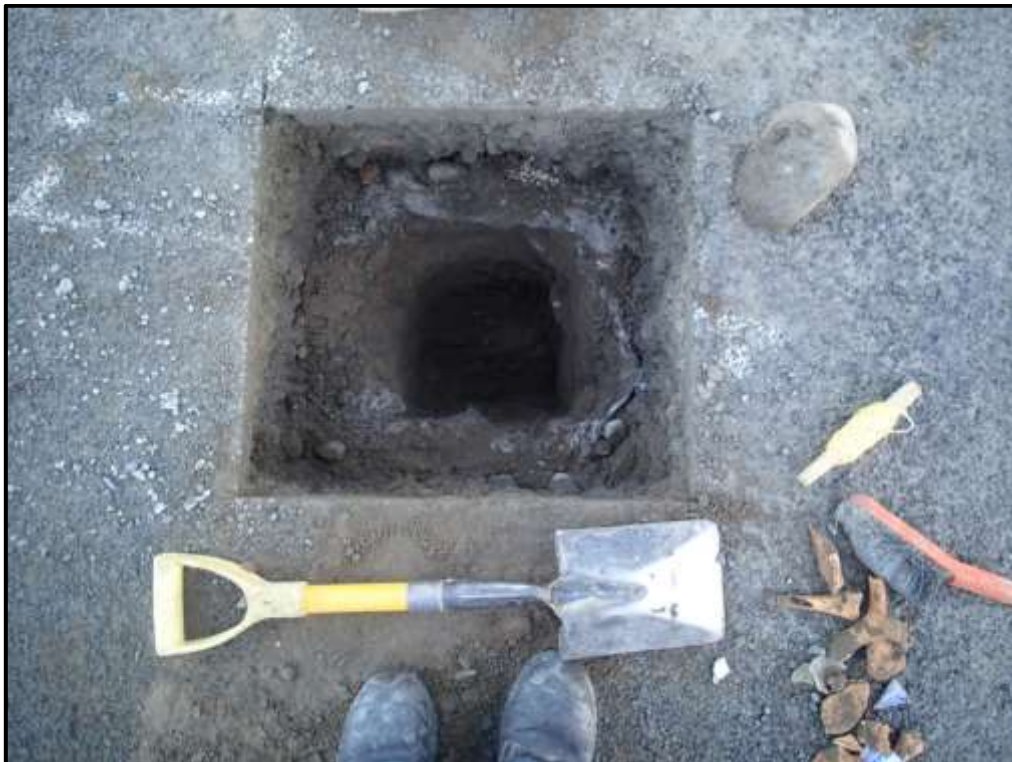
Figure 8. The test pit in which Feature 1 was first uncovered. Some of the ceramic and faunal material that was hand excavated from this test pit is visible at lower right. West is at top of image.

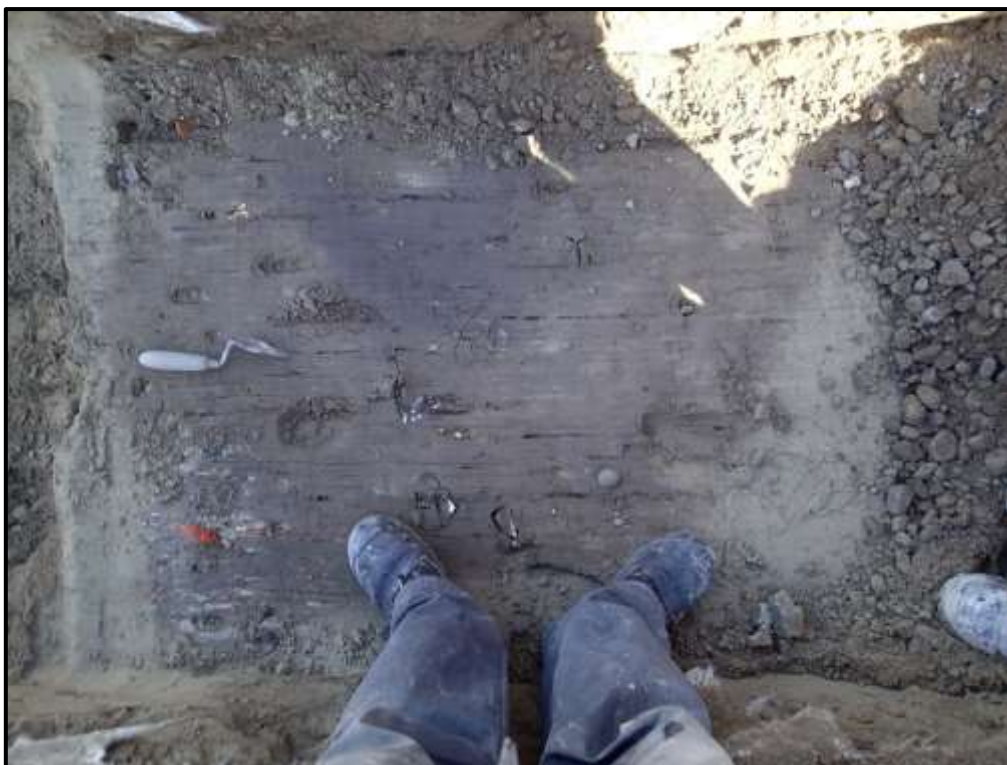
Figure 9. Feature 1, domestic rubbish pit, as exposed in the main trench at a depth of 600 mm. Note the dark colour of the ash stained fill matrix within the pit, compared to the lighter colour of the natural sandy substrate into which the pit was dug. West is at top of image.

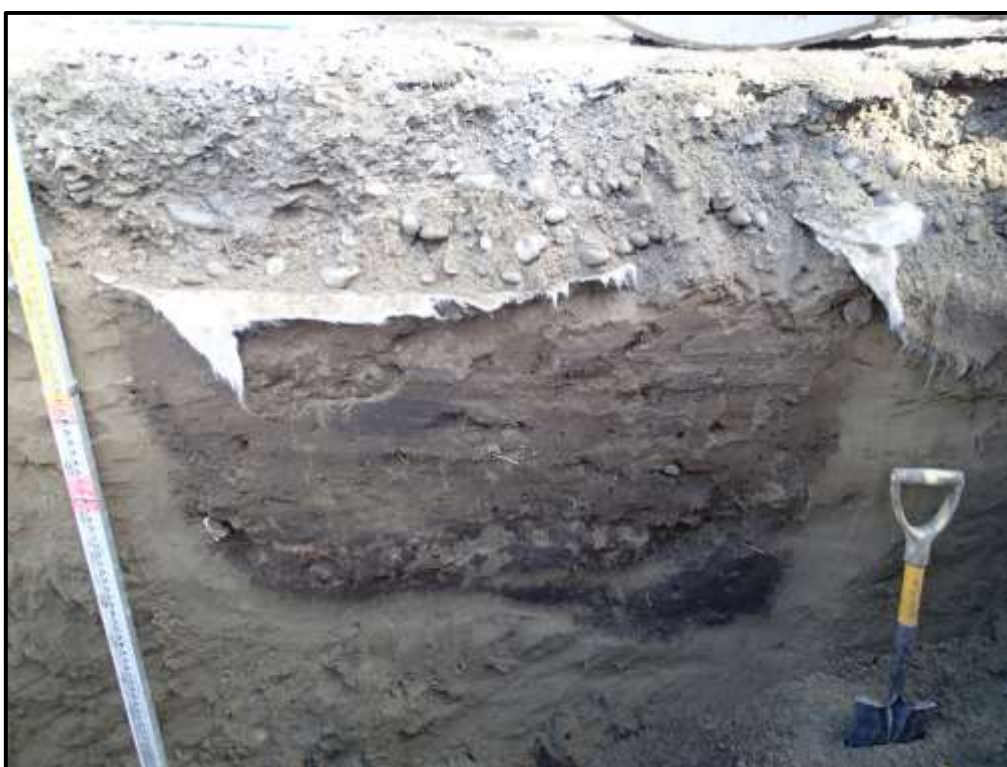
Figure 10. Feature 1, domestic rubbish pit, as transected by the trench. Looking west.

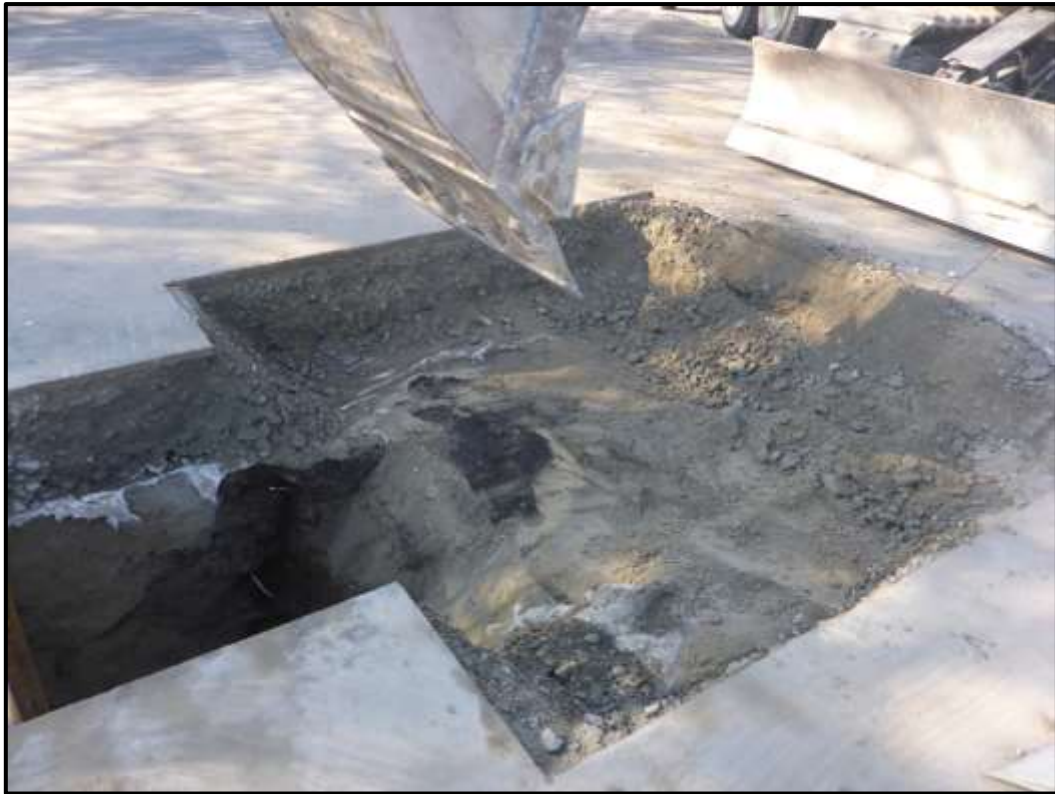
Figure 13. The top of Feature 2 (black ashy staining) as exposed immediately below the bidim cloth at a depth of 440 mm, looking southeast.

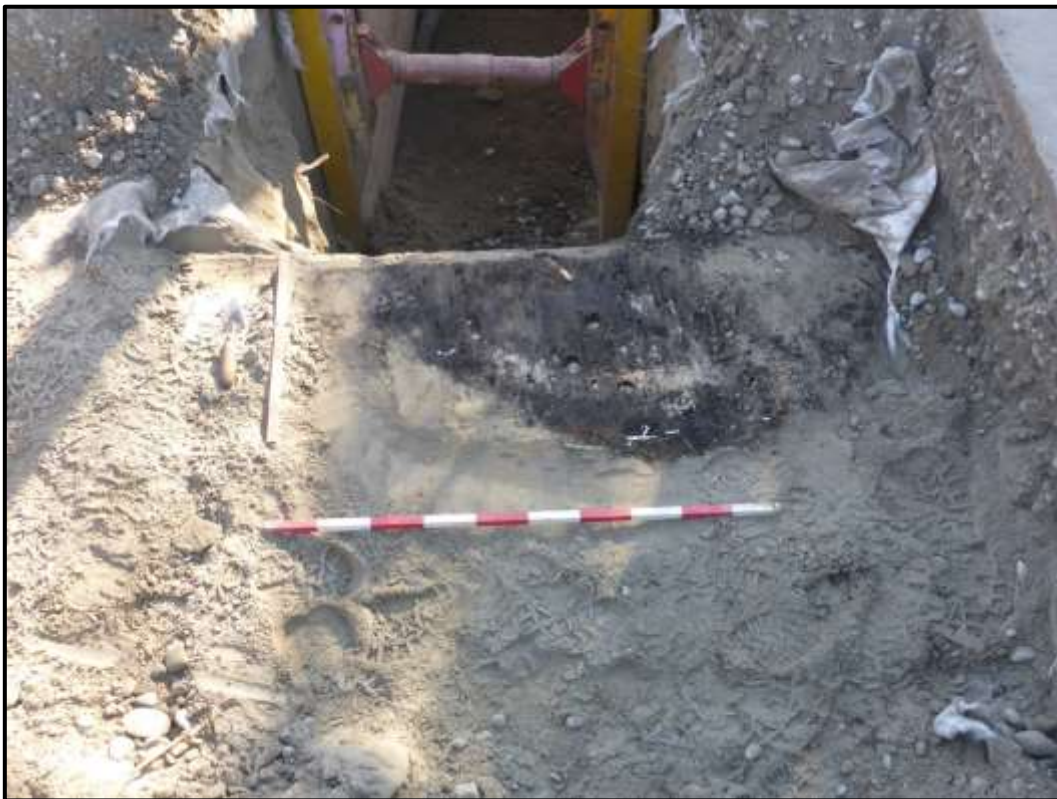
Figure 14. The upper portion of Feature 2, as exposed at a depth of 500 mm. North is at top of image.

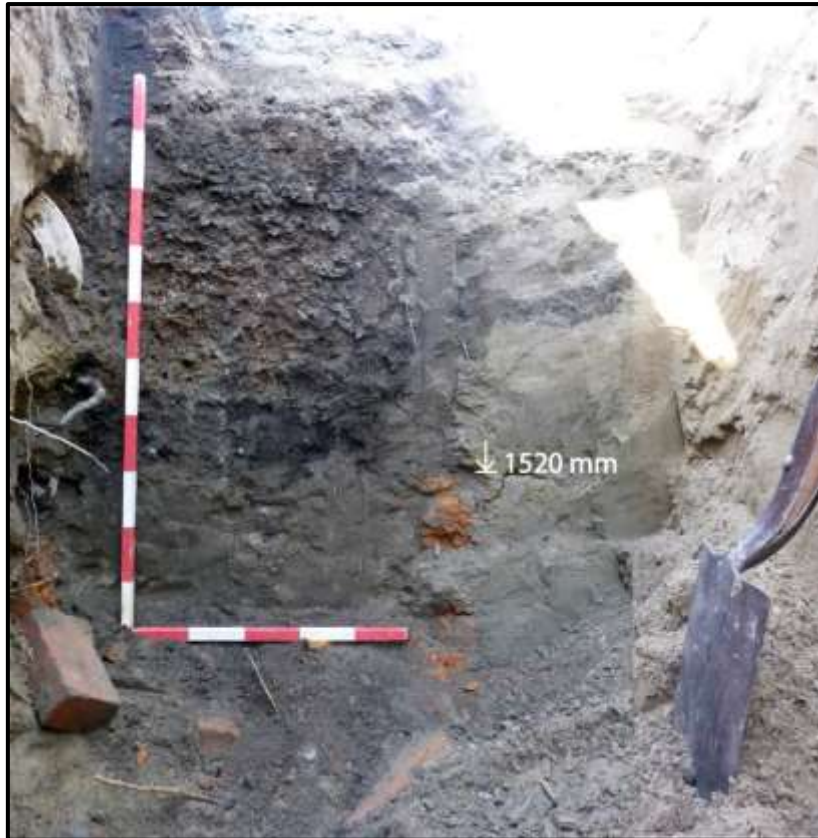
Figure 15. The northern side of Feature 2, in section, looking south. Note the black charcoal and ash stained fill matrix, and the in situ (albeit displaced) bricks from the lining of the well.

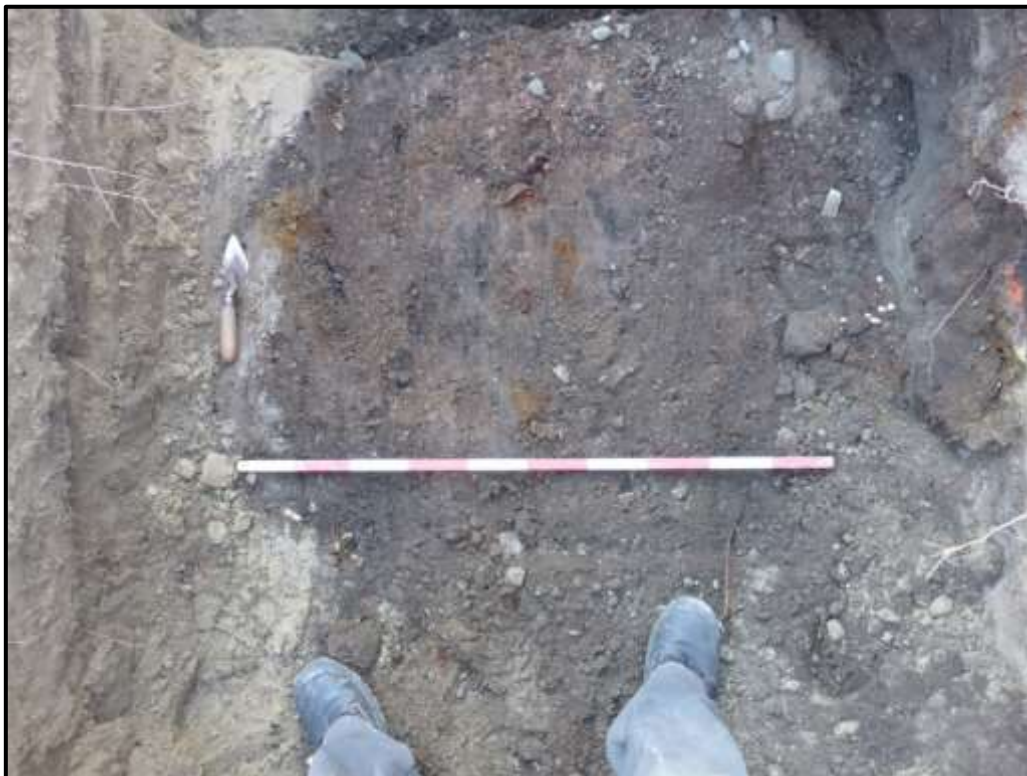
Figure 16. The black charcoal and ash stained fill matrix of Feature 2 at a depth of 760 mm. North is at top of image.

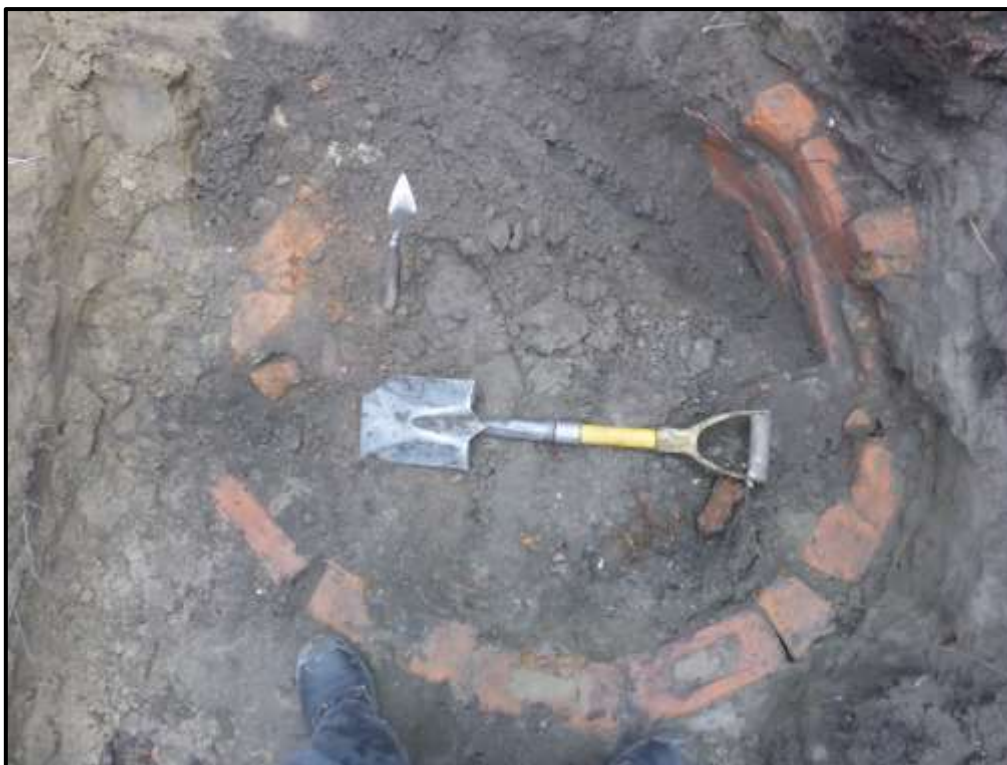
Figure 17. The brick lining of the well as first exposed at a depth of 1520 mm. North is at top of image.

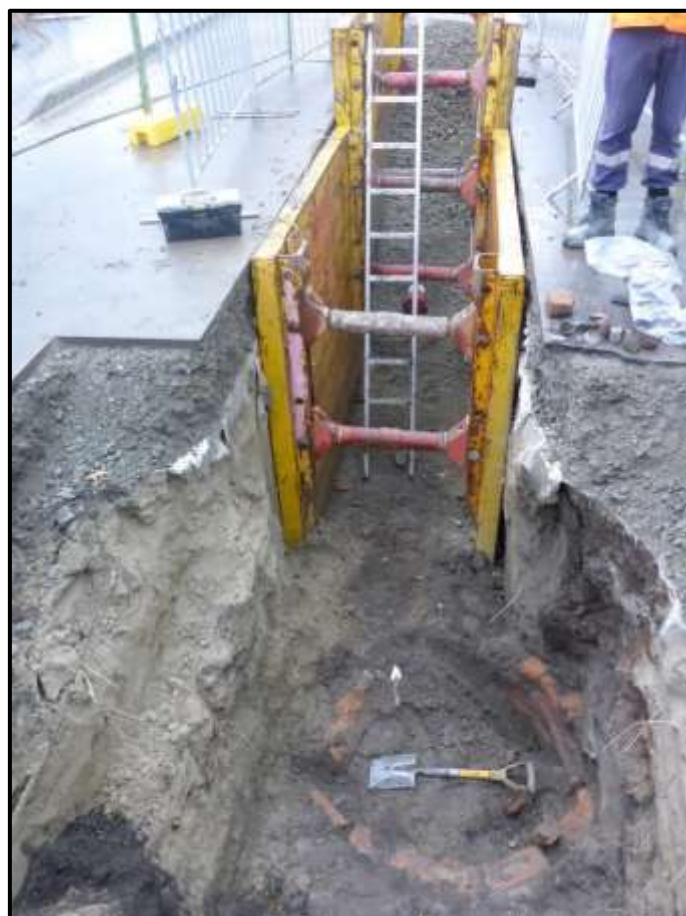
Figure 18. Looking northwest across the excavated area showing the first of the bricks that lined the well, exposed at a depth of 1520 mm.

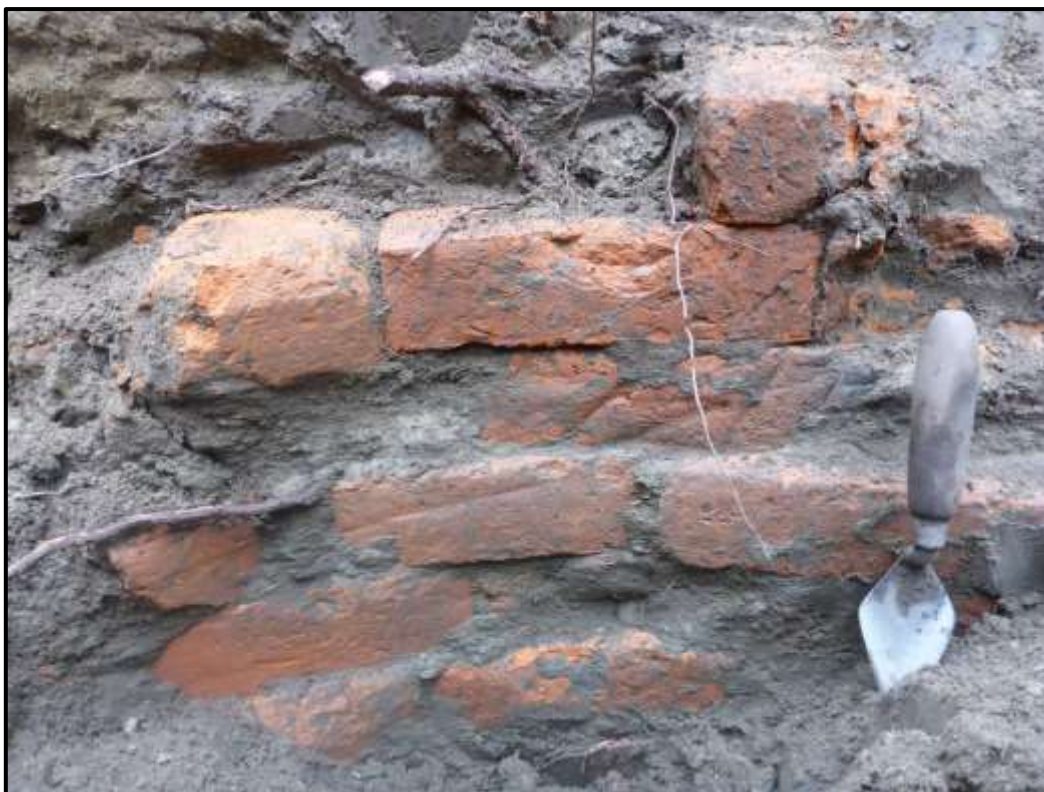
Figure 19. Representative section of the six uppermost remaining courses of bricks that lined the well. These had been laid dry without any mortar.

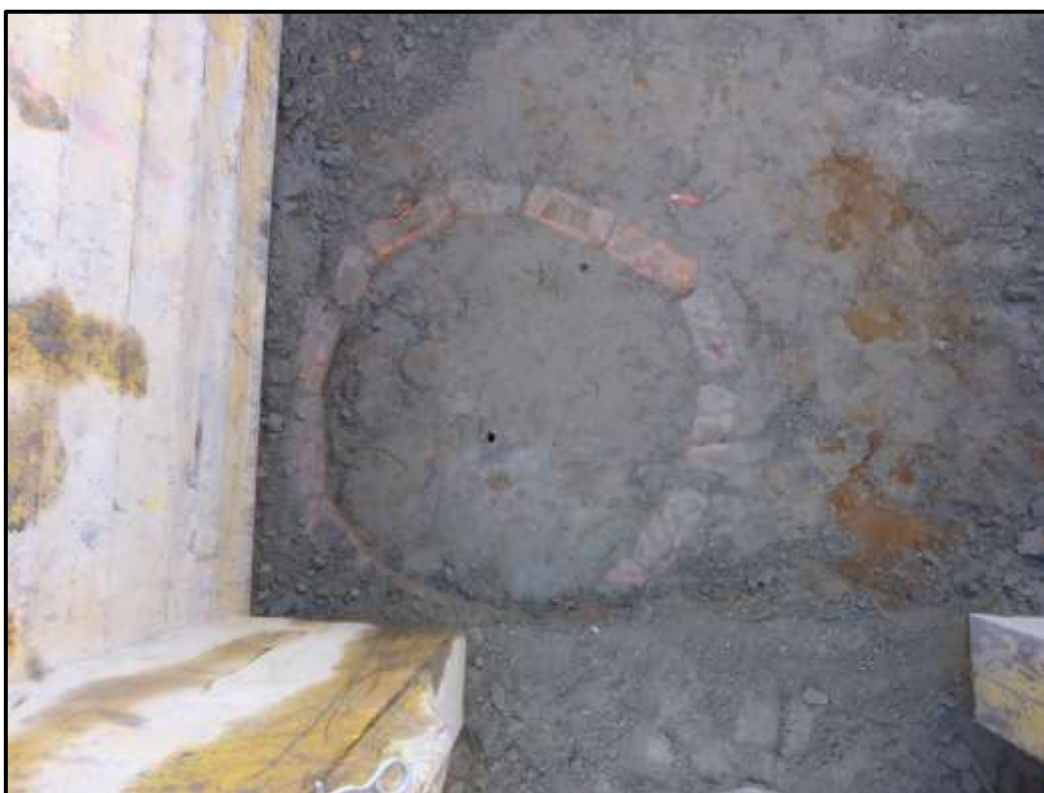
Figure 20. The brick lining of the well that remains in situ at a depth of 2450 mm. East is at top of image.

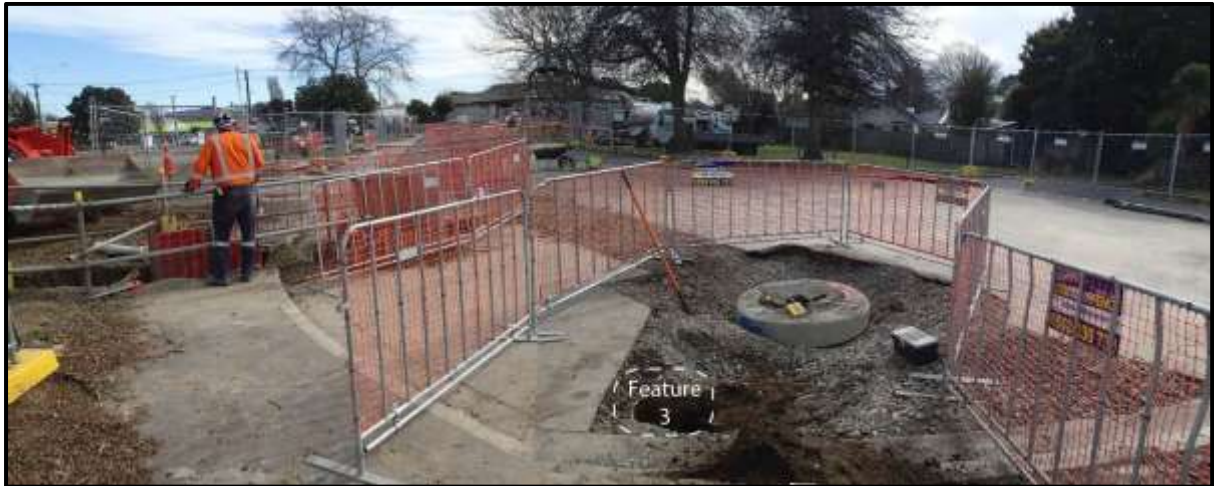
Figure 23. Looking northeast across the Sorensens Place works area, with the location of Feature 3 highlighted.

Feature 3 was a 19th century rubbish deposit of glass, ceramic, and faunal material that was exposed below the southeast end of the roadway on 22 August (Figure 22, Figure 23, and Figure 24). The top of the feature (which extended over a 1.6 m x 1.8 m area) was exposed at a depth of 440 mm, immediately below the bidim cloth, and extended to a depth of 840 mm. The stratigraphy exposed in this location, along with the large size of the feature and the absence of any clearly defined edges to the feature, supported the interpretation that it was a *surface accumulation* (Butcher and Smith 2010: 56), with the artefacts possibly discarded in a shallow gully or similar low spot that had been filled in, possibly as a single deposition event. The fill matrix of the featured was a ferrous stained grey sand that contained ash, charcoal, and 19th century artefacts (Figure 25 and Figure 26). Part of Feature 3 remains in situ immediately west of the excavated area, and thus the maximum spatial extent of this deposit as it was observed to extend in this direction is not known.

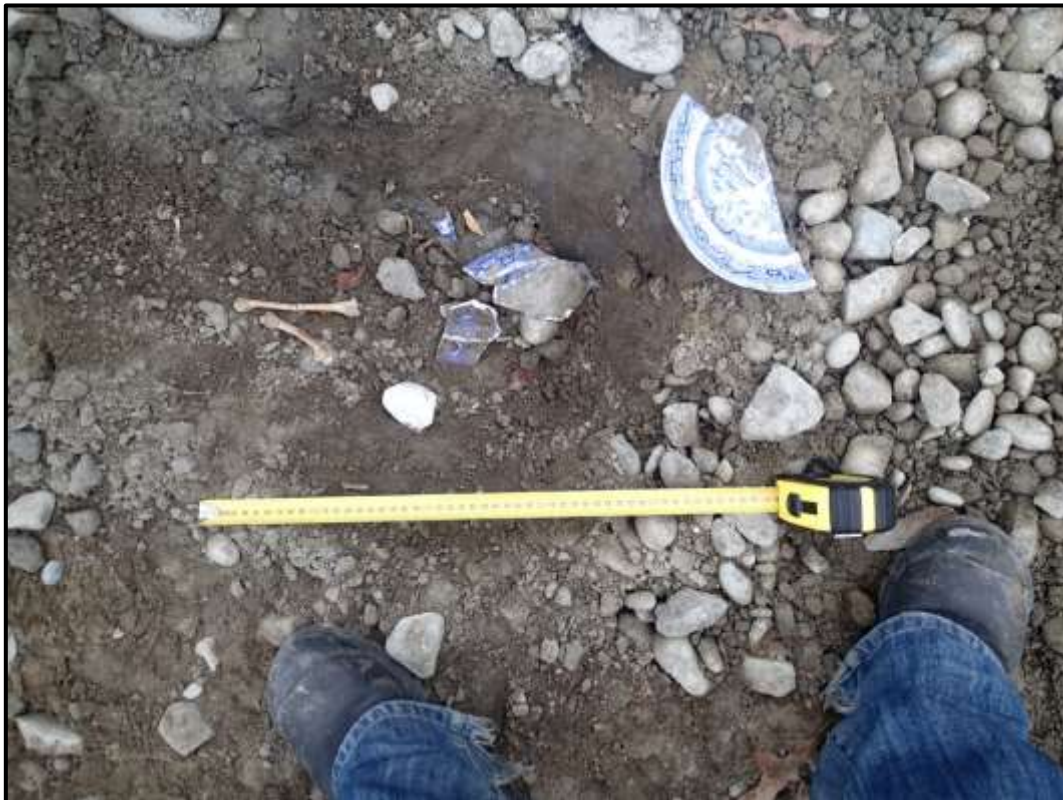
Figure 24. Feature 3, as first exposed at a depth of 440 mm. West is at top of image.

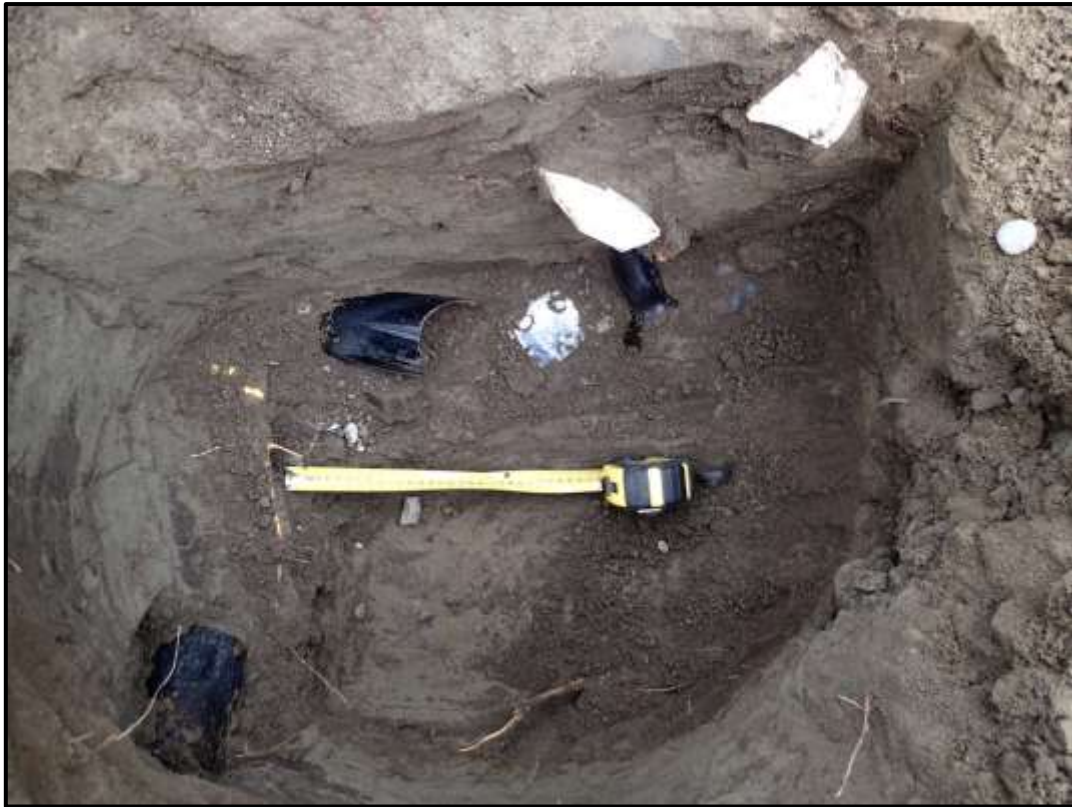
Figure 25. Feature 3 as excavated to a depth of 700 mm. West is at top of image.

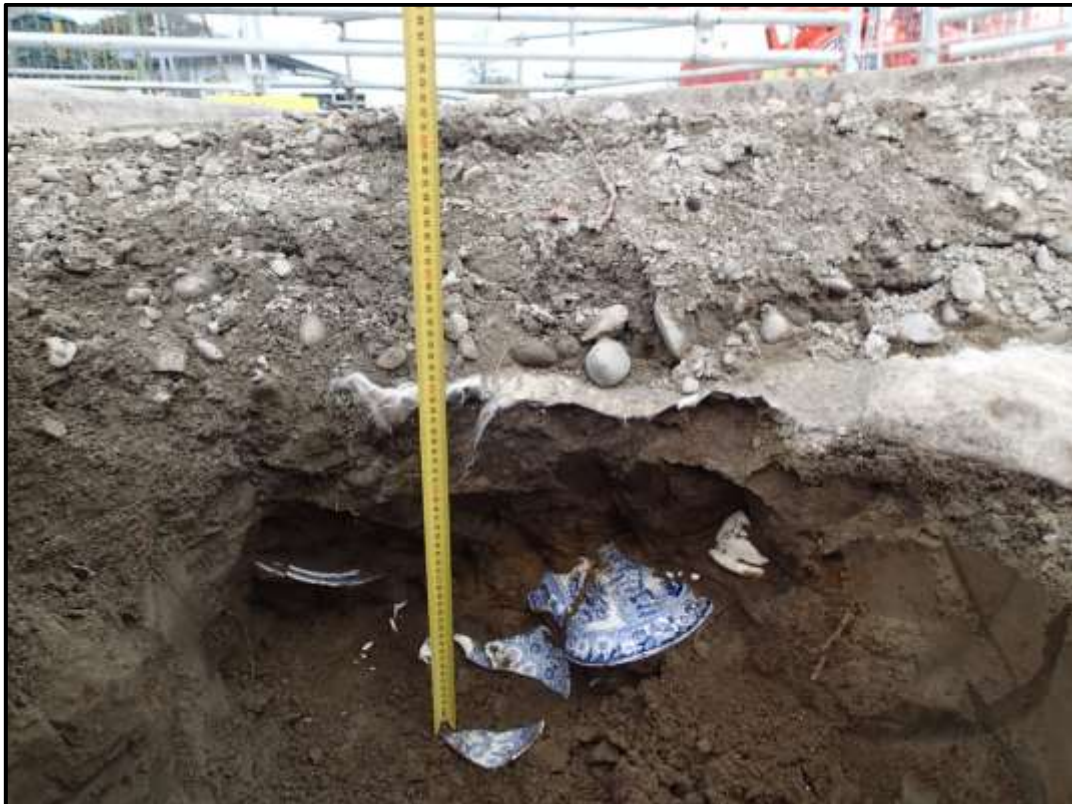
Figure 26. Blue transfer printed tablewares as exposed in Feature 3 at a depth of 600 mm, looking west.

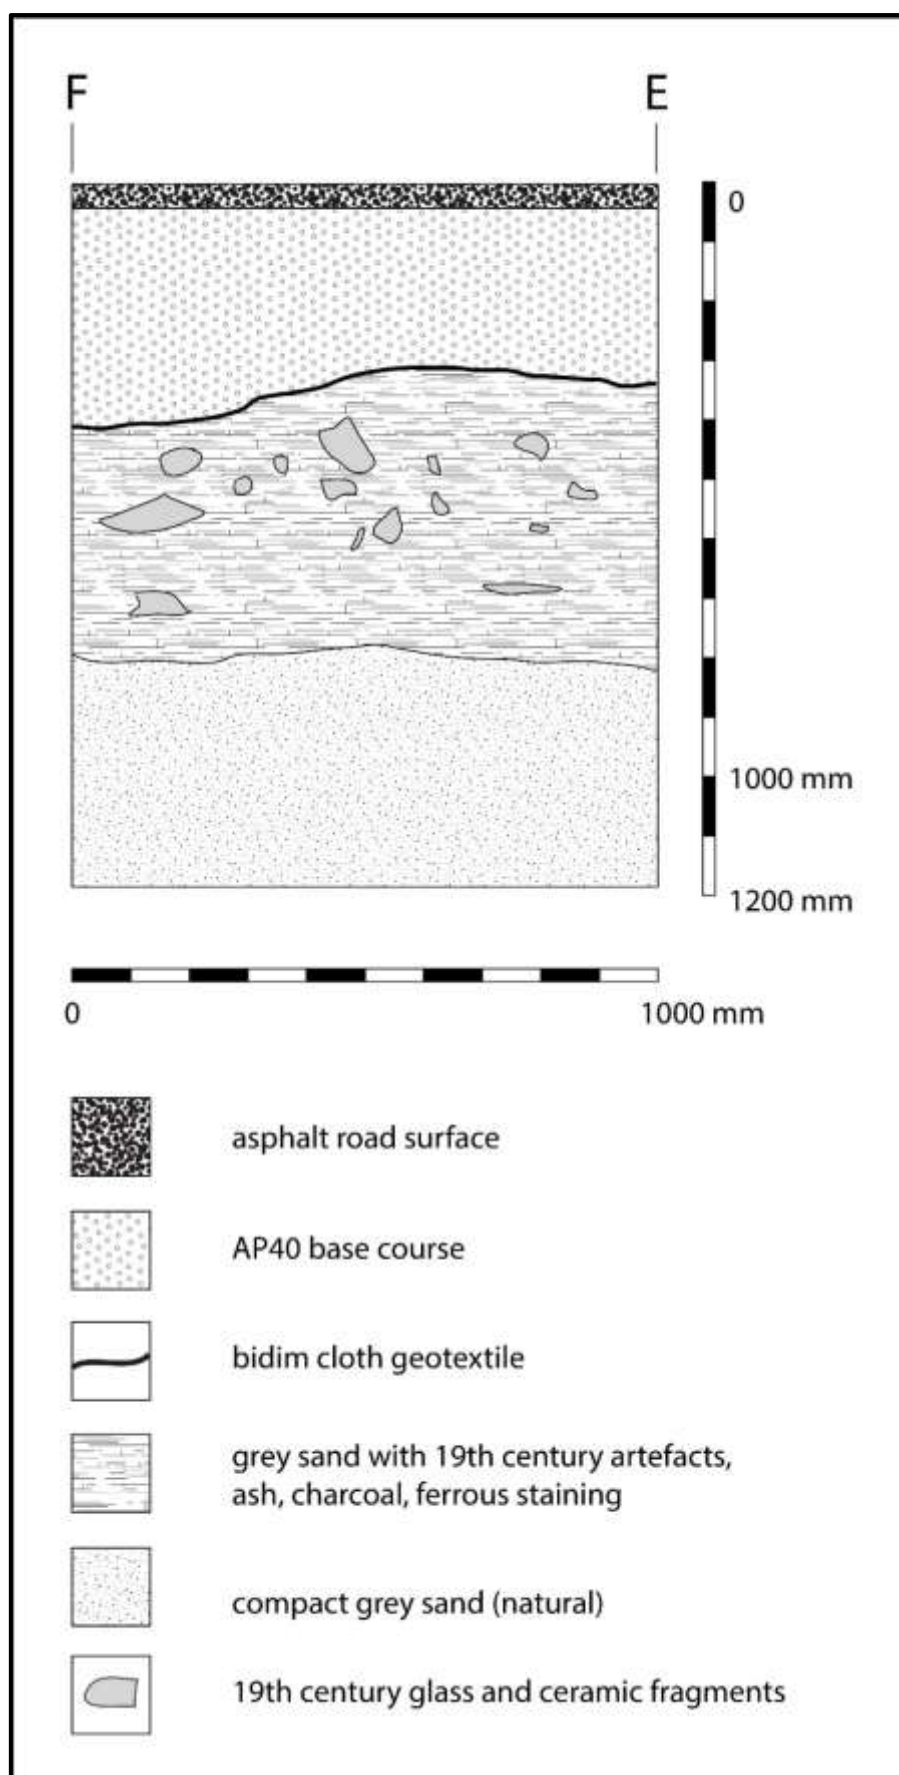
Figure 27. Stratigraphic profile drawing (F-E) through representative section of Feature 3, as exposed in the western baulk of the excavation.

1. The first stratum was a layer of asphalt and was 60 mm in depth. This layer was laid down subsequent to the 2011 earthquake.
2. The second stratum was a layer of AP 40 aggregates and was up to 360 mm thick. This hard fill base course layer was laid down subsequent to the 2011 earthquake.
3. The third stratum was a layer of bidim cloth of 2 mm thickness. This capped the natural sandy substrate and the top of Feature 3 and was laid down subsequent to the 2011 earthquake.
4. The fourth stratum was the Feature 3 fill deposit in the suspected gully, comprising a ferrous stained grey sand that contained ash, charcoal, and 19th century artefacts. This layer was up to 500 mm thick.
5. The fifth stratum was a layer of compact grey sand, which was the natural substrate and extended to the base of the excavation. The base of this layer was not reached.

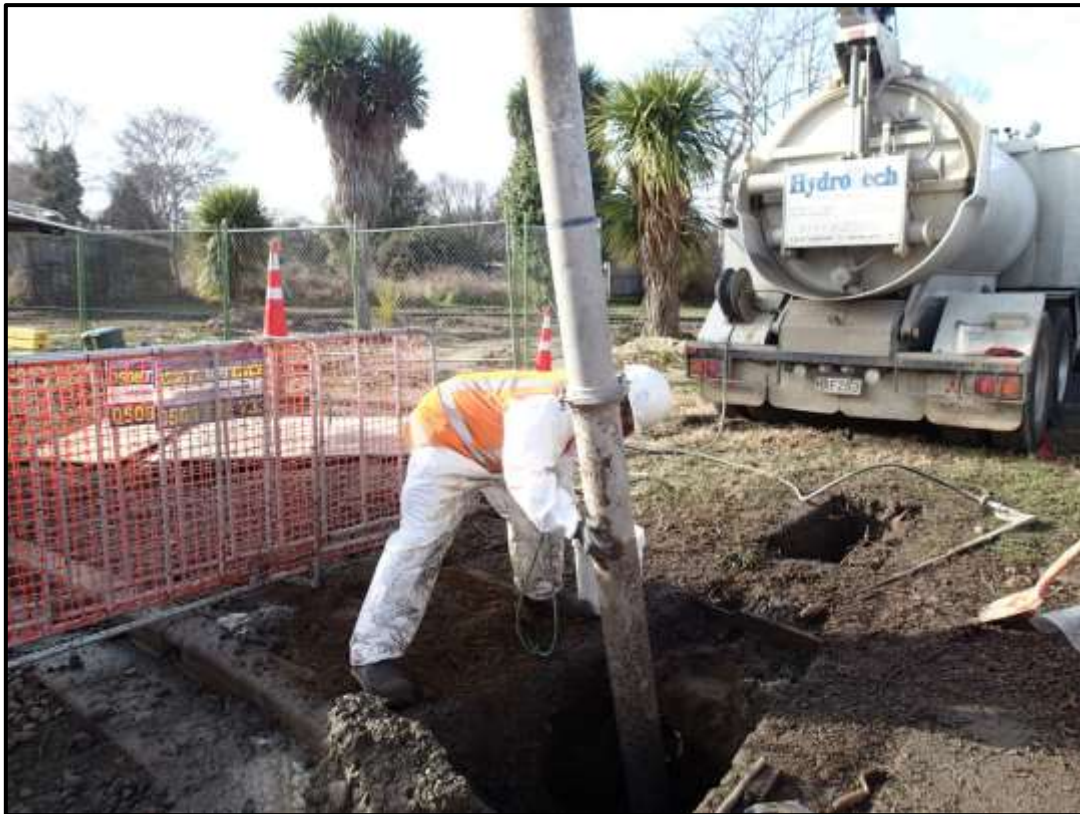
Figure 28. The lateral trench where the Feature 4 rubbish deposit was uncovered under hydro excavation, looking southeast.

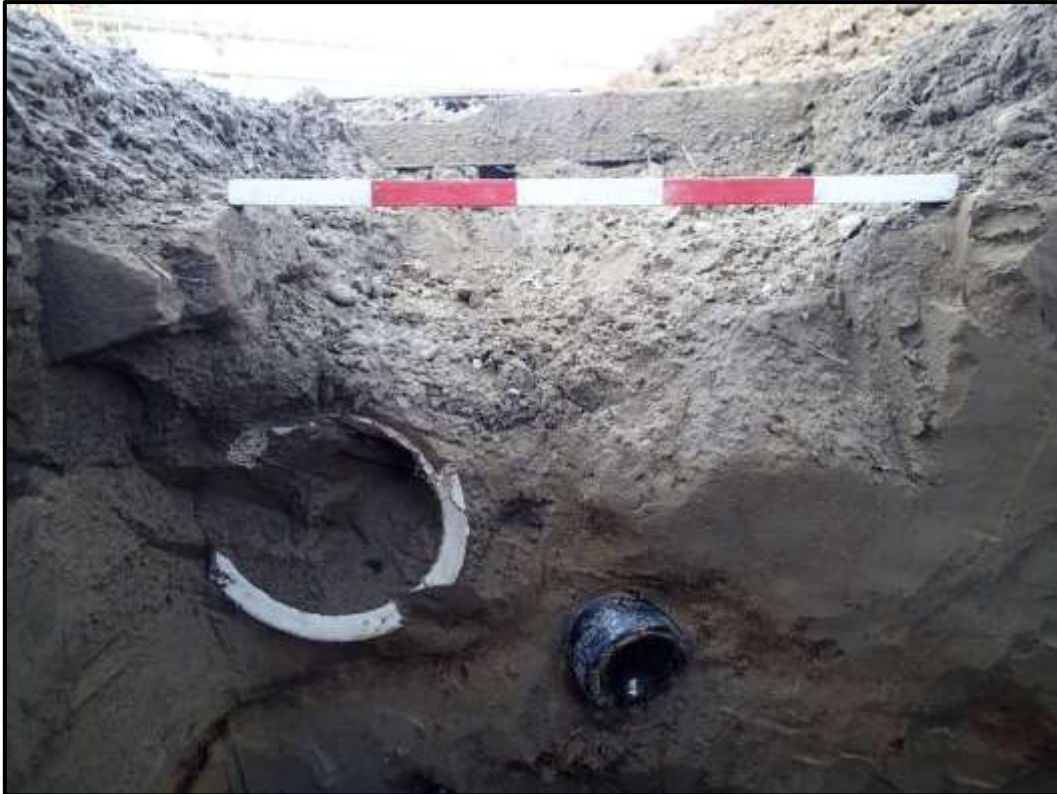
Figure 29. Chamber pot and black glass bottle as first exposed at the top of Feature 4, looking south.

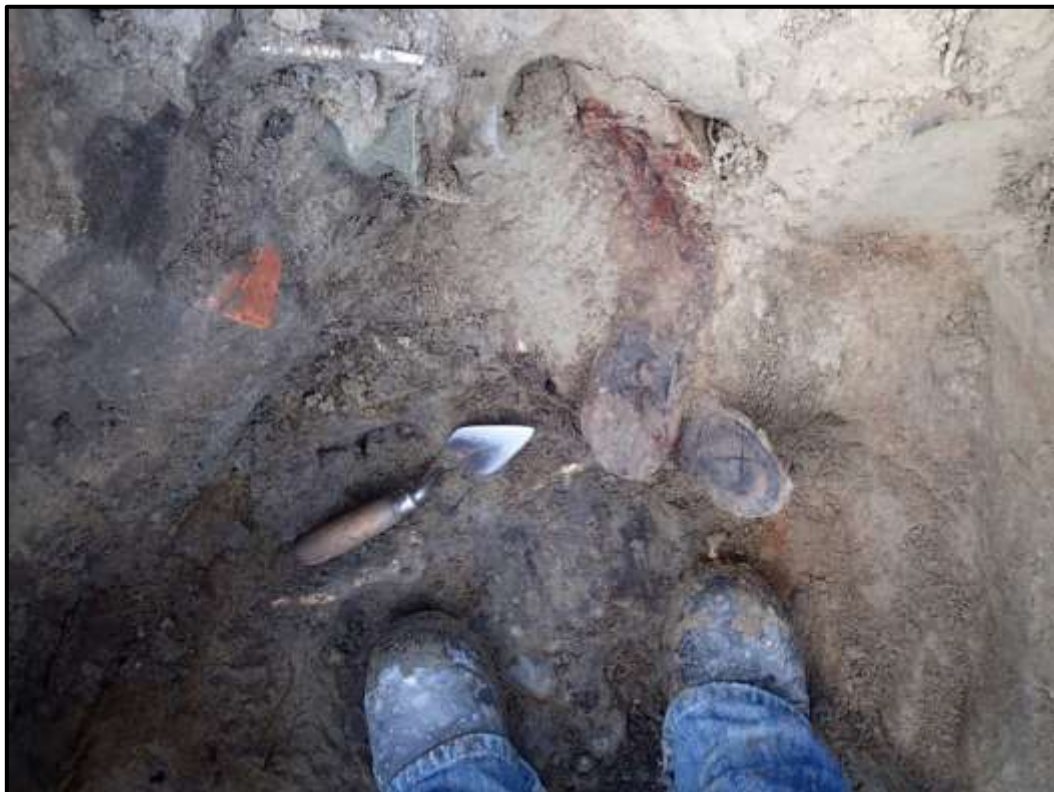
Figure 30. Brick, bone, and leather shoes exposed in Feature 4 at a depth of 500 mm. South is at top of image.

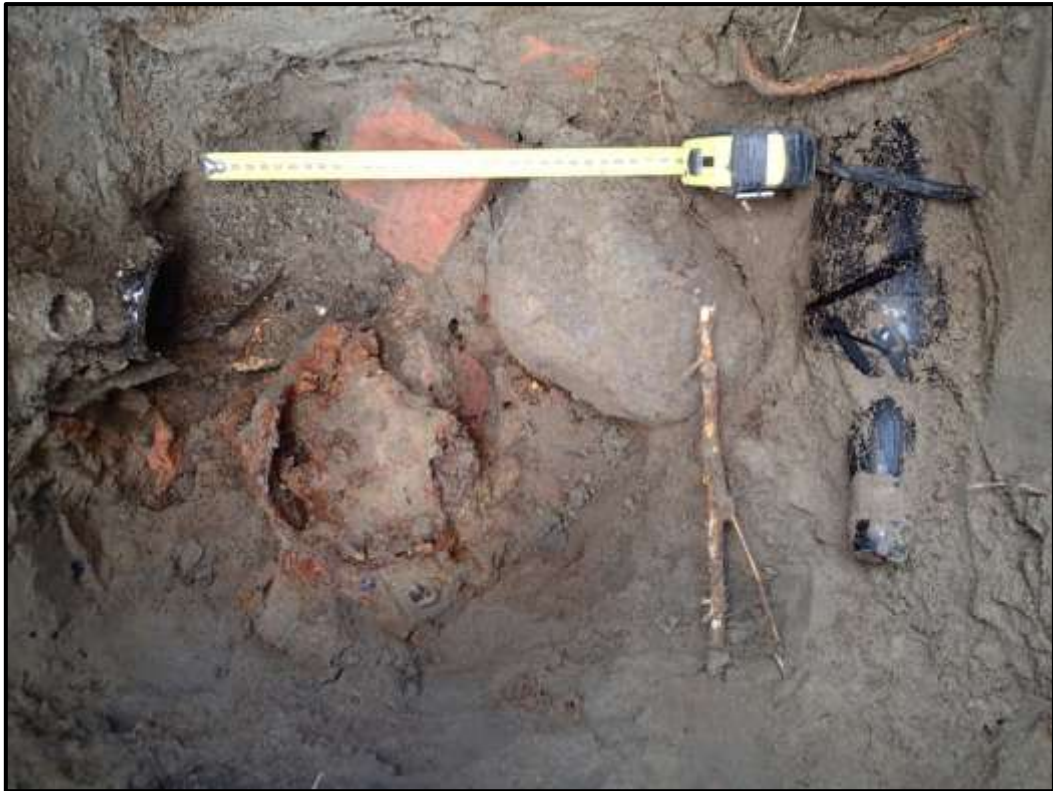
Figure 31. Brick, black glass bottle, greywacke cobble and metal cooking pot fragment exposed in Feature 4 at a depth of 980 mm. South is at top of image.

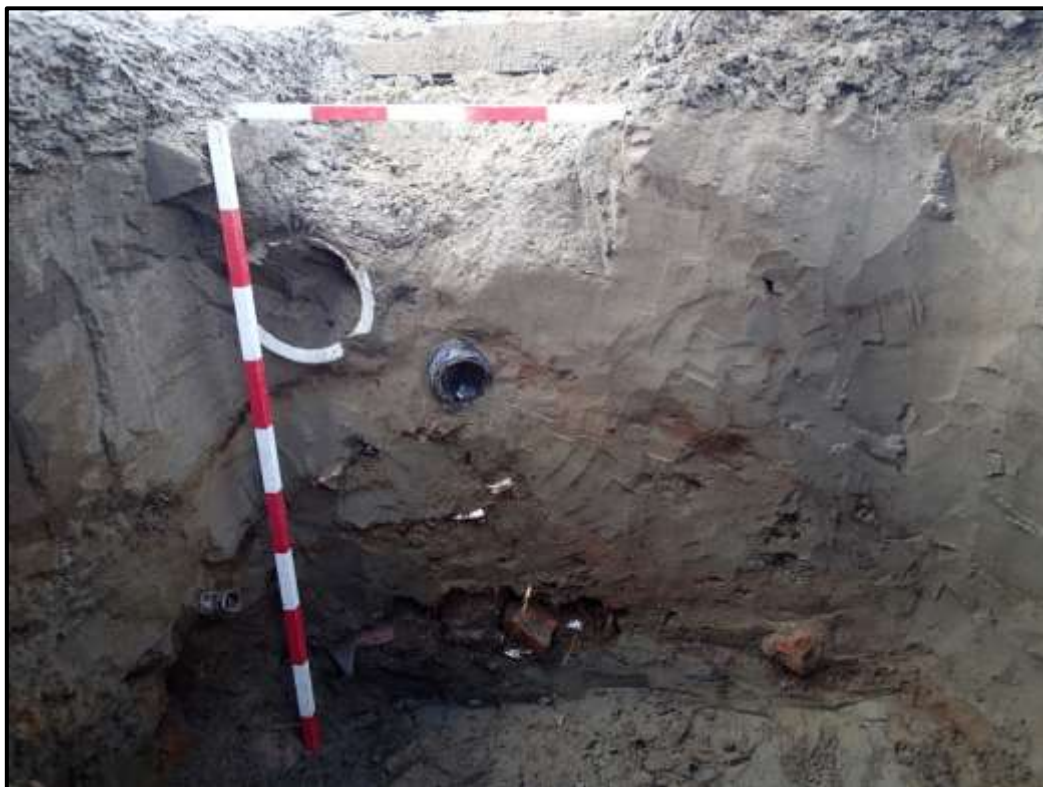
Figure 32. Feature 4 as excavated to a depth of 1200 mm, looking south. Note the ferrous banding that runs through the feature. A stratigraphic profile was drawn of this.

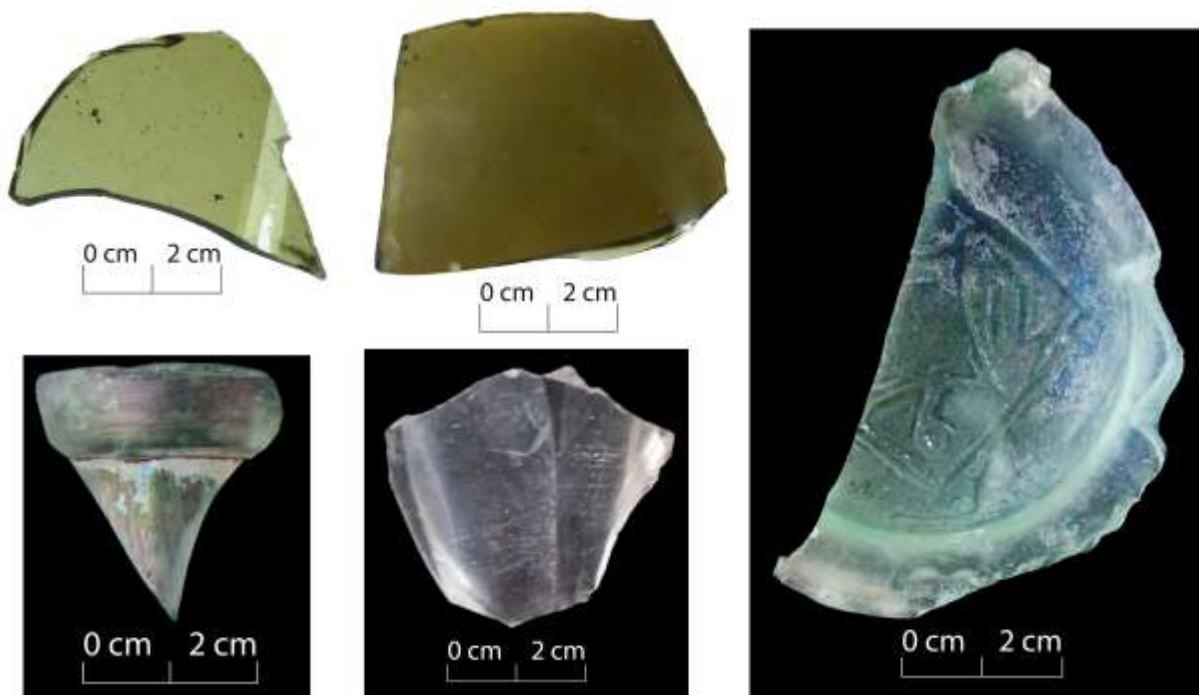
Figure 35. Glass artefacts from Feature 1. Clockwise from left: forest green body fragments (SCIRT50-G-20 and G-22), aqua green light bottle with a registration diamond embossed on the base (SCIRT50-G-21), cut panelled tumbler (SCIRT50-G-18) and wide mouth jar or bottle finish (SCIRT50-G-19).

Five small glass fragments were found in Feature 1 (Table 8 and Figure 35). Two of these were forest green coloured, which might have been part of ring seal wine/beer bottles. One wide mouth jar or bottle was also identified from the light aqua green finish recovered and one cut panelled fragment, likely part of a tumbler. Additionally, one round cross-sectioned aqua green bottle was encountered. The base fragment had a registration diamond embossed on the base. The mark was so faint as to be illegible, although a number was discernible on the right corner, indicating a registration date between 1842 and 1867 (Brooks 2005: 74). This fragment, most of which had a registration diamond embossed on the base, was probably part of a salad oil bottle.

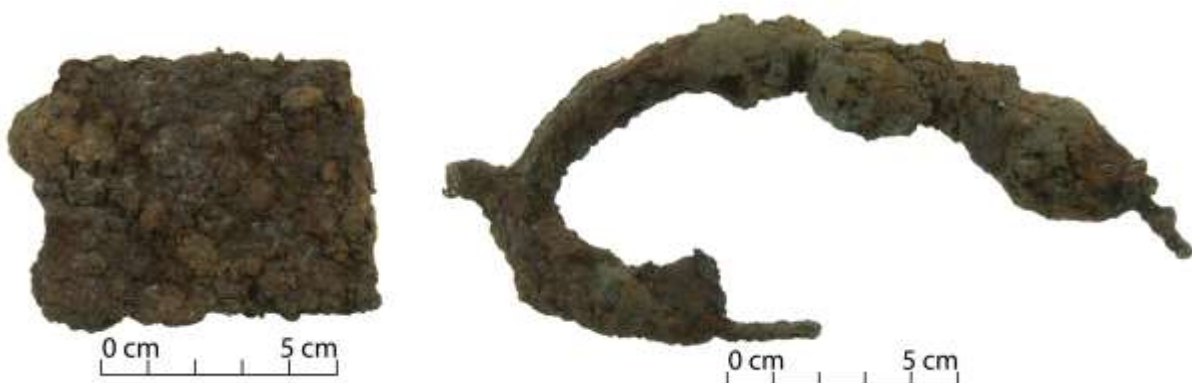
Figure 36. Ferrous elements from Feature 1: rectangular shaped artefact (SCIRT50-M-1) and handle (SCIRT50-M-2).

One of the artefacts was a fragment of strip metal (Figure 36). The second ferrous artefact was a curved handle, which might have been part of a latch for holding a door closed (Figure 36). However, the handle may also have been part of a piece of furniture, kettle or other metal container. It is difficult to know for certain due to the condition of the fragments.

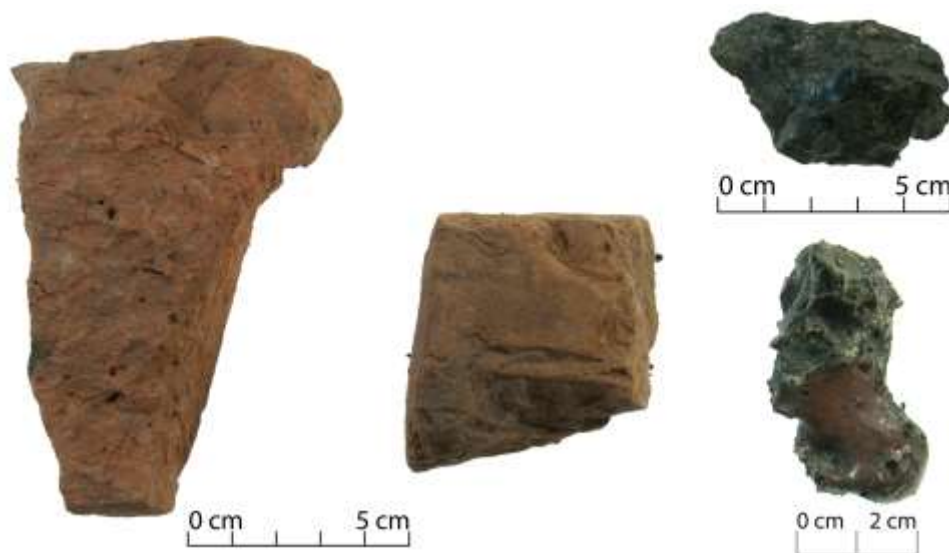
Figure 37. Other items found in Feature 1. Clockwise from left: brick fragments (SCIRT50-B-1), coal (SCIRT50-MC-18) and unidentified burned material (SCIRT50-MC-17).

Other items were exposed within Feature 1, consisting of two small fragments from a hand-pressed bricks, one coal fragment and one unidentified burned fragment that contained stones, coal and metal (Figure 37).
