Sorensens Place, Christchurch: report on Archaeological Monitoring

A report which details the archaeological investigations carried out during the course of SCIRT project 11232, wastewater renewal work in Sorensens Place.

SORENSENS PLACE, CHRISTCHURCH (M35/1440): REPORT ON ARCHAEOLOGICAL MONITORING

SCIRT 11232

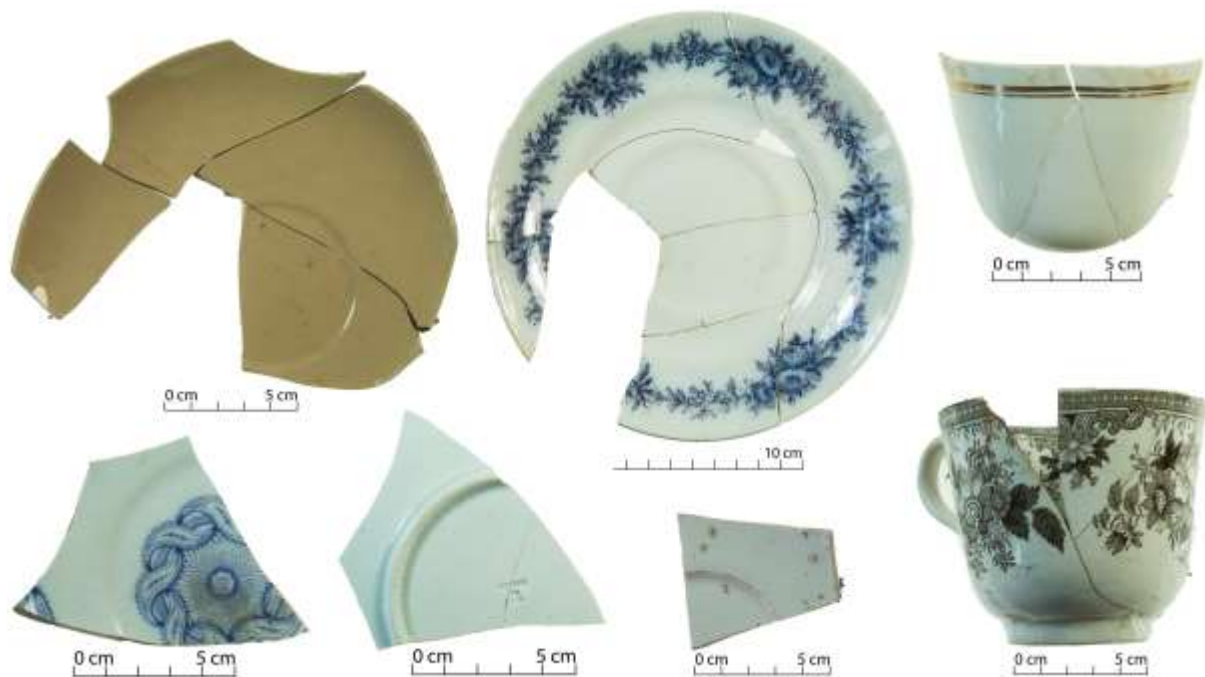
Figure 38. Tea wares encountered within Feature 2. Top row from left: yellow-ware saucer (SCIRT51-C-17), floral and foliage cable decorated saucer (SCIRT51-C-40) and gilt banded bone china teacup (SCIRT51-C-18). Bottom row: Florence patterned saucer with the Scott impressed mark on the base (SCIRT51-C-32), red banded saucer (SCIRT50-C-2) and Asiatic Pheasants patterned teacup (SCIRT51-C-25).

Tea wares included one yellow-ware saucer, one gilt banded bone china teacup and one red banded saucer. The other vessels were underglaze transfer printed (Figure 38). Two patterns were identified, in the form of one Asiatic Pheasants teacup and one Florence patterned saucer. The former is one of the most ubiquitous patterns found on 19th century historical sites though New Zealand and elsewhere around the world. It is easily identifiable by its floral border and central scene with one or more pheasants depicted among a floral arrangement. It is usually found in a pale blue colour although it is also transfer printed in black as this example shows. The Florence pattern was a border motif with a small accompanying design in the centre of the base, featuring ribbons and small chevrons on the rim (Transferware Collector's Club 2017). This saucer had 'SCOTT' impressed on the base, likely referring to A. Scott and Co./Sons, a Staffordshire pottery firm. 'SCOTT' was used as a mark from 1838 until the 1890s (Godden 1991: 587). Unidentified motifs featured repeating ribbon elements and a floral and foliage pattern were noted on the rim of one of the saucers. Although produced earlier in the century,

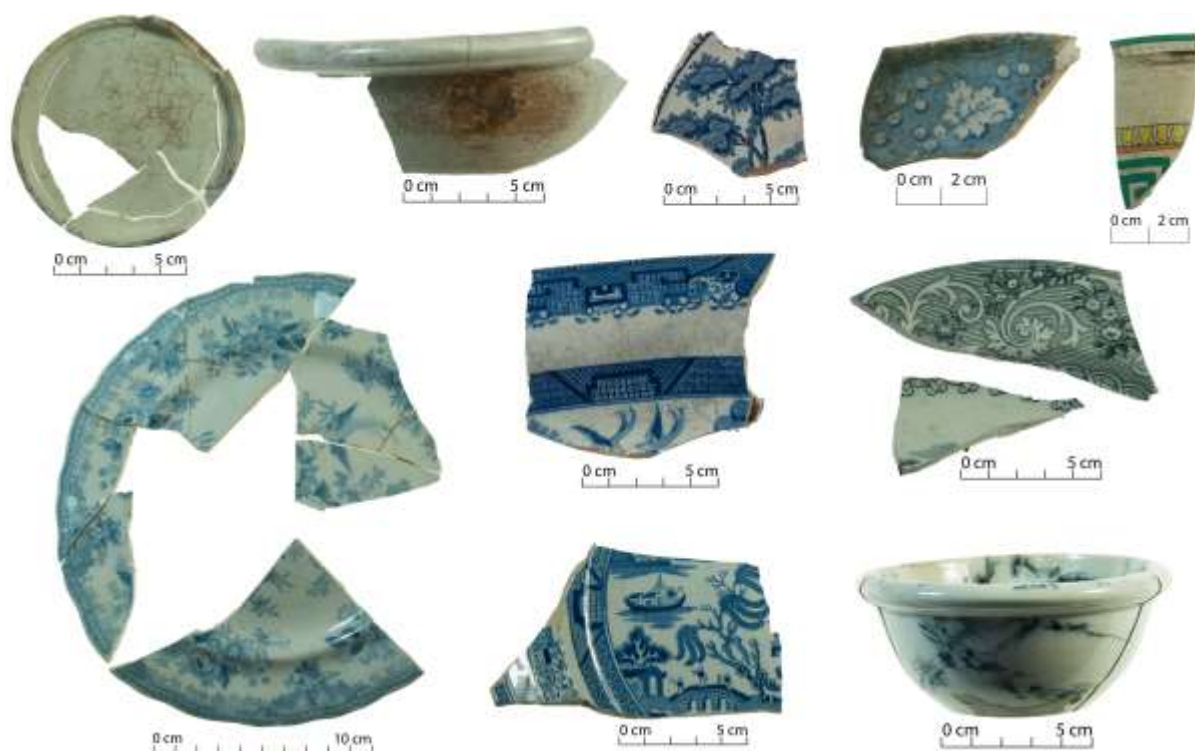
Figure 39. Table wares from Feature 2. Top row from left: unidentified hollow-ware (SCIRT51-C-22), undecorated bowl (SCIRT51-C-21), small fragments from blue transfer printed plates (SCIRT50-C-1 and SCIRT51-C-39) and unglazed and painted hollow-ware (SCIRT51-C-27). Bottom row: Asiatic Pheasants plate (SCIRT51-C-35), Willow patterned bowl (SCIRT50-C-5) and plate (SCIRT51-C-37), Rhine plate (SCIRT51-C-24) and Marble patterned small bowl (SCIRT51-C-28).

Several forms and decorations were identified among the table wares from Feature 2 (Figure 39). The assemblage contained a few undecorated hollow-wares and a range of blue transfer printed plates and bowls. One unglazed whiteware vessel was also recovered, which was painted in yellow, green and orange featuring geometric and repetitive Greek key elements. The unidentified blue patterns from the small fragments bore foliage motifs. The assemblage is dominated by the presence of scenic or sheet patterns covering most or all of the vessel, styles which are characteristic of mid-19th century ceramic consumption (Garland et al. 2015, Samford 1997).

A number of recognisable patterns were identified, including the Asiatic Pheasants, Willow, Rhine and Marble patterns (Figure 39). At least one dinner set was noted, including five Willow patterned vessels (three plates, one bowl and one unidentified hollow-ware vessel). Rhine was another particularly common pattern, identified through its distinct stylised rim border and romantic central scenes (Coysh and Henrywood 1983: 300-301). It is most often found in grey, although it has also been found in archaeological assemblages in blue, black and green. Marble was a sheet pattern so called based on its similarity with marble stone and the veins on its surface.

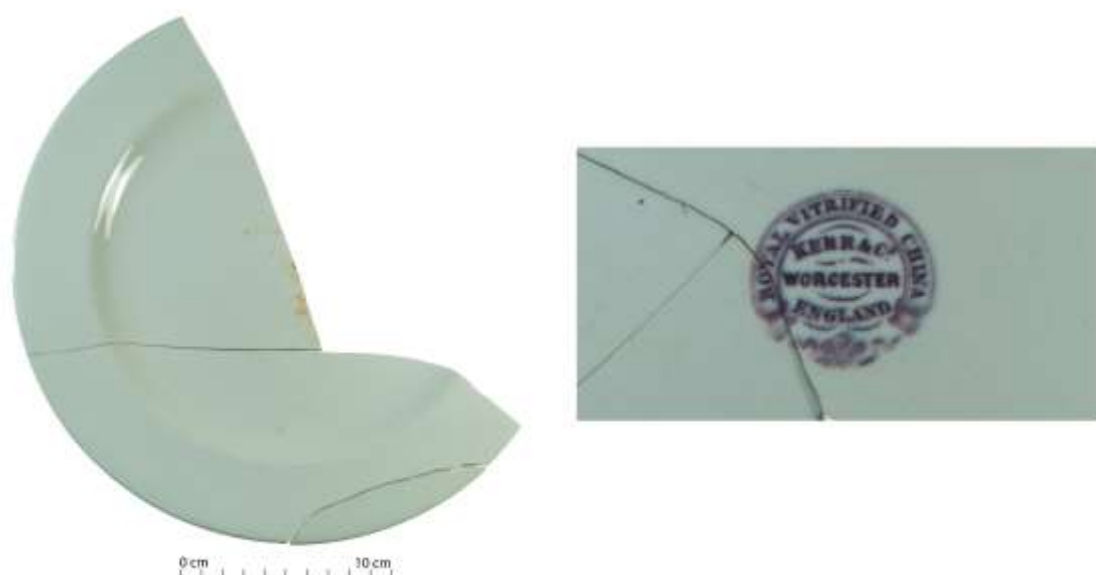
Figure 40. Undecorated dinner plate with the Kerr and Company printed mark on the base (SCIRT51-C-33).

A maker's mark was identified on the base of a semi-vitrified dinner plate (Figure 40). The printed mark read ROYAL VITRIFIED CHINA surrounding a scroll and KERR & CO / WORCESTER / ENGLAND within it, referring to Kerr and Binns Pottery (1852-1862). In 1852, Richard William Binns and William Henry Kerr, both Irish, took over the management of the Chamberlain and Company porcelain works in Worcester. In 1862 Kerr returned to Ireland and under the leadership of Richard Binns, the Worcester Royal Porcelain factory climbed to new heights of success (Antique Marks 2016; Godden 1991: 696).

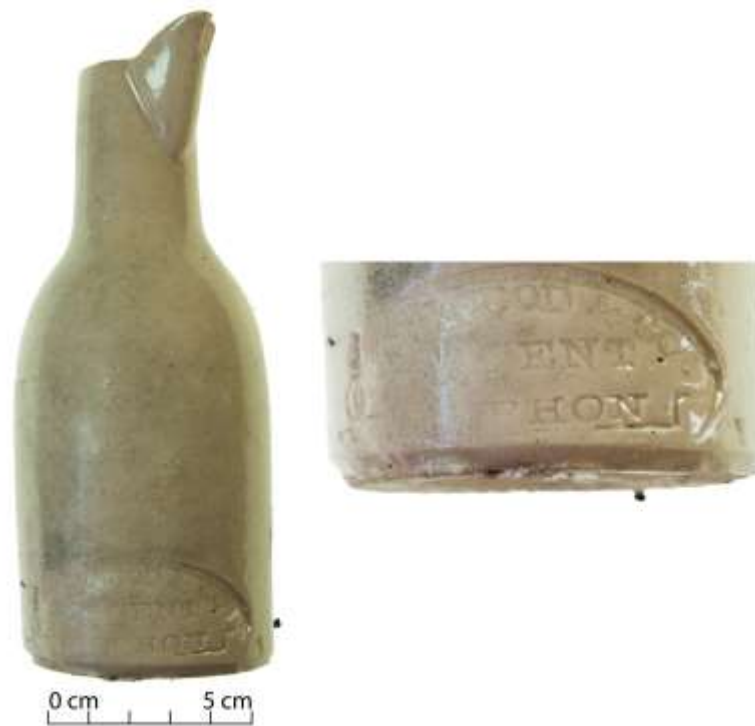
Figure 41. Spouted ink bottle (SCIRT50-C-3) and detail of the impressed mark on the body.

Another maker's mark was impressed on the spouted stoneware ink bottle, which read BLACKWOOD & Co / PATENT / SYPHON on heel (Figure 41). The letters "O" and "Y" were also impressed on the body. Blackwood and Company were well-known ink bottle manufacturers, founded in 1843 (McGuinness 2013). They had premises at 26 Long Acre in London, before moving to 18 Bread Street at an unspecified date. The first mention of Blackwood inks in New Zealand newspapers was in 1861 (*Otago Witness* 25/05/1861: 4). The production of Blackwood inks continued until at least the 1920s (McGuinness 2013). The mark is often found on syphon ink bottles, so named thanks to their distinctive spouted syphon finish, designed to eliminate the need to remove a cork to open the bottle.

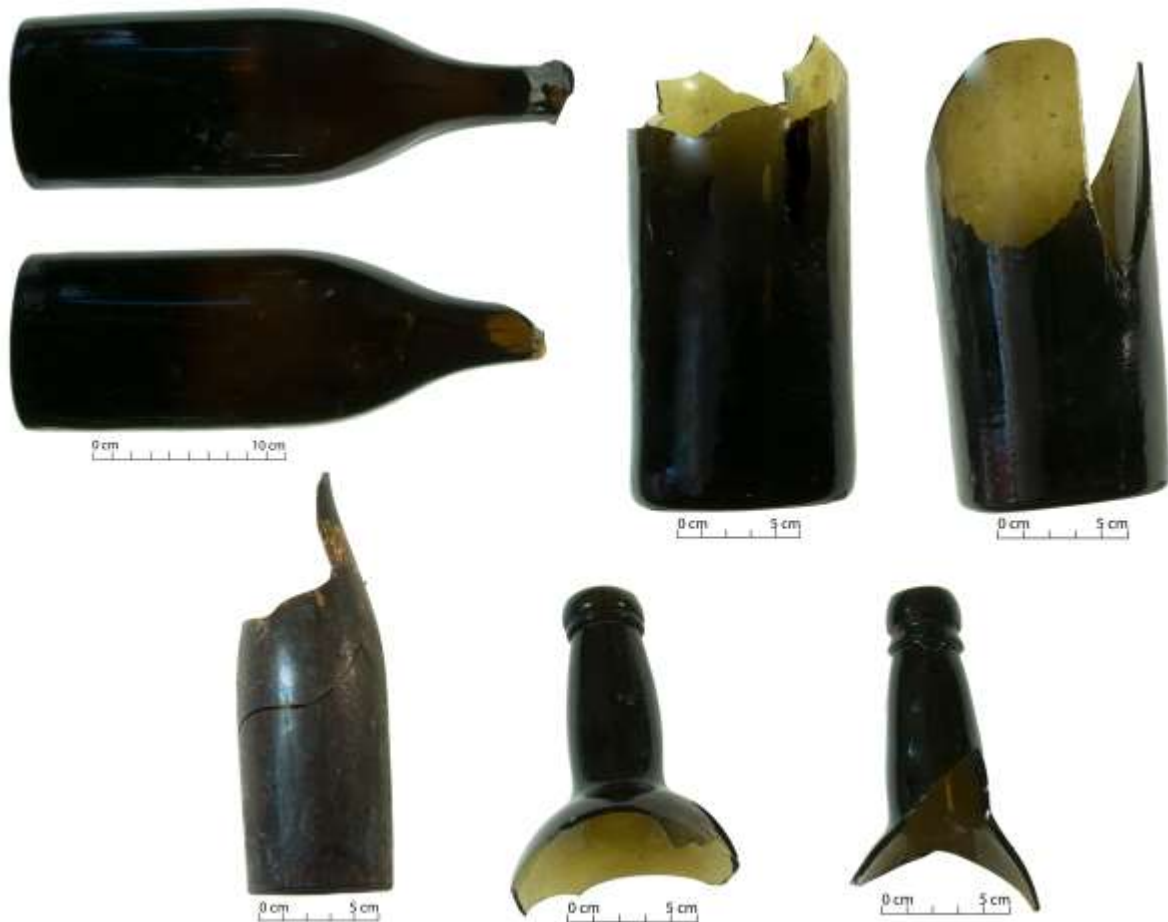
Figure 42. Alcohol bottles found in Feature 2. Top row from left: black porter bottles (SCIRT51-G-34) and pint sized and quart sized black beers (SCIRT50-G-3 and G-1). Bottom row from: amber round sectioned bottle (SCIRT50-G-6) squat bottle (SCIRT50-G-5) and black beer finish (SCIRT50-G-4)

The majority of the alcohol bottles consisted of black beer bottles in several shapes and sizes (Figure 42). Most of these were ‘quart’ sized (identified as large squat or large bottles⁴). However, ‘pint’ sized (identified as small squat or small bottles) were also represented as well as two black porter bottles. Such differences in bottle size corresponded directly to the quantities in which beer and spirits were sold, both wholesale and in a retail context (Illinois Glass Catalogue 1906: 250; Lindsey 2017). Newspaper advertisements from the 1870s and 1880s suggest that quarts of beer sold for approximately 6-9 pence per bottle, depending on the variety of beer, the quantity purchased and where it was sold. Pint bottles appear to have cost roughly half that of quarts (*Evening Post* 8/6/1871: 3, 10/5/1880: 4). All the black beer bottles were made using dip moulds and no embossing or labelling was noted on them, making it difficult to determine the product that they originally contained. These bottles are known to have been used for beer and spirits such as whisky and gin (Garland 2016).

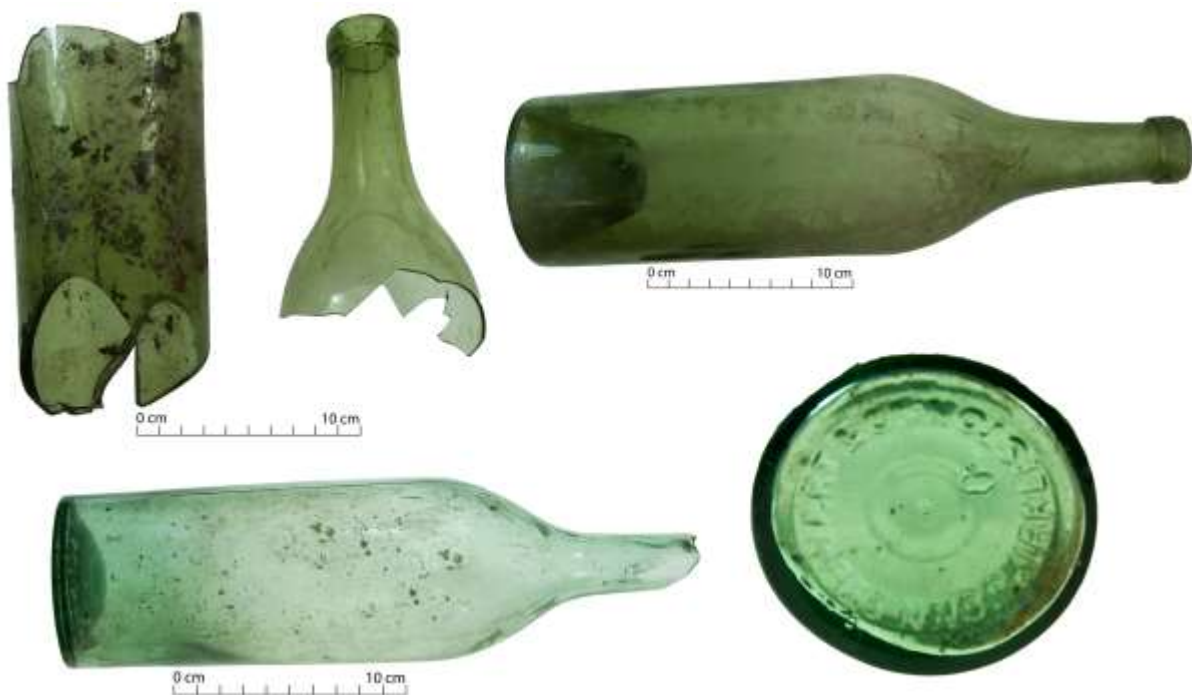
Figure 43. Spirit bottles. Clockwise from top left: incomplete and complete ring seal (Bordeaux) bottles (SCIRT51-G-39 and G-33), embossed spirit bottle referring to John Stewart and Company from Kirkliston (SCIRT51-G-38).

Apart from the black beers, alcohol bottles from this assemblage included three spirit shaped bottles in aqua green light colour (Figure 43). With the exception of the embossed bottle, these were made using a one-piece dip mould. The embossed bottle was made using a two-piece mould with a cup bottom. The embossing on the base read JOHN STEWART & CO KIRKLISTON, referred to John Stewart and Company. They were whisky distillers based at the Kirkliston distillery in West Lothian, Scotland, from 1855 until 1877. The Kirkliston distillery was established in 1795 and went through several owners. Stewart and Company took over the business in 1855, installing a Coffey still and converting it to a primarily grain based distillery. In 1877, John Stewart and Company was one of the six Scottish whisky distillers to form the Distiller's Company Ltd, who continued in business well into the 20th century, although Kirkliston ceased to operate as a distillery in the early 20th century (Townsend 2015).

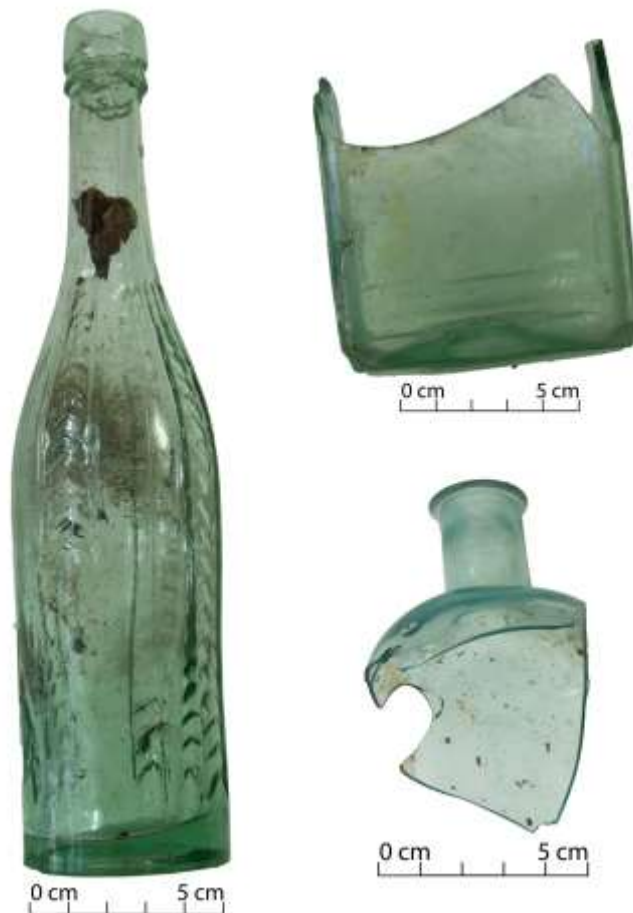
Figure 44. Other bottles from Feature 2. Clockwise from left: salad oil bottle (SCIRT51-G-32), pickle jar (SCIRT50-G-6), and oval pharmaceutical bottle (SCIRT51-G-29).

The non-alcoholic bottles from Feature 2 were several condiment bottles and two oval aqua blue bottles, probably used for pharmaceutical purposes (Figure 44). One unidentified amber round sectioned bottle and one wide mouth jar in clear glass were also found (Figure 44). Condiment bottles included panelled and press moulded body shapes. The complete example was identified as a salad oil bottle. Salad oil typically came in tall slender bottles, often with embossed or moulded decorated bodies. Such bottles were often decorated due to their presence at the dinner table or in order to associate a product with particular manufacturers (Campbell et al. 2009: 214).

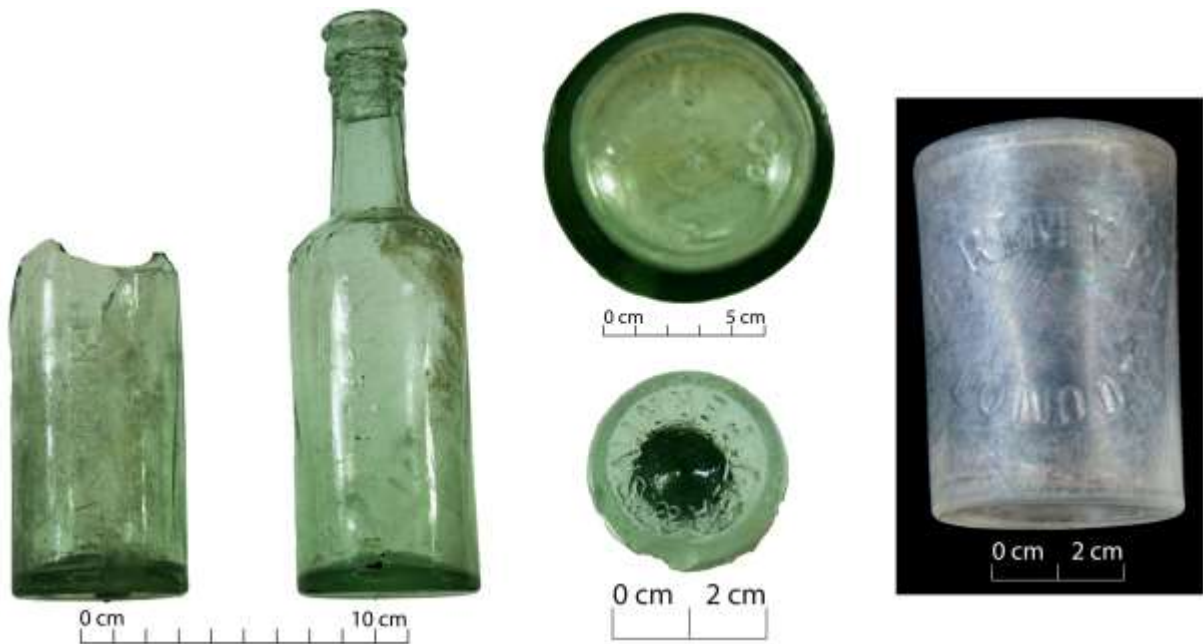
Figure 45. Embossed glass from left: Lea and Perrins Worcestershire sauce bottles with detail of the Aire and Calder Bottle Company base (SCIRT51-G-27), Rimmel cosmetic bottle (SCIRT50-G-15) and Lea and Perrins stopper (SCIRT51-G-28).

As well as the embossed whisky bottle, two sauce bottles had the embossing WORCESTERSHIRE SAUCE around the shoulder and LEA & PERRINS down the side (Figure 45). Lea and Perrins is one of the most commonly found condiment bottles from 19th century sites in New Zealand and it has been one of the most popular sauces in New Zealand since at least 1852 (Tasker 1989: 88). The letters A C B & Co embossed on the base refer to the Aire and Calder Glass Bottle Company, a branch of the E. Breffit and Co. glassmaking company established in the mid-19th century. Breffit and Company appears to have acquired the factory and begun manufacturing glass under the name of Aire and Calder by at least the 1860s, possibly earlier. The company became associated with the manufacture of Worcestershire sauce and other company bottles during the mid-late 19th century (Lockhart et al. 2015, Toulouse 1971: 79).

One perfume bottle was found, identified as such from the embossing, which read E RIMMEL / LONDON (Figure 45). The company was started in 1834, when Eugene Rimmel became his father's apprentice at his newly opened perfumery in London. By the age of 24, Eugene was an expert perfumer and cosmetic maker, and opened his own flagship store in Regent Street. When he died, in 1887, his two sons took over the business (*Guardian* 23/1/2012). The company became one of the most successful cosmetics companies of the 19th century: their products included a range of cosmetics, hair products, personal hygiene products and perfume vaporises, scents and toilet waters, all of which were widely advertised in New Zealand newspapers from 1852 well into the 20th century (*Daily Southern Cross* 24/9/1852: 1, *Nelson Evening Mail* 28/3/1884: 1, *Press* 14/12/1937: 11).

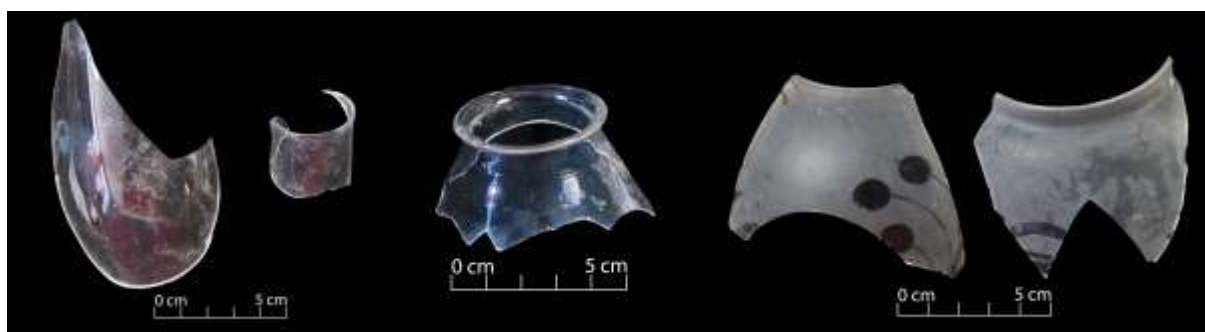
Figure 47. Lamp fragments recovered from Feature 2 from left: lamp chimney (SCIRT50-G-7), bottom of lamp chimney (SCIRT50-G-41 and frosted and decorated lamp chimney (SCIRT50-G-8).

Several lamp chimneys were found, one of which was frosted and decorated. These are likely to have originally formed the glass chimneys from oil or gas lamps, either portable and fixed examples, a form of lighting in use for most of the 19th and much of the 20th century (Figure 47).

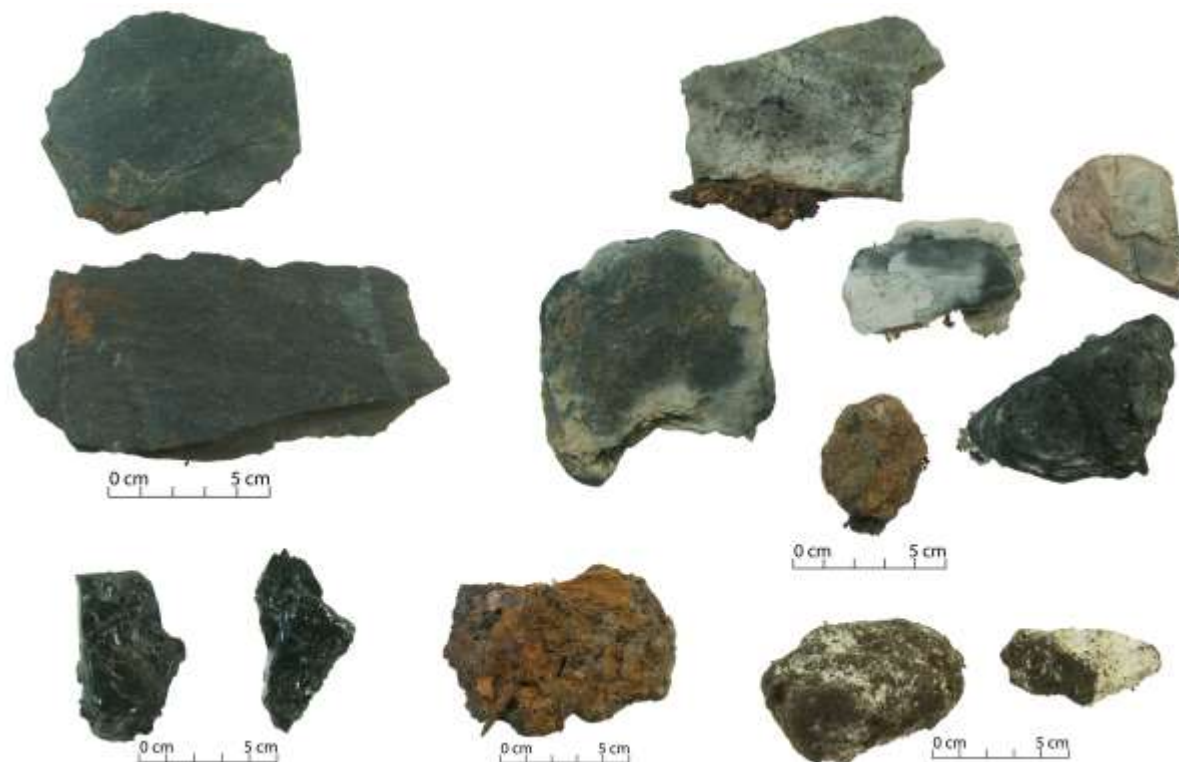
Figure 48. Other items from Feature 2. Clockwise from top left: slate fragments (SCIRT50-MC-13), plaster fragments (SCIRT50-MC-12), unidentified artefact, probably plaster (SCIRT50-MC-16), conglomerate (SCIRT50-MC-14) and coal fragments (SCIRT50-MC-11).

Eleven other items were found in Feature 2, most of which were likely associated with structural elements, comprising a variety of materials such as slate, coal, plaster and conglomerate (Table 17 and Figure 48).

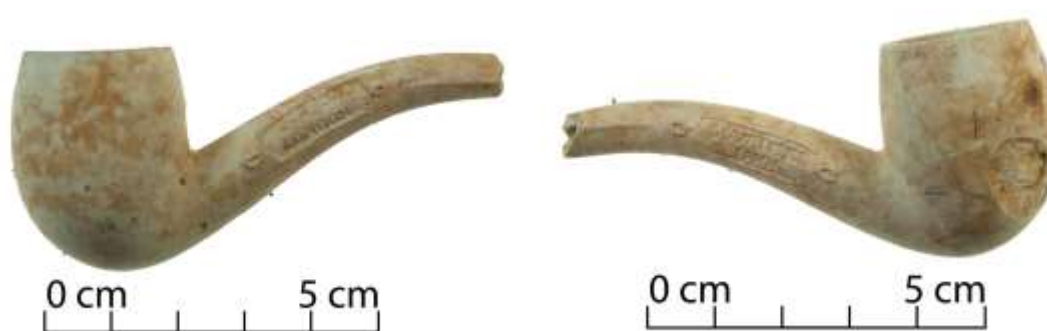
Figure 50. White clay smoking pipe from Feature 2. Left side: C. CROP LONDON. Right side: SQUATTERS OWN (SCIRT51-MC-3).

One white clay smoking pipe was also recovered from Feature 5. The bowl was a slightly rounded cutty shaped and the stem indicated a pipe with half bent stem configuration (Figure 50). The stem had the

relief moulded and impressed mark of SQUATTERS OWN / C. CROP / LONDON in a twisted rope border. Charles Crop was a London pipe manufacturer operating between 1856 and 1891 (Museum Victoria 2017). His pipes are commonly found on archaeological sites in New Zealand and Australia (Ayto 1999: 14, Brassey 1991: 30, Macready et al. 1990: 57). ‘Squatters Own’ pipes were also found at the Victoria Hotel site in Auckland, examples which also included SYDNEY in the mark on the stem (Brassey and Macready 1994). Brassey (1991: 29) suggested that they may have referred to a hotel, as an example of merchandising using clay smoking pipes. Pipes known as ‘Squatters Own Budgereee’ or ‘Squatters Budgereee’ have been found on several sites in Australia, where they are often associated with depictions of European settlers and Aborigines on the bowl of the pipe. These pipes are well advertised in Australia and appear to be almost exclusively found in an Australasian context (Clough 2003: 131, Gojak and Stuart 1999). Similar pipes to this have been found on other Christchurch sites (Dodd 2012, Dodd and Hennessey 2012, Williams et al. 2016). Additionally, advertisements in New Zealand newspapers in the 1860s cautioned people against buying imitations of Crop’s Squatters’ Own pipes: this may suggest that Crop’s version of the pipes were distinct from the Squatter’s Own Budgereee pipes, but also indicates that they were popular enough to be counterfeited (*New Zealand Herald* 25/7/1865: 8).

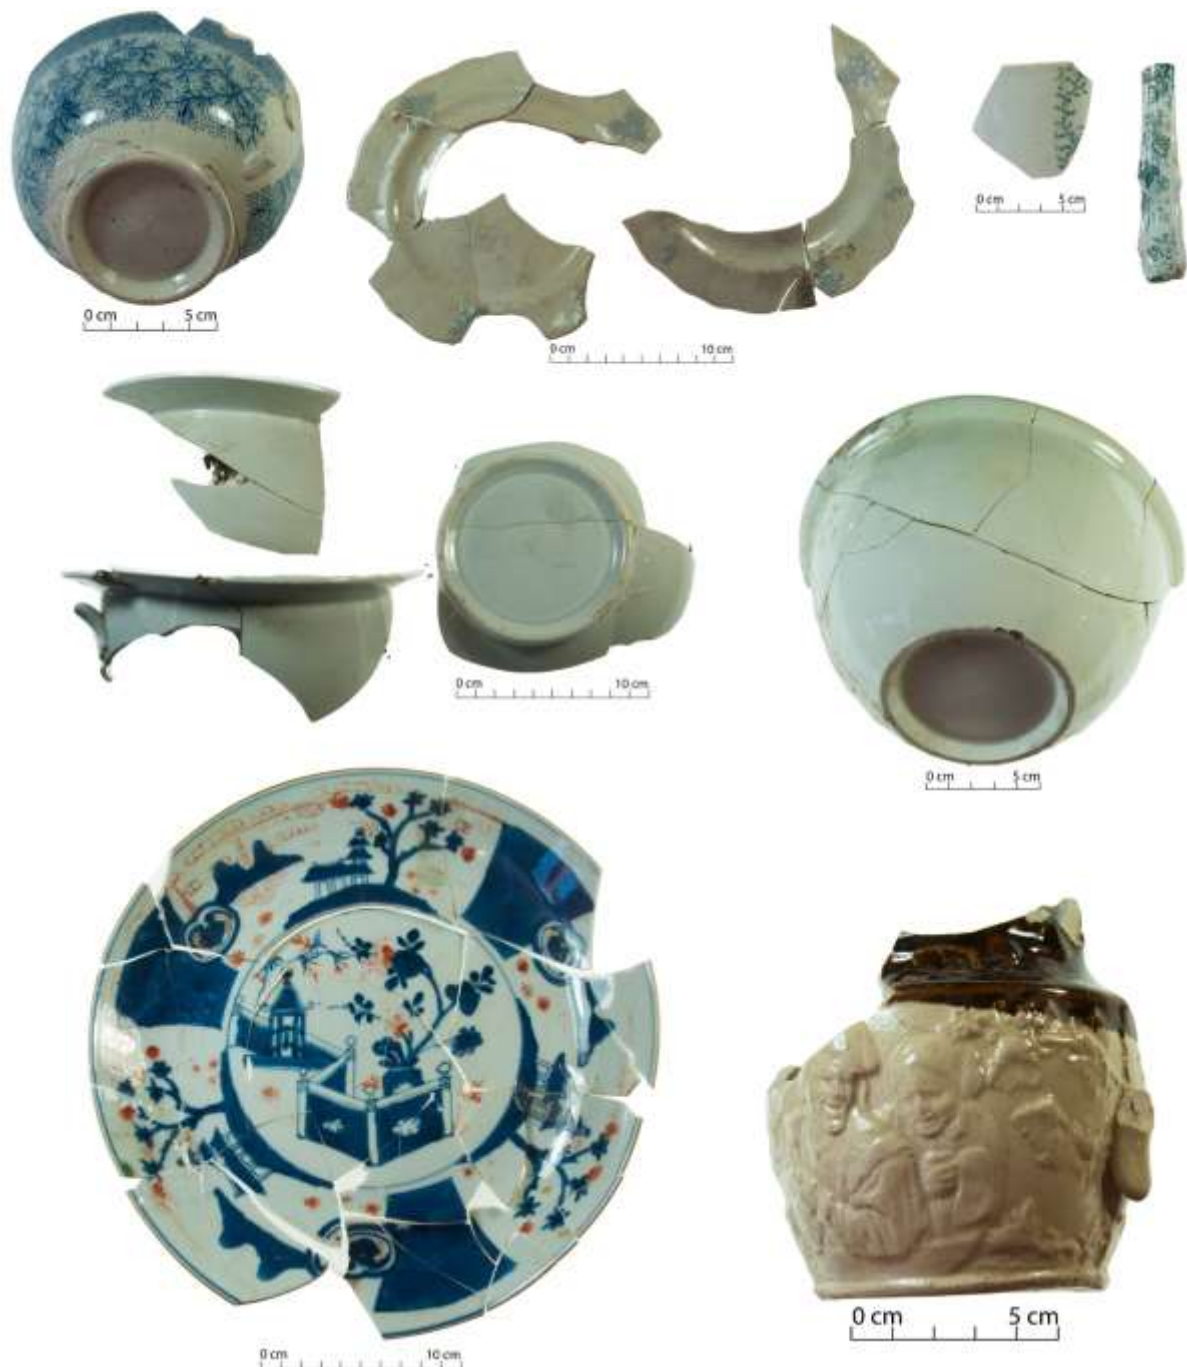
Figure 51. Tea and table wares from Feature 3. Top row from left: blue transfer printed teacup (SCIRT52-C-70), sprigged saucers (SCIRT52-C-47) and fragments of a green printed jar (SCIRT52-C-42). Middle row: banded chamber pot (SCIRT52-48) and undecorated bowl (SCIRT52-C-50),. Bottom row: dish featuring a Chinese design (SCIRT52-C-71) and buff-bodied jug (SCIRT52-C-69).

Unidentified transfer printed patterns consisted of sheet patterns of floral and foliage designs, one of which resembled the Fibre pattern. Sprigged decoration was noted on two saucers along with the moulded edge. This technique was easily identifiable by the small blue applied moulded sprigs of floral and foliage motifs, frequently common in the mid-19th century (Brooks 2005: 43). One example of a buff-bodied Bristol glazed jug was found, characterised by a two tone glaze moulded decoration. The

relief moulding was of a pastoral scene in which people are drinking surrounded by trees. This type of relief moulded stoneware jug, decorated with complex designs that often depicted sentimental, floral, gothic, biblical or patriotic themes, gained popularity in the early Victorian period (Hughes 1985: 9). Such inexpensive but artistic vessels were produced in quantity beginning around 1830 and continuing until the 1870s (Henrywood 1984: 50, Hildyard 2005: 184, Hughes 1985). They were used to serve a variety of liquids, including water, beer, milk, mulled ale and wine (Jefferson Patterson Park and Museum 2017). The polychrome hand painted dish was decorated with a Chinese design, including pagodas and orange trees in blue. Red was used to highlight some parts of the scene, including the fruits from the trees (Figure 51).

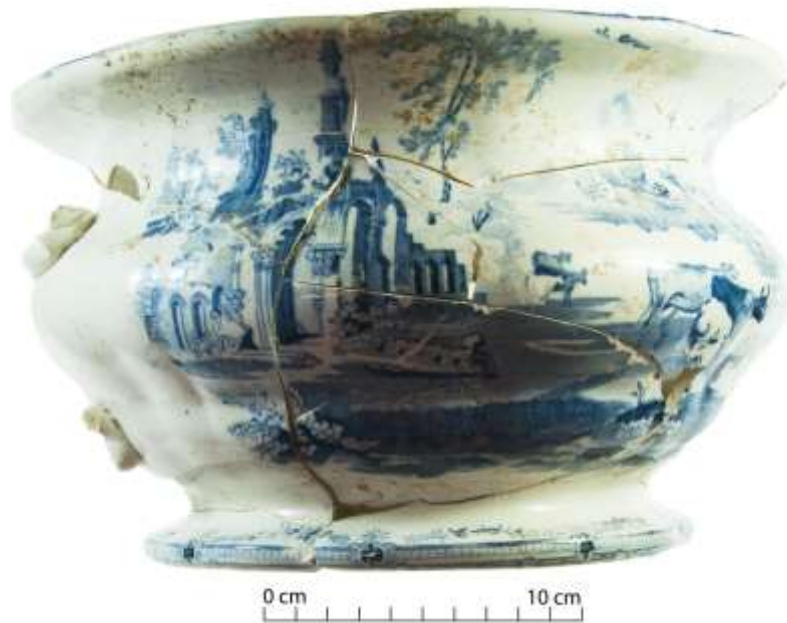
Figure 53. Cattle Scenery chamber pot (SCIRT52-C-45).

The Cattle Scenery was a rural pattern depicting a man who tends his cows in a picturesque landscape, with impressive Gothic abbey ruins across the water and a church with steeple in the background. The scene appears within a floral border with large roses (Coysh and Henrywood 1982: 76, Transferware Collector's Club 2017; Figure 53).

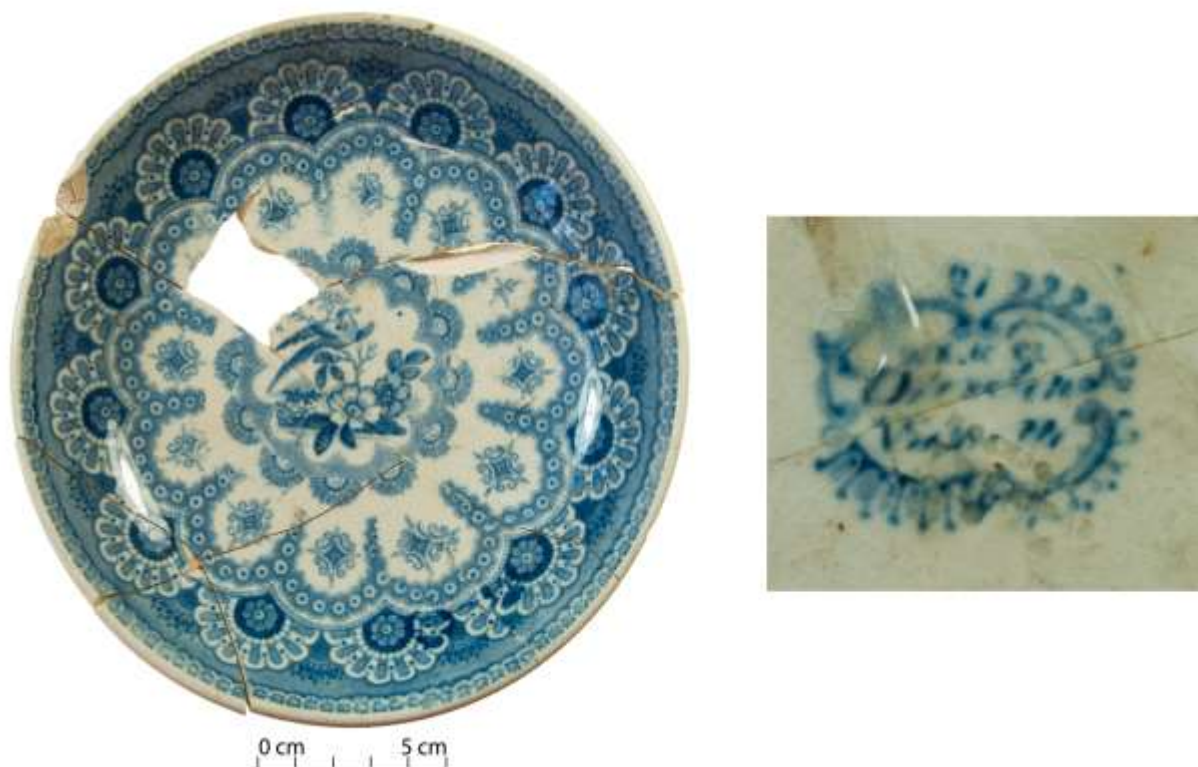
Figure 54. Dresden Vignette saucer with the W. S. & Co. maker's mark on the base (SCIRT52-C-51).

The Dresden Vignette saucer had a complete impressed mark with the pattern name 'Dresden Vignette' below the maker's mark 'W . S . & Co', referring to William Smith and Company, a Staffordshire pottery located at Stockton-on-Tees, Yorkshire. The company was producing earthenwares between c. 1825 and 1855 (Godden 1991: 583, The Potteries 2017; Figure 54).
