Lessons learned from one of New Zealand's most challenging civil engineering projects: rebuilding the earthquake damaged pipes, roads, bridges and retaining walls in the city of Christchurch 2011 - 2016.

## Beca Heritage Week brochure – Central City

# UNCOVERING OUR PAST WHILE BUILDING FOR OUR FUTURE

A walk and talk tour of the Central City

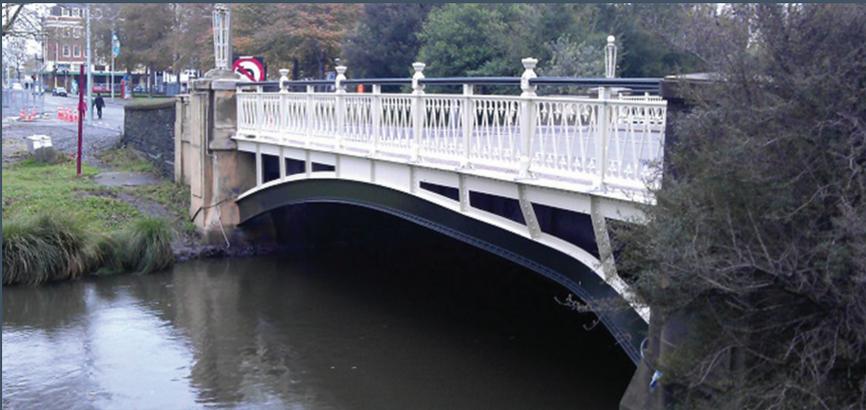
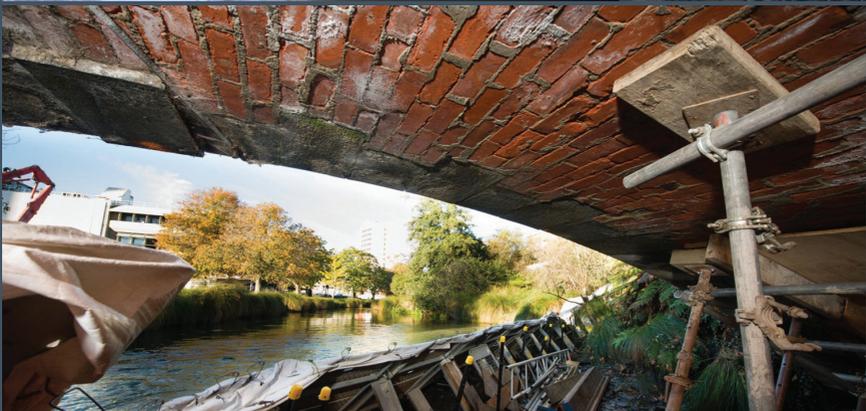
### Front cover images:

**Top:** Colombo bridge - The warp of the girders is visible in this shot. The curve has been retained in the repaired and strengthened bridge as a memory of the effects of the earthquake.

**Bottom:** Armagh Street bridge - Dams were installed in the river around the Armagh Street bridge so the lower sections of a crack could be accessed and repaired.

In the February 2011 earthquake, the aesthetic arched girders, which are not load bearing, warped and twisted. The bridge's abutments twisted about 30 degrees, causing the hand rails to bend and pull out of the pilasters.

SCIRT, at the request of the Christchurch City Council, designed the bridge's repair so it would intentionally keep some of these earthquake damaged elements as a visual reminder of the February 2011 earthquake.

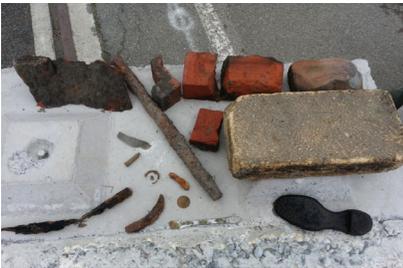
*Below: Some of the old treasures found under the Armagh Street bridge.*

While repairing the bridge, SCIRT has discovered some interesting items, including numerous old bricks (dating back to pre 1900), pieces of metal, an old bullet casing, a tiny hand-nailed shoe, rusty horse shoes and old wooden piles from the original wooden bridge built in the 1870s. Archaeologists

took one of the old bricks, the bullet casing, the shoe, a piece of timber and a metal pin for assessment. The timber pile from the original bridge was identified as Beech. There is a horse ramp near the bridge where people used to wash their steeds and carts hence the horseshoes.
