Gloucester Street bridge, Christchurch - report on archaeological monitoring

GLOUCESTER STREET BRIDGE, CHRISTCHURCH (M35/1317): REPORT ON ARCHAEOLOGICAL MONITORING

SCIRT 11136

SHANA DOOLEY, CHRISTINE WHYBREW & MARIA LILLO BERNABEU
UNDERGROUND OVERGROUND ARCHAEOLOGY LTD

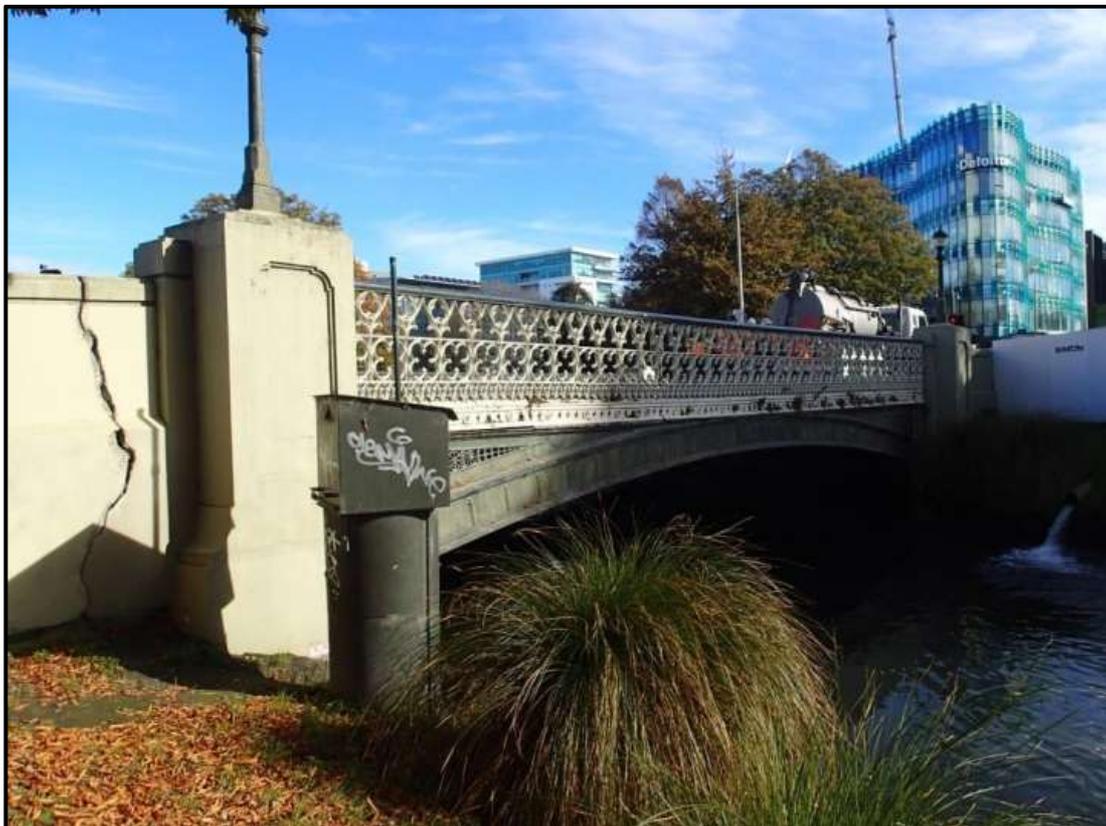
During the 2011 Canterbury earthquakes and aftershocks, cracks formed in the wing walls of the Gloucester Street bridge (Figure 7 and Figure 8). The Fletcher Construction Company and subcontractors undertook earthworks to repair and renovate the bridge from February to December 2016. Shana Dooley and Hamish Williams (Underground Overground Archaeology Ltd) monitored and inspected the earthworks for the redevelopment. A plan of the site showing the location of the monitored or inspected hydro-excavated holes and trenches was prepared (Figure 9).

Figure 7. The Gloucester Street bridge, showing a crack that formed during the 2011 earthquake, looking southwest.

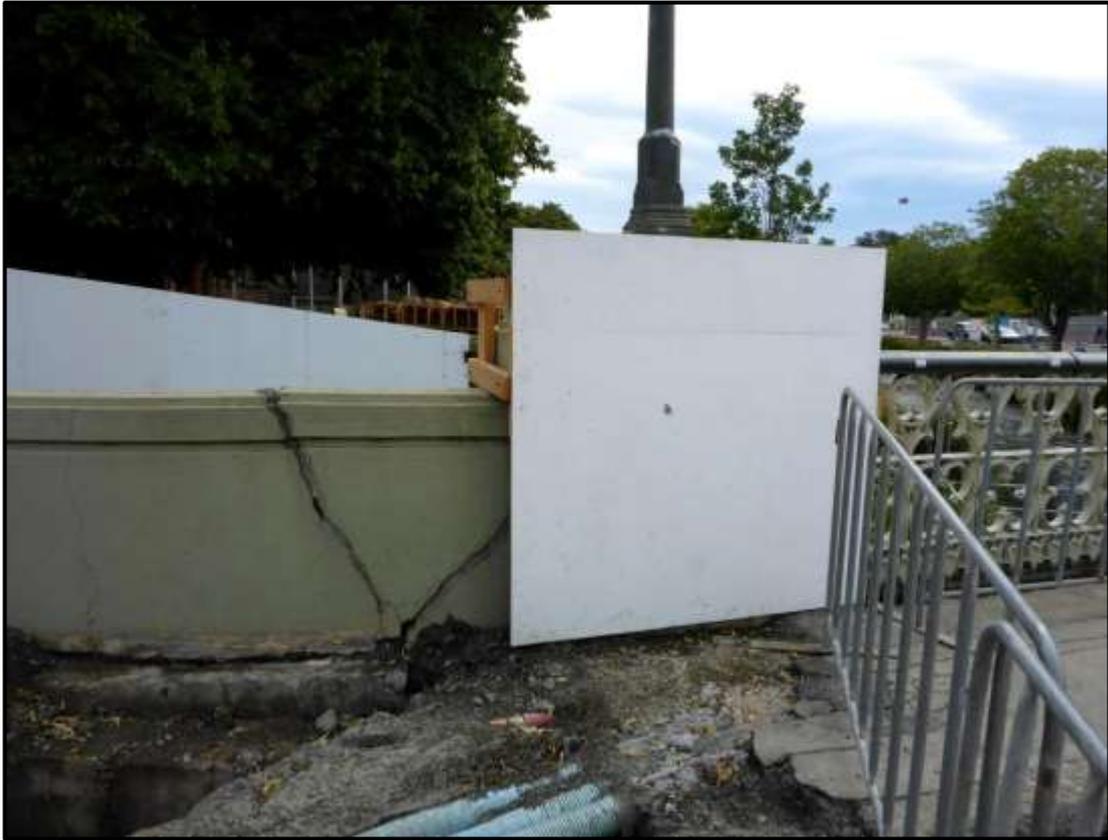
Figure 8. Cracks that formed during the 2011 earthquake in the northern wing wall, looking north.

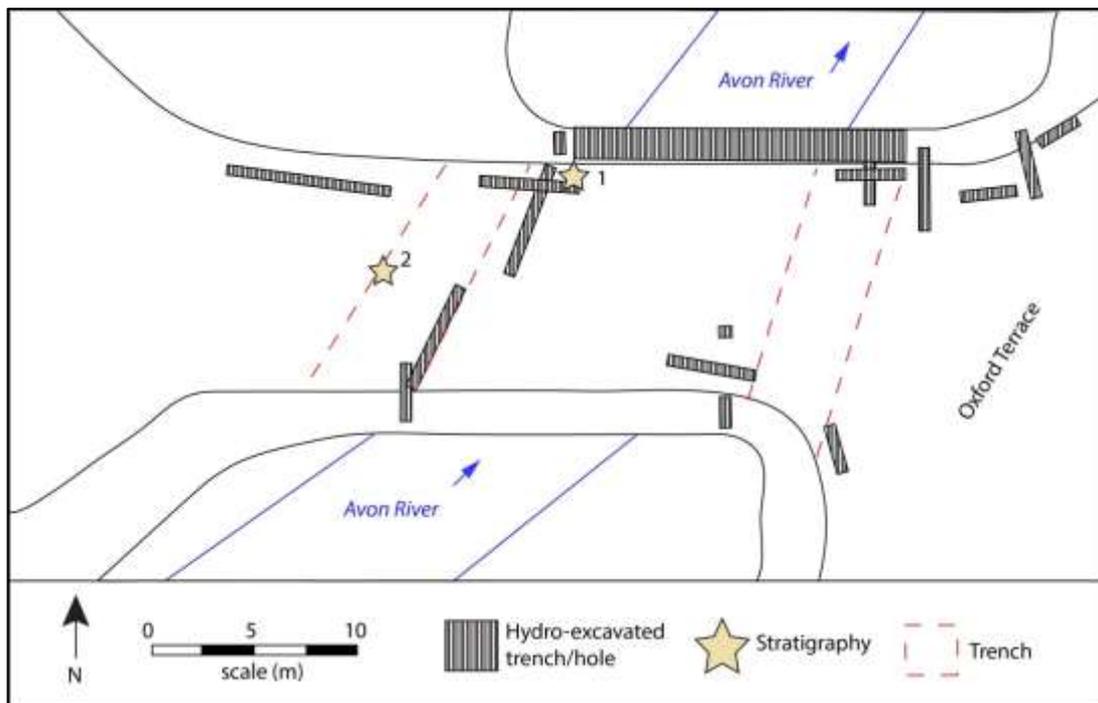
Figure 9. Plan showing the location of the monitored or inspected hydro-excavated holes and mechanically excavated trenches.

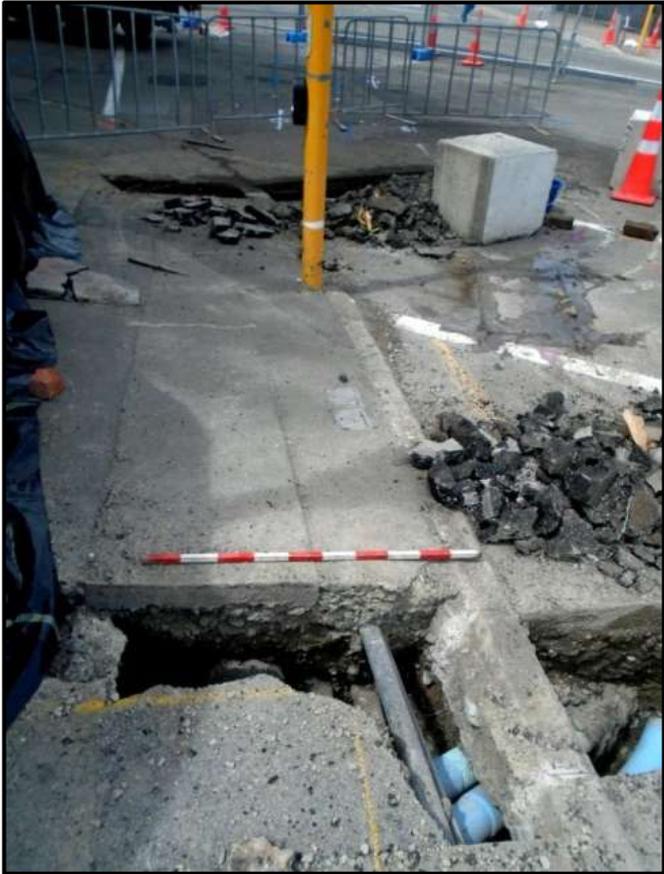
Figure 10. Hydro-excavated holes by the north footpath, looking east.

The first stage of earthworks for the redevelopment and repair of the bridge consisted of hydro-excavation to determine the depth and location of the existing services. The holes and trenches varied in dimension, but were generally 700-1200 mm in depth (Figure 10, Figure 11, Figure 12, and Figure 13). Earthworks also consisted of two mechanically excavated trenches on either side of the bridge

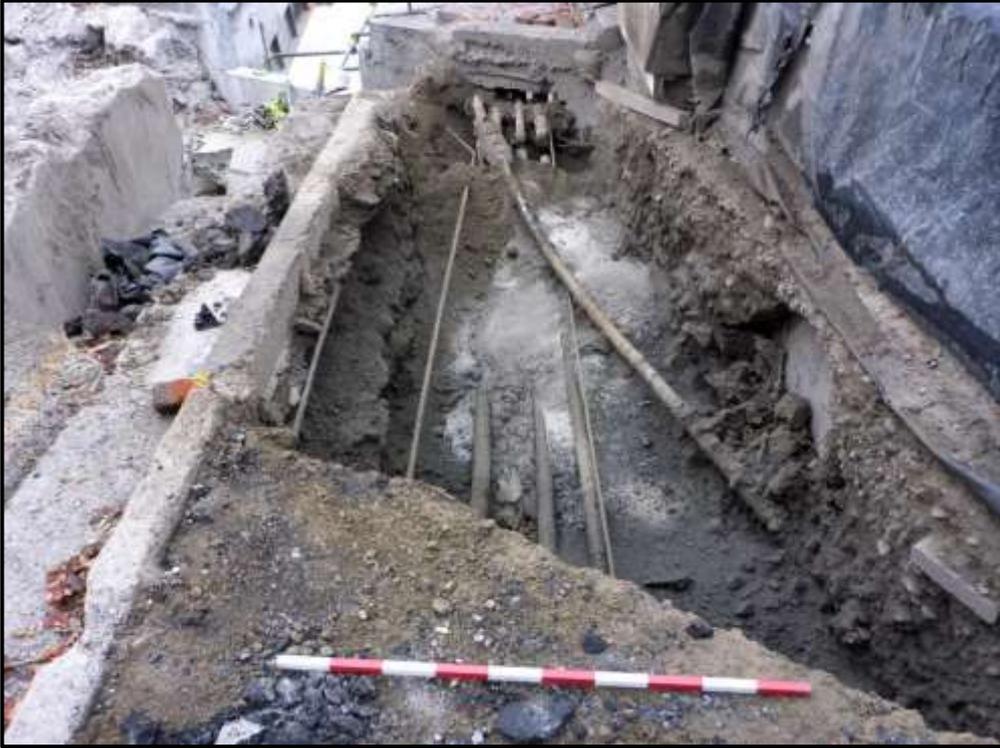
Figure 11. Hydro-excavation for services on the north footpath, looking west.

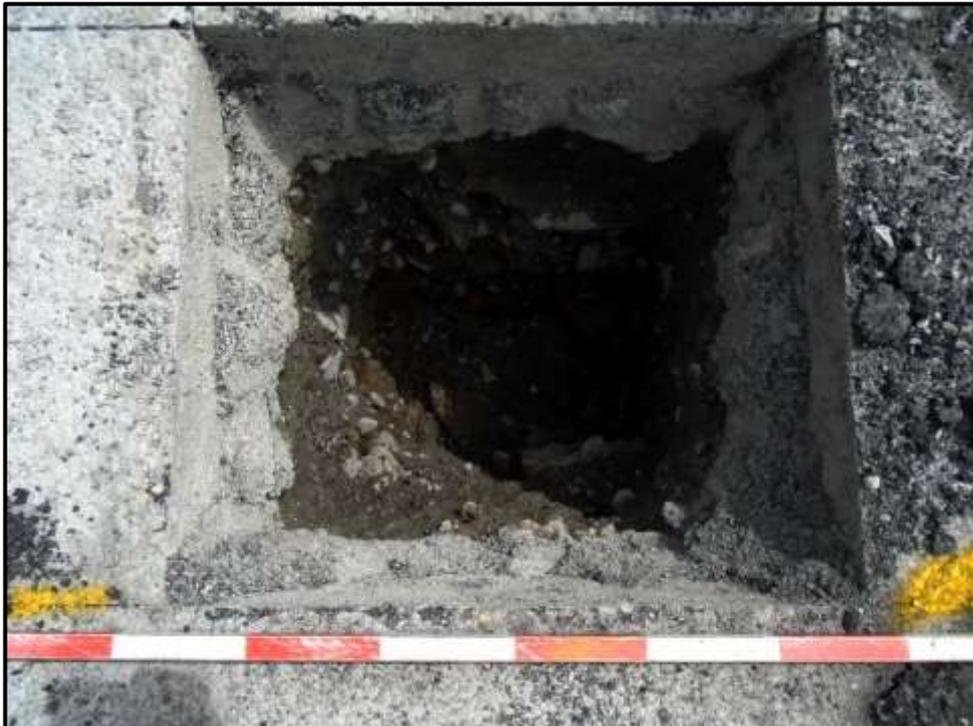
Figure 12. Hydro-excavated hole.

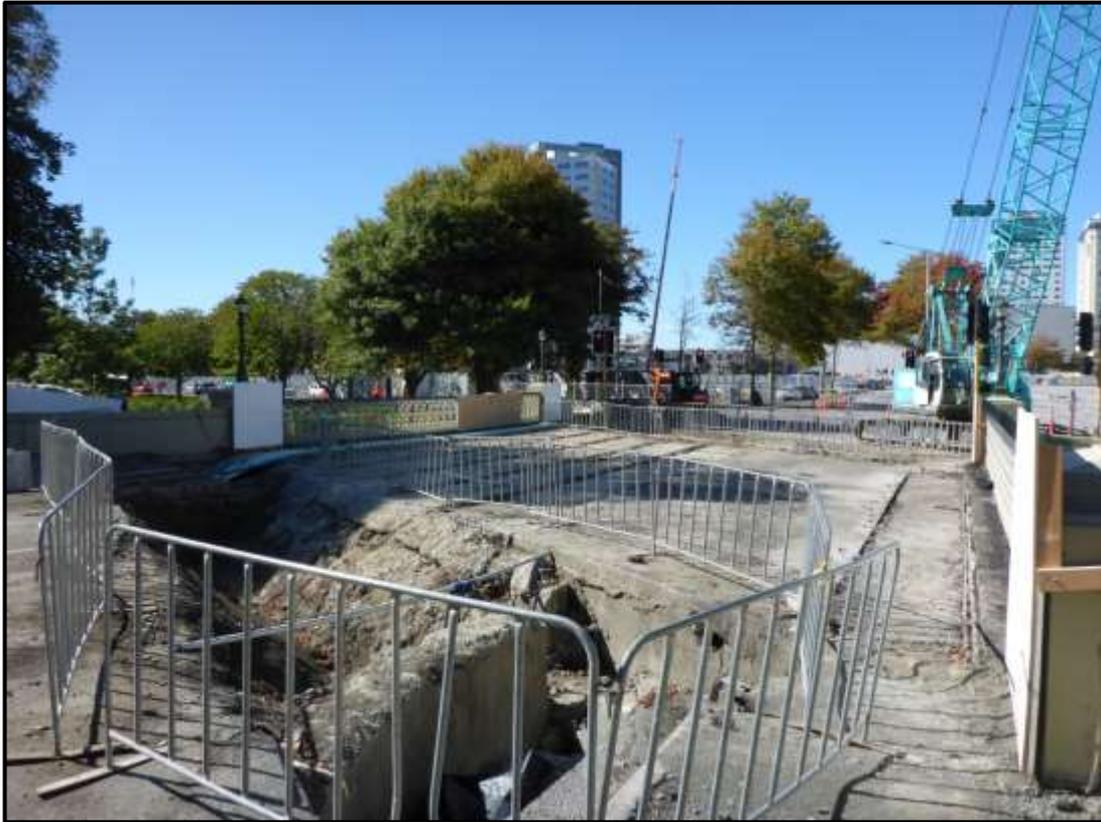
Figure 13. Overview of the site, showing the trenches on either side of the bridge, looking northeast.

abutments/approaches. The trenches were 4.3 and 4.9 m wide and 1.5 to 1.6 m in depth. Original bridge features were exposed in the trenches and artefacts were recovered from the fill layers that were exposed in both in the trenches and hydro-excavated holes.

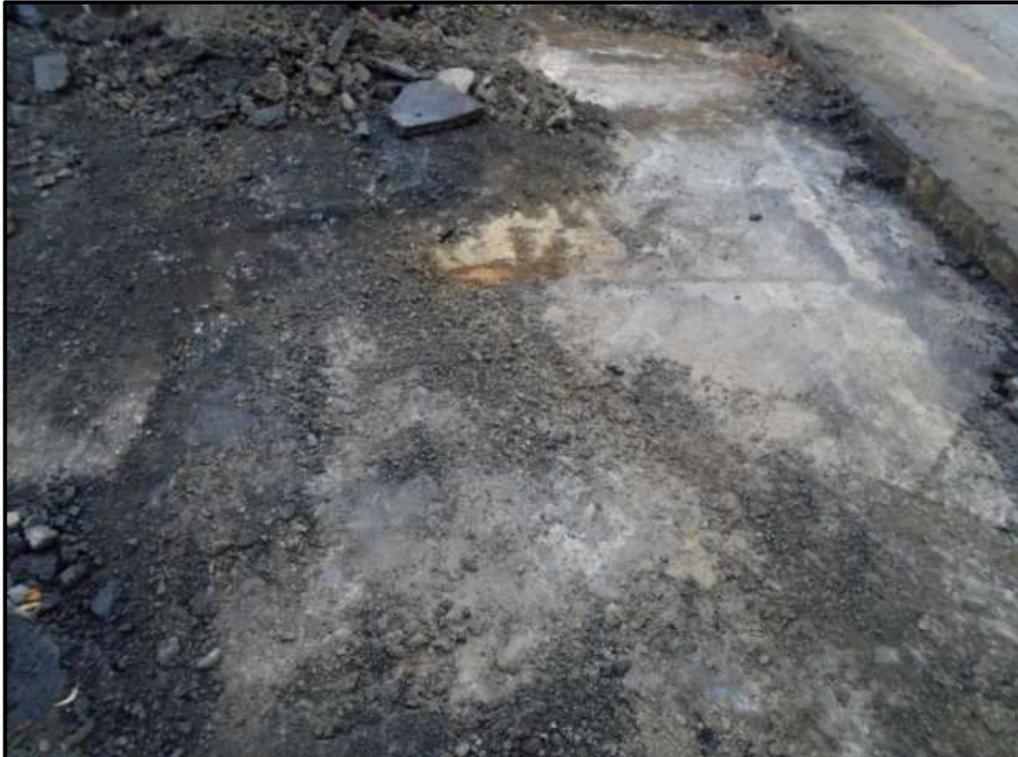
Figure 14. Layer of tar exposed with a clay layer after the removal of the modern road surface, looking west.

During the early phase of earthworks for the project, the modern asphalt road surface was removed, exposing a layer of coal tar with a clay surface underneath, this being the 'macadamised' layer observed during the test pitting phase (Figure 14, Williams 2015). The removal of these layers exposed the original concrete decking with the buckle plates (Figure 15). The concrete deck was later removed but the buckle plates were left in place (Figure 16 and Figure 17). The bridge railings were removed to repair and re-paint them (Figure 18).

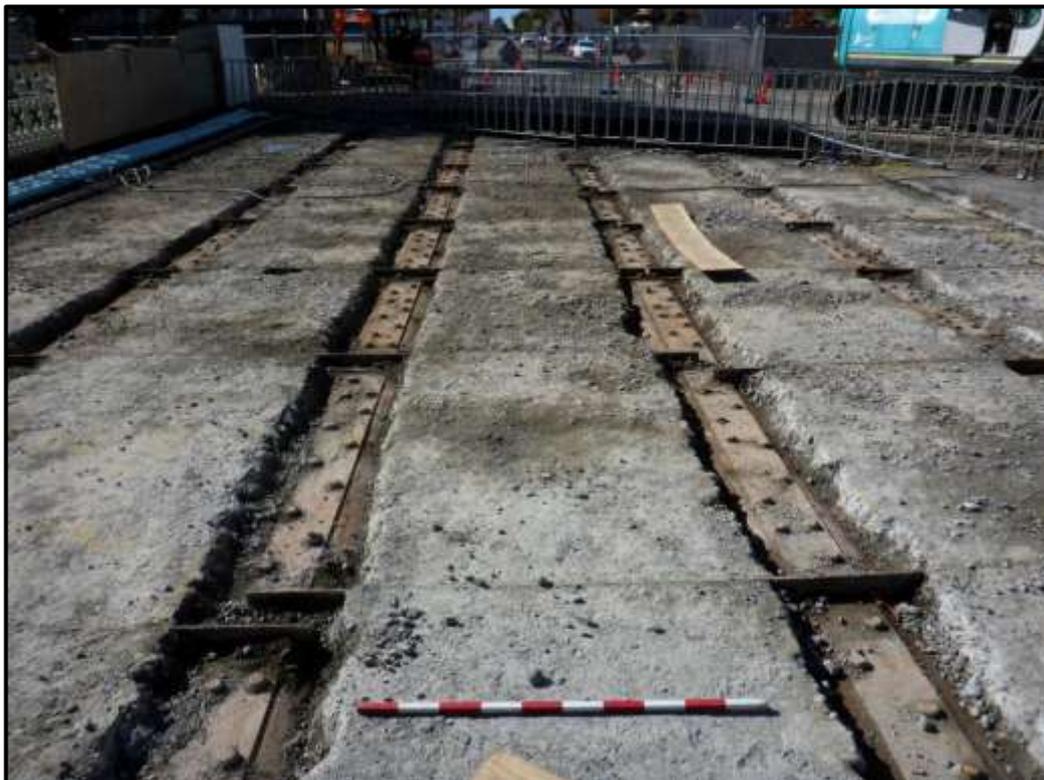
Figure 15. Bridge deck after the removal of the asphalt with the concrete and buckle plates exposed, looking east.

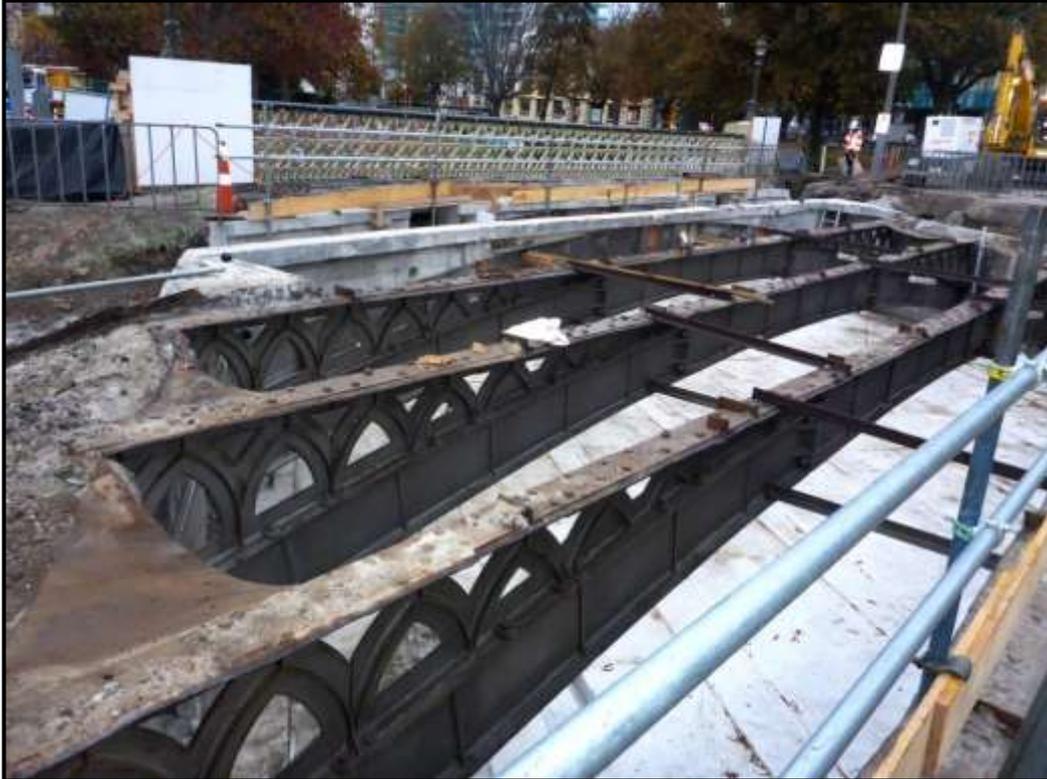
Figure 16. The buckle plates after the removal of the concrete decking, looing southwest.

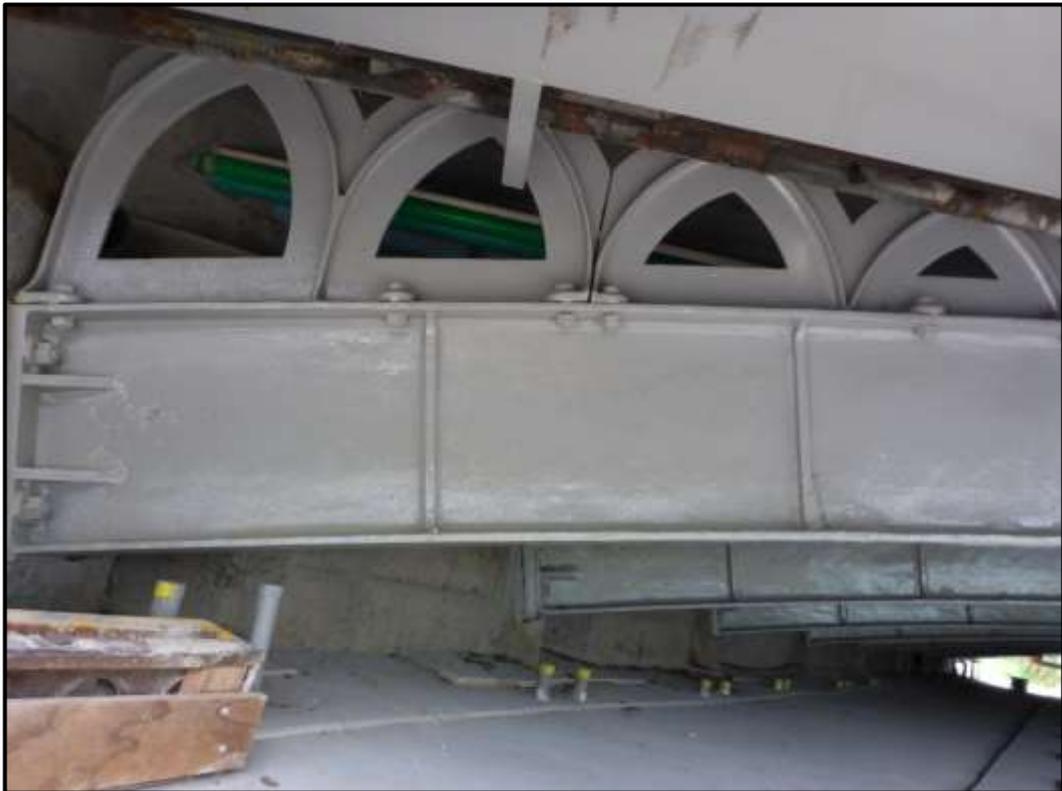
Figure 17. The buckle plates under the bridge after repair, looking north.

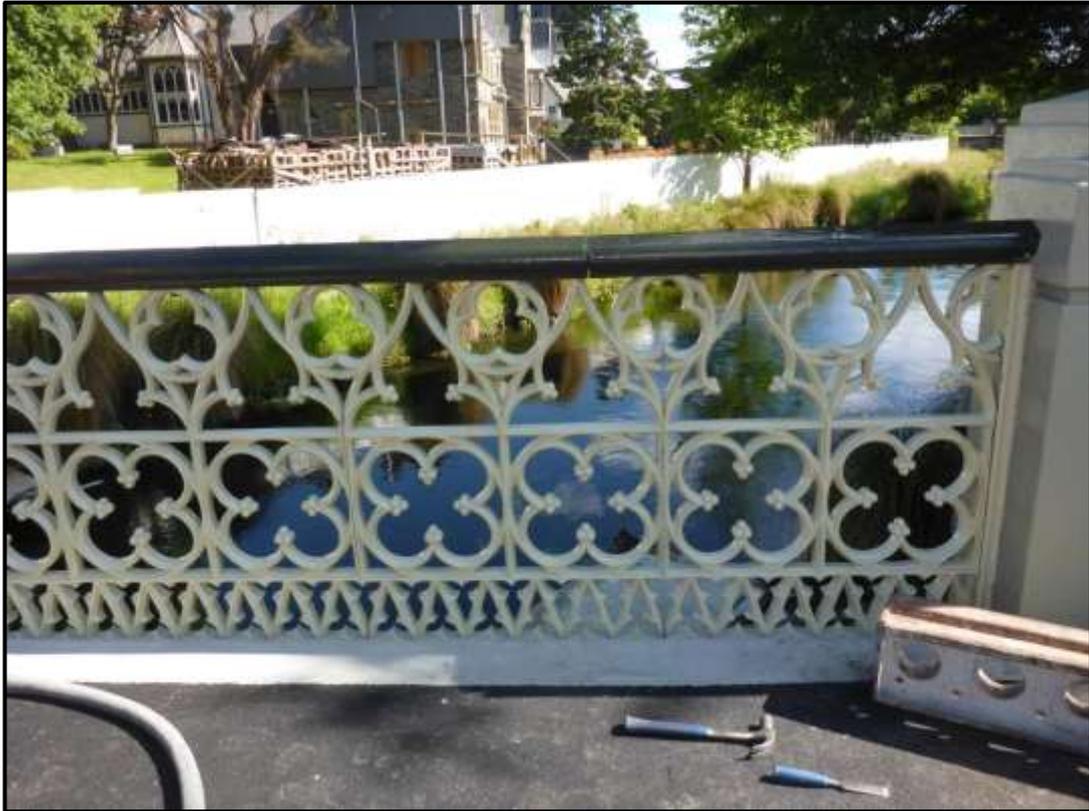
Figure 18. The railing on the north end of the bridge after repair, looking north.

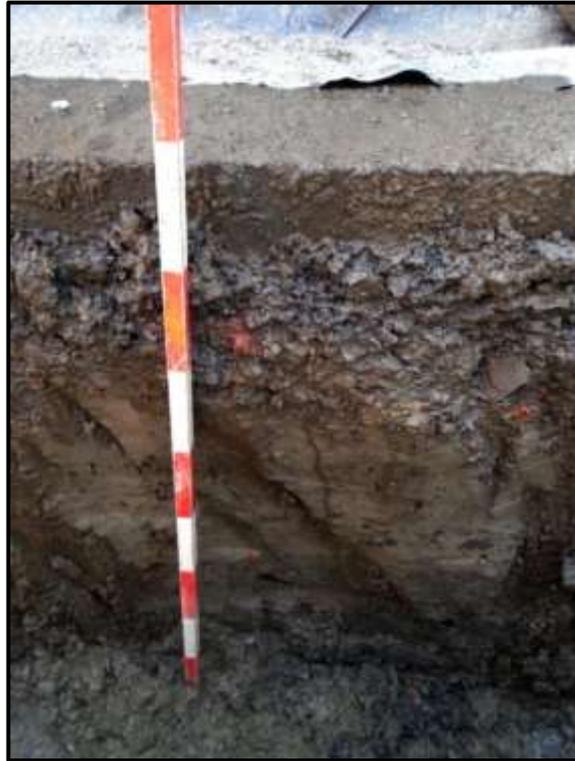
1. The first stratum was a layer of asphalt that was 50 mm thick.
2. The second stratum was a layer of greyish brown gravelly sand, hard fill introduced into the site. This layer was 150 mm in depth.
3. The third stratum was a layer of yellowish brown sand that was 650 mm in depth. Artefacts were interspersed through this layer.
4. The fourth stratum was a layer of brown sandy clay that was at least 75 mm in depth. This layer appeared to be natural. The base of this layer was not reached.

Figure 19. Baulk of hydro-excavation trench, looking north.

The stratigraphy of the site was recorded in two places, the northern baulk of a hydro-excavated hole on the bridge (#1) and part of the western baulk of a trench on the approach to the bridge (#2). The stratigraphy on the bridge (#1) was as follows (Figure 19 and Figure 20):

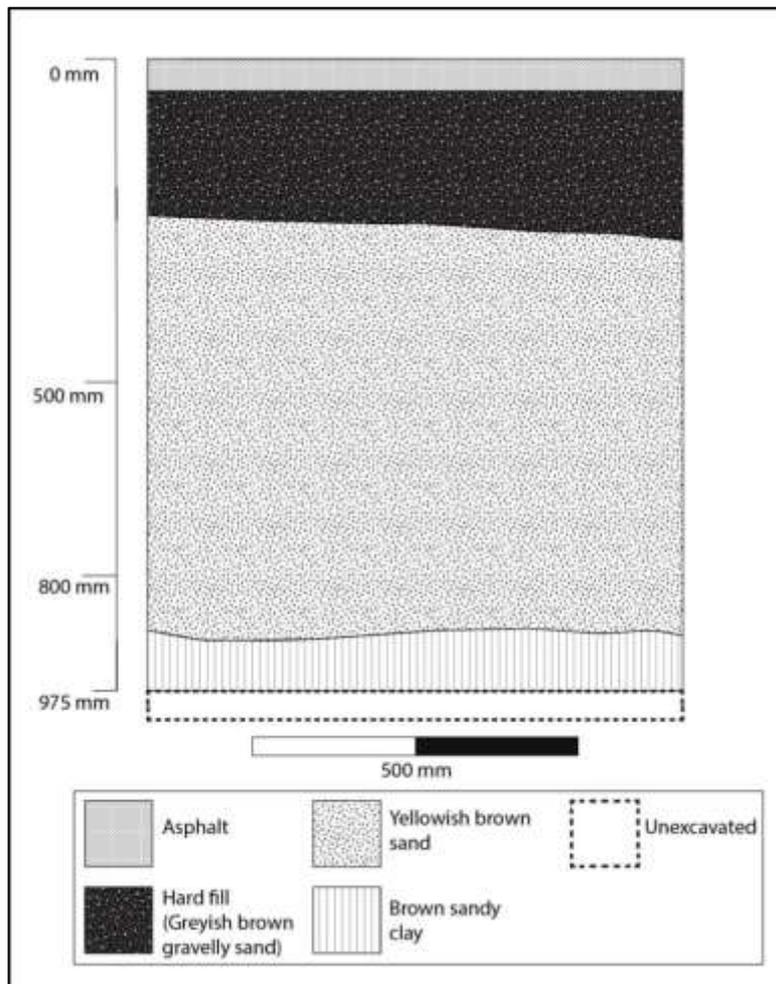
Figure 20. Stratigraphic drawing on the bridge (#1).

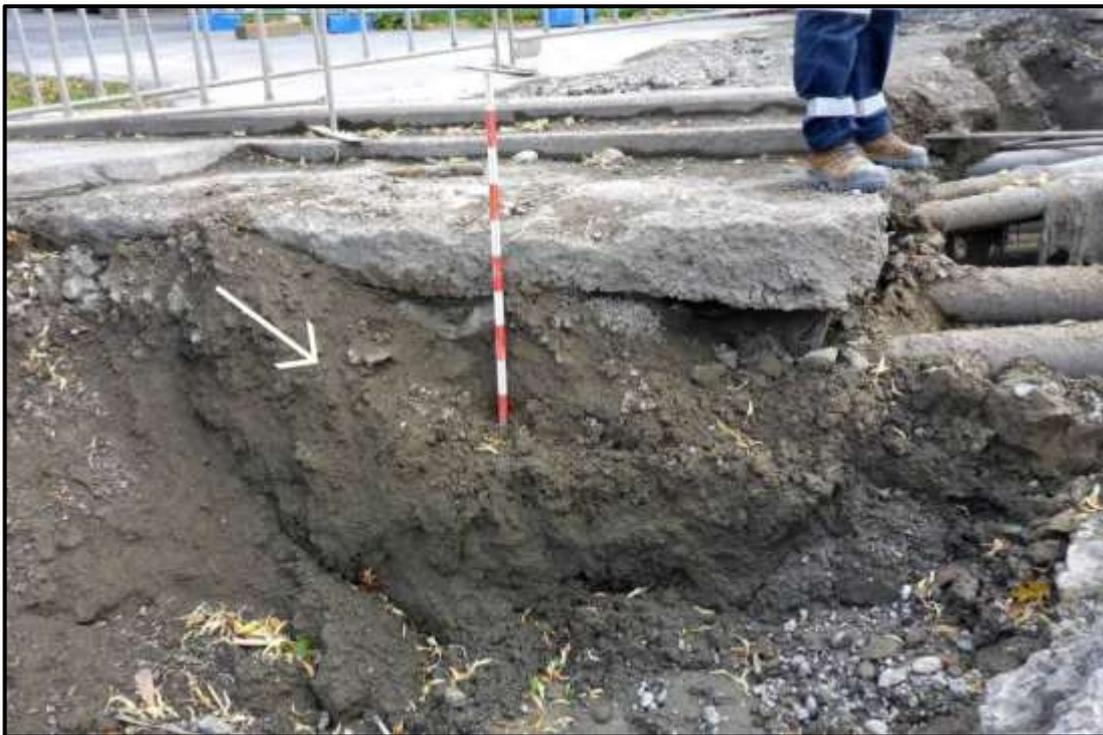
1. The first stratum was a layer of concrete that was 150 mm thick.
2. The second stratum was a layer of yellowish brown sand that was 500 mm thick. Artefacts were scattered throughout this layer.
3. The third stratum was a layer of brown sandy clay that was at least 850 mm in depth. This layer appeared to be natural. The base of the layer was not reached.

Figure 21. Part of the western baulk of the western trench (#2), looking northwest. The layer of fill is indicated by the arrow.

The stratigraphy of part of the western baulk of the trench on the approach to the bridge (#2) consisted of the following strata (Figure 21 and Figure 22):

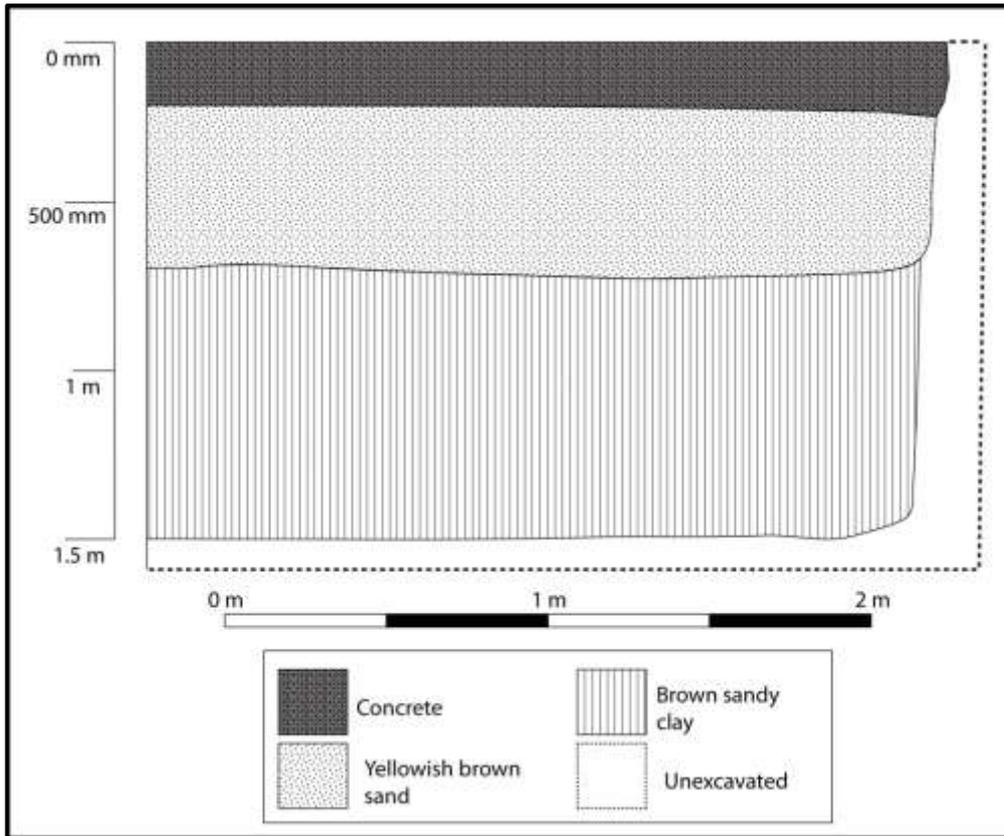
Figure 22. Stratigraphic drawing of part of the western baulk of the trench (#2).

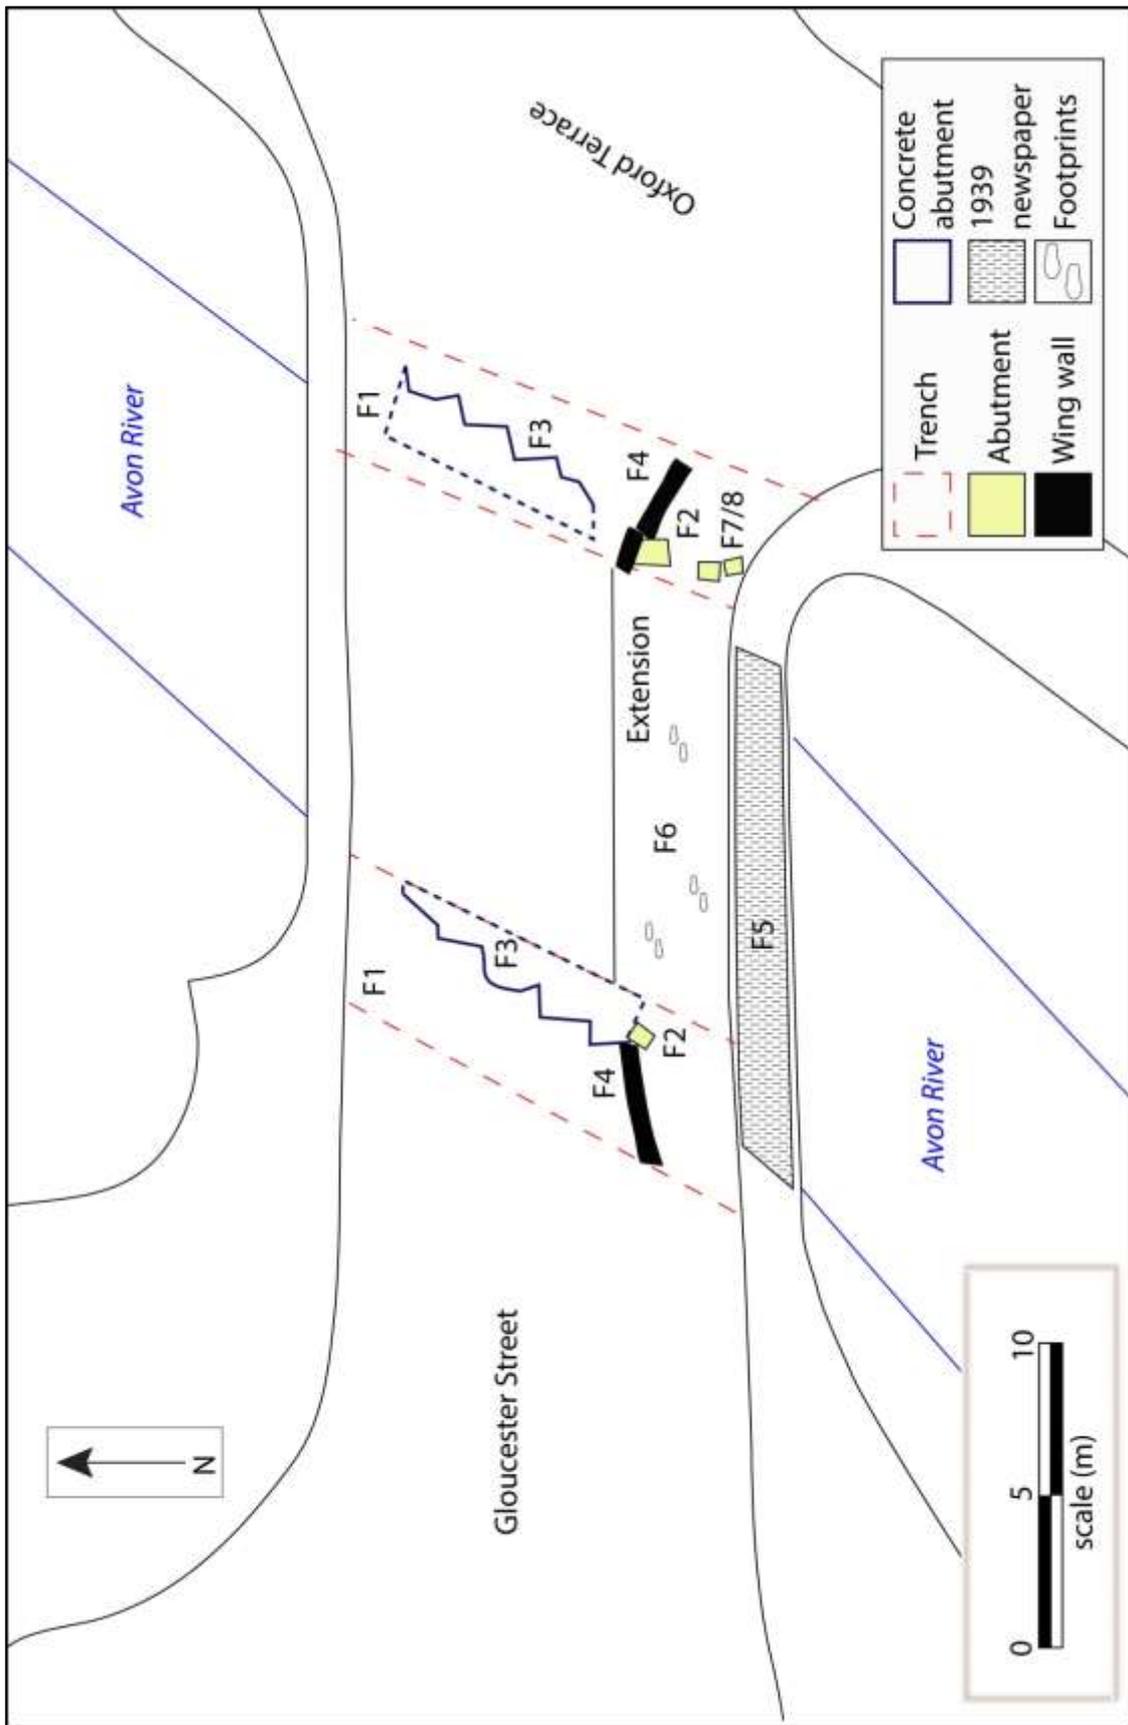
A total of eight archaeological features were identified during earthworks (Figure 23). Feature 1 was a layer of fill containing artefacts. Features 2-4 and 7-8 were structural elements from the original 1886 bridge (Figure 24). Features 5 and 6 were 20th century structural elements associated with the 1936 bridge widening. The bridge features were recorded using a Trimble M3 DR 5" total station.

Figure 23. Plan of site showing the archaeological features recorded on the Gloucester Street bridge.

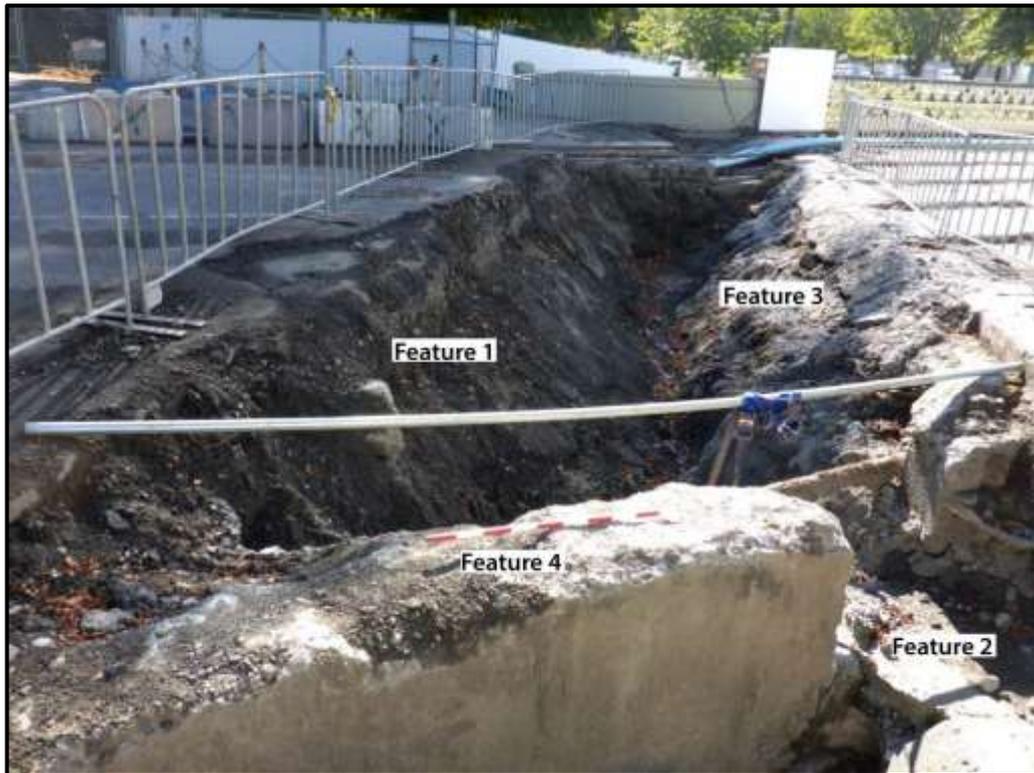
Figure 24. Overview of Features 1-4 exposed in the trench on the western end of the bridge, looking north.

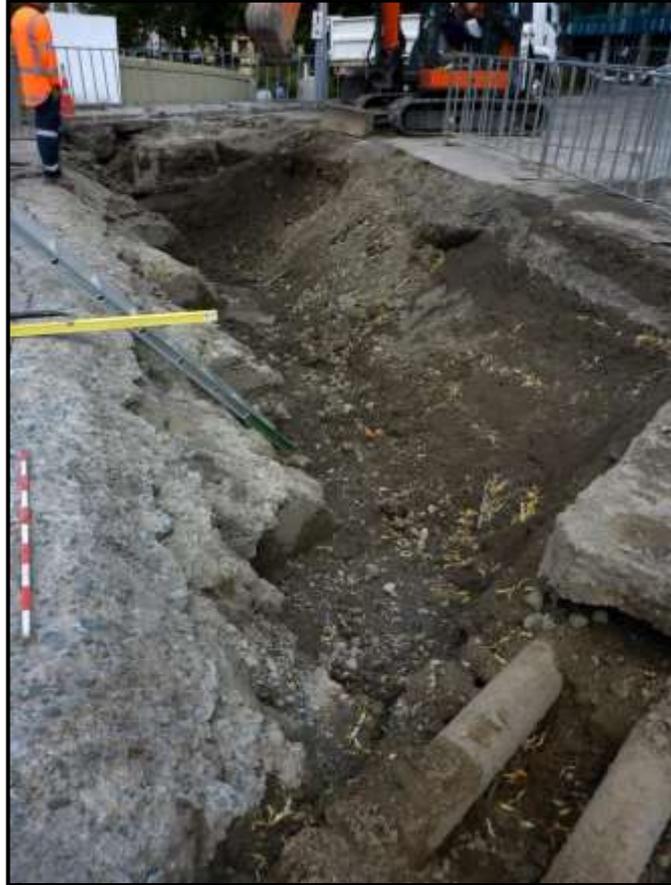
Figure 25. Trench 1, the trench excavated on the west side of the bridge in which the artefact bearing fill layer was exposed, looking southwest.

Feature 1 was a fill layer that contained 19th century artefacts. It was exposed in both the north-south orientated trenches dug to expose the bridge abutments, in the fill layer exposed next to and around the original bridge substructure and in several of the service location test pits (Figure 25, and Figure 26). This layer may be a ground levelling fill imported to the site at the time of bridge construction or later when the bridge approaches were formed. The artefacts were collected for analysis.

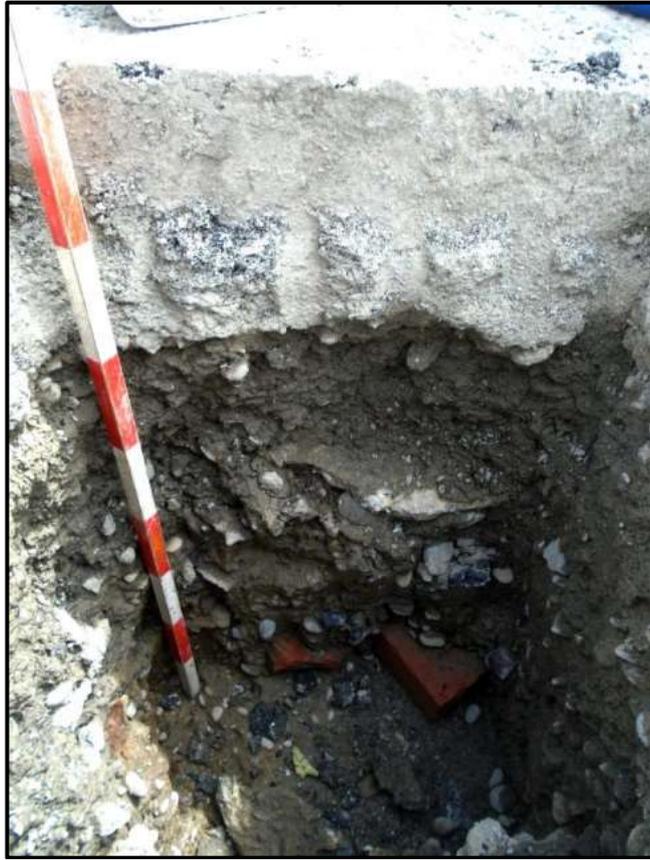
Figure 26. Baulk of a hydro-excavated pothole, looking west. Artefacts were found in the fill layers.

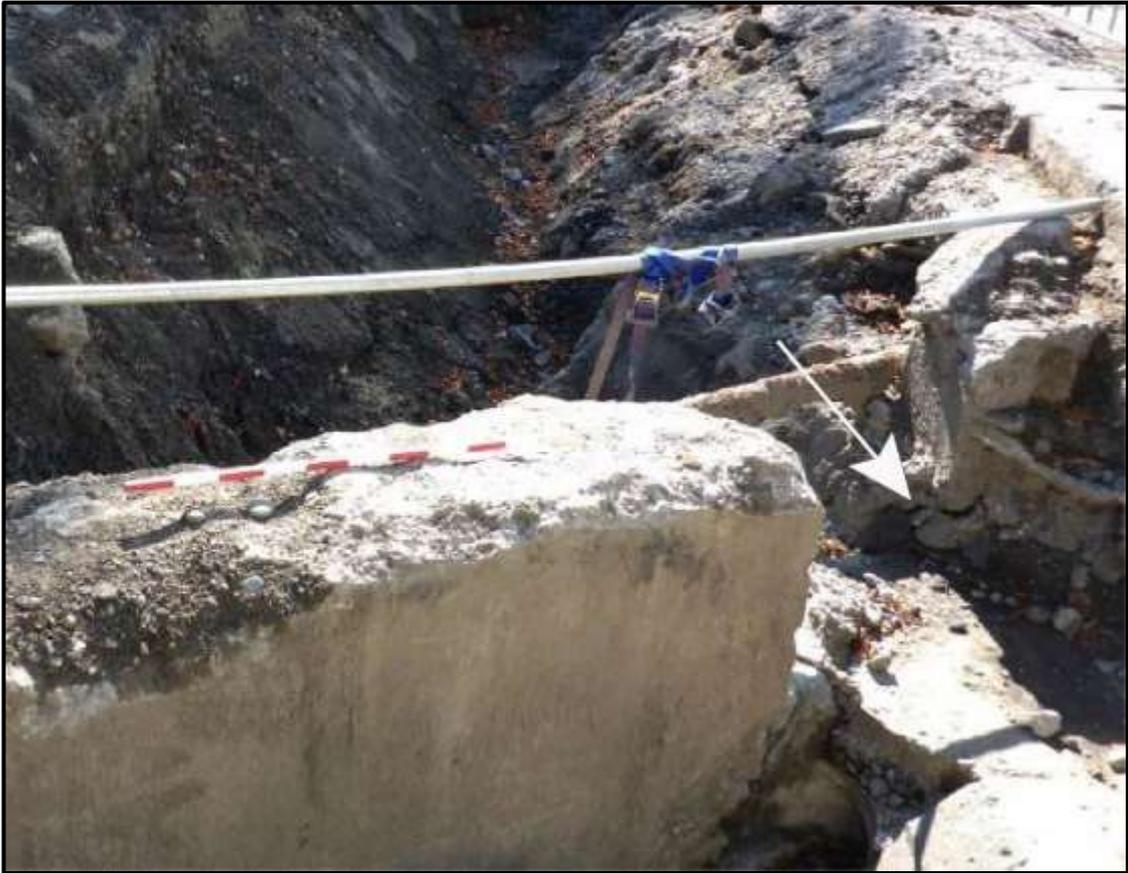
Feature 2 consisted of two individual Mt Somers limestone blocks that had made up part of the lower portions of the stone piers that flanked the wing walls of both the eastern and western bridge approaches prior to the 1936 widening. Both of these were exposed on the southern side of the concrete foundations of each wing wall (Feature 4), which were also left in situ when the bridge was widened. That exposed on the western side of the bridge (at the eastern end of the wing wall foundation) measured approximately 1.2 m by 1.2 m and was exposed at a depth of 800 mm (Figure 27). That exposed on the eastern side of the bridge (at the western end of the wing wall foundation) measured approximately 1.3 by 1.2 m and was exposed a depth of 800 mm (Figure 28 and Figure 29). It was approximately 800 mm in depth. The maximum height of both stone blocks could not be established as they were not able to be fully exposed during the works. Both of these were able to remain in situ. The upper edges of both finely dressed stone blocks were bevelled at a 45 degree angle.

Figure 27. At left, Feature 4, the concrete foundation of the wing wall of the western bridge approach, and at right, Feature 2, the stone block from one of the piers (white arrow), looking north.

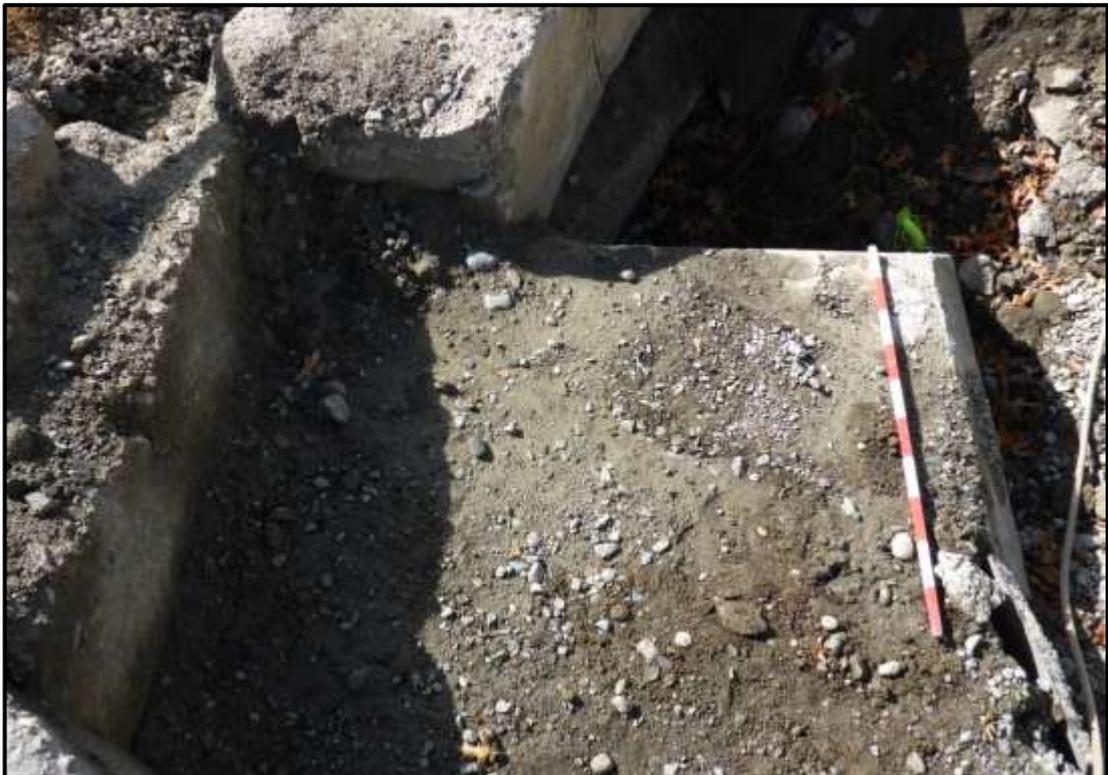
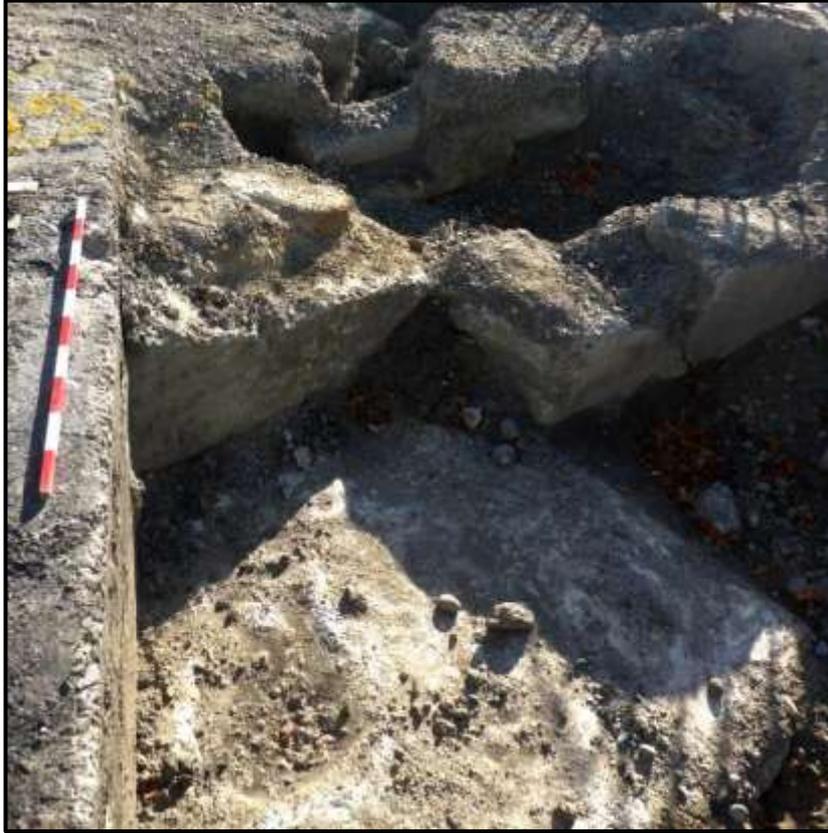
Figure 28. Feature 2, the stone block from the pier on the eastern side of the bridge.

Figure 29. Feature 2, the stone from the pier on the eastern side of the bridge, and associated concrete wing wall foundation (Feature 4), looking north.

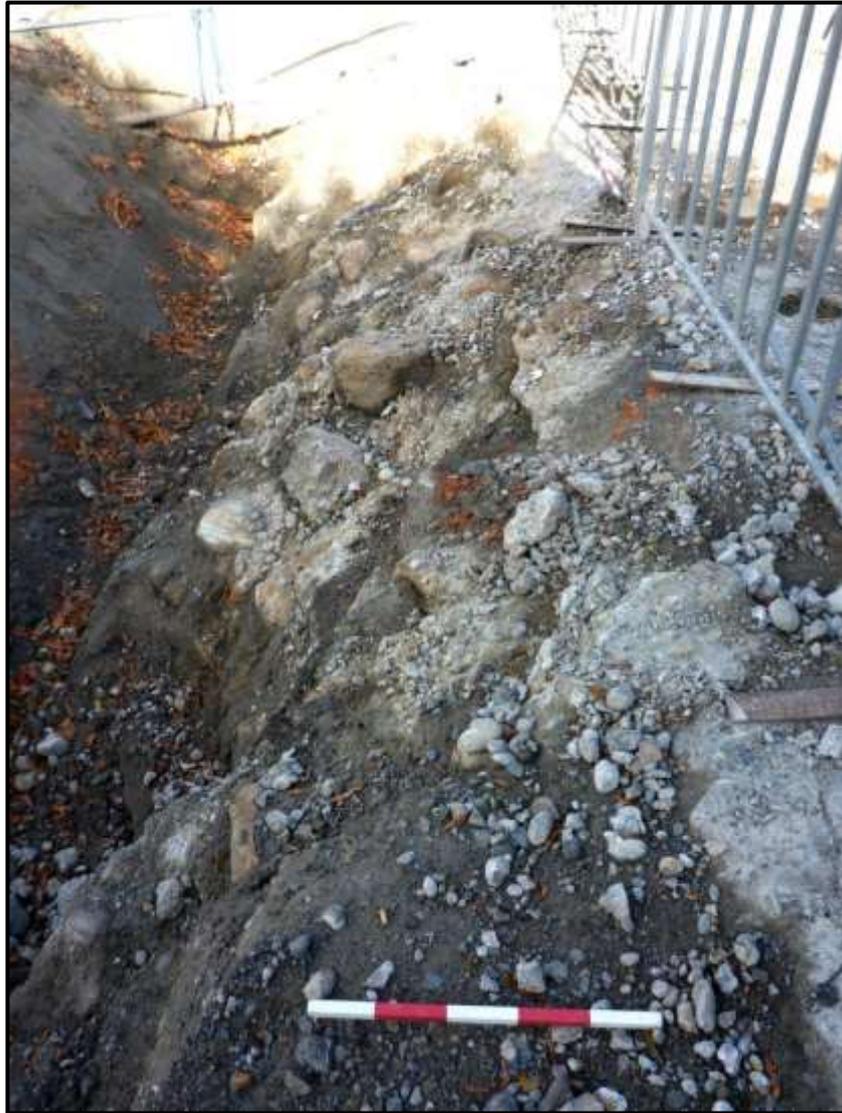
Feature 3 consisted of concrete abutments that were exposed on both sides of the bridge. The top of both of these were exposed at a depth of approximately 300 mm below the road surface, and were of concrete that contained rounded greywacke rocks as the aggregate component. Larger rocks were also observed in the concrete, but the exact rock type could not be identified.

The western abutment was 1 m wide, 8 m long, and extended to a depth of approximately 1 m (Figure 30). The eastern abutment was 1 m wide, 7.5 m long, and extended to a depth of 1 m (Figure 31 and Figure 32). The western abutment was in a much more degraded condition than the east. Whether either of these concrete abutments contained any reinforcing was not able to be confirmed.

Figure 30. Feature 3, concrete abutments on the western side of the bridge, looking north. Note the cobbles incorporated into the concrete.

Feature 3 was reduced in height during the course of the project, but most of the feature remains in situ.
