Gloucester Street bridge, Christchurch - report on archaeological monitoring

GLOUCESTER STREET BRIDGE, CHRISTCHURCH (M35/1317): REPORT ON ARCHAEOLOGICAL MONITORING

SCIRT 11136

SHANA DOOLEY, CHRISTINE WHYBREW & MARIA LILLO BERNABEU
UNDERGROUND OVERGROUND ARCHAEOLOGY LTD

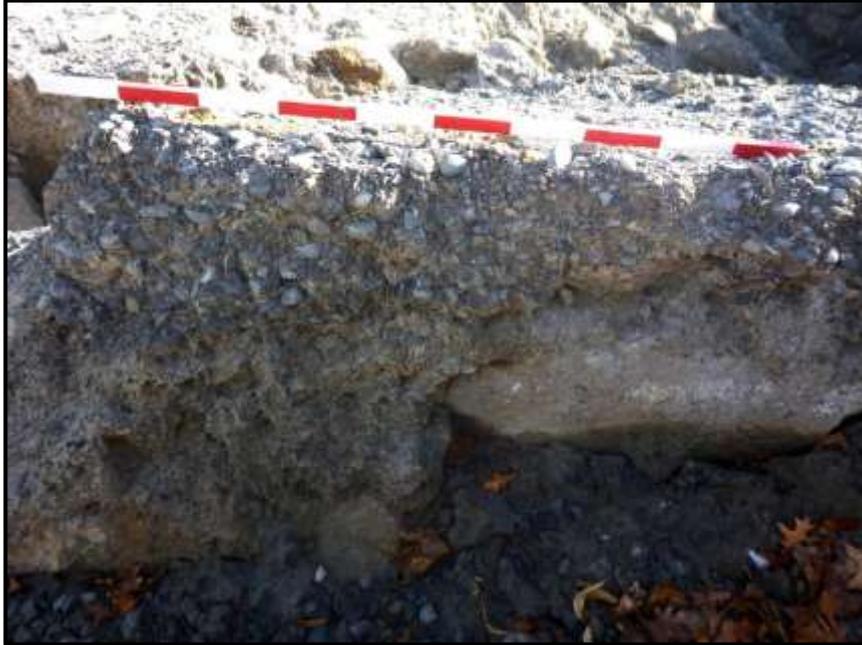
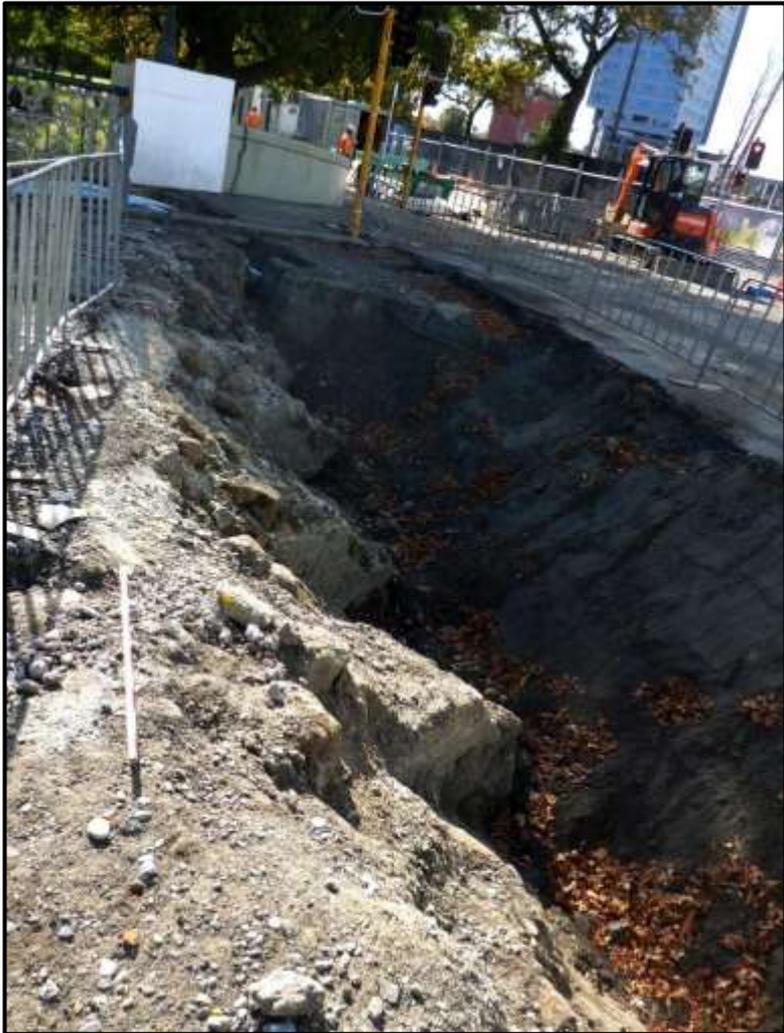
The western abutment was 1 m wide, 8 m long, and extended to a depth of approximately 1 m (Figure 30). The eastern abutment was 1 m wide, 7.5 m long, and extended to a depth of 1 m (Figure 31 and Figure 32). The western abutment was in a much more degraded condition than the east. Whether either of these concrete abutments contained any reinforcing was not able to be confirmed.

Figure 31. Detail of a section of the concrete abutment from the eastern side of the bridge, looking north.

Figure 32. Concrete abutment exposed on the eastern side of the bridge, looking north.

Feature 3 was reduced in height during the course of the project, but most of the feature remains in situ.

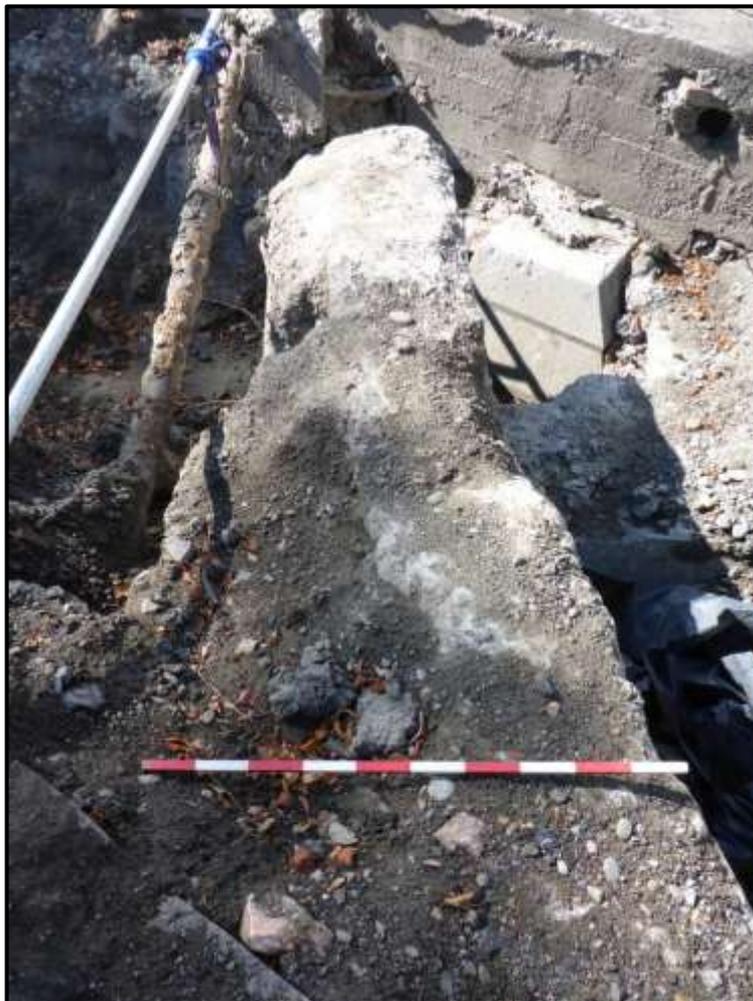
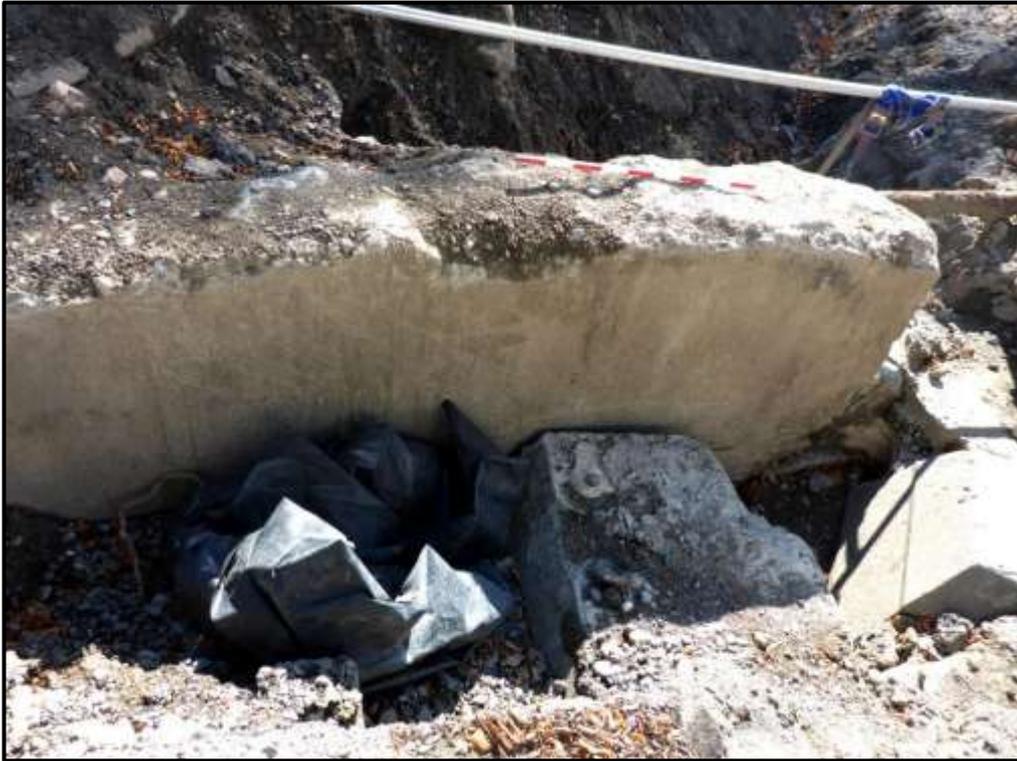
Feature 4 consisted of the concrete wing walls on both the eastern and western bridge approaches on the south end of the bridge, adjacent to the 1936 extension. The western wing wall was approximately 4 m in length, 500 mm in width, and extended to a depth of 1.3 m (Figure 33 and Figure 34). The wall was slightly curved and appeared to be truncated or disturbed at the eastern end as it did not extend all the way to the bridge deck. The eastern wing wall was 650 mm in width and was broken into two sections divided by Feature 2, the block from the stone pier (Figure 35 and Figure 36). As such, it appeared the second or easternmost section of this wing wall had been disturbed, likely during the course of the widening works. The first section next to the bridge was 1.25 m long and the second section was 2.5 m in length. The eastern wing wall was 1.3 m in depth. A large crack had also formed in part of this wall. Both wing wall foundations were constructed using concrete with pebble or river cobble aggregate. Whether either wing wall contained any reinforcing could not be confirmed.

Figure 33. Feature 4, the wing wall on the western end of the bridge, looking north-northeast.

Figure 34. Feature 4, the wing wall on the western side of the bridge, looking north.

Feature 4 was reduced in height during the course of the project, but most of the feature remains in situ.

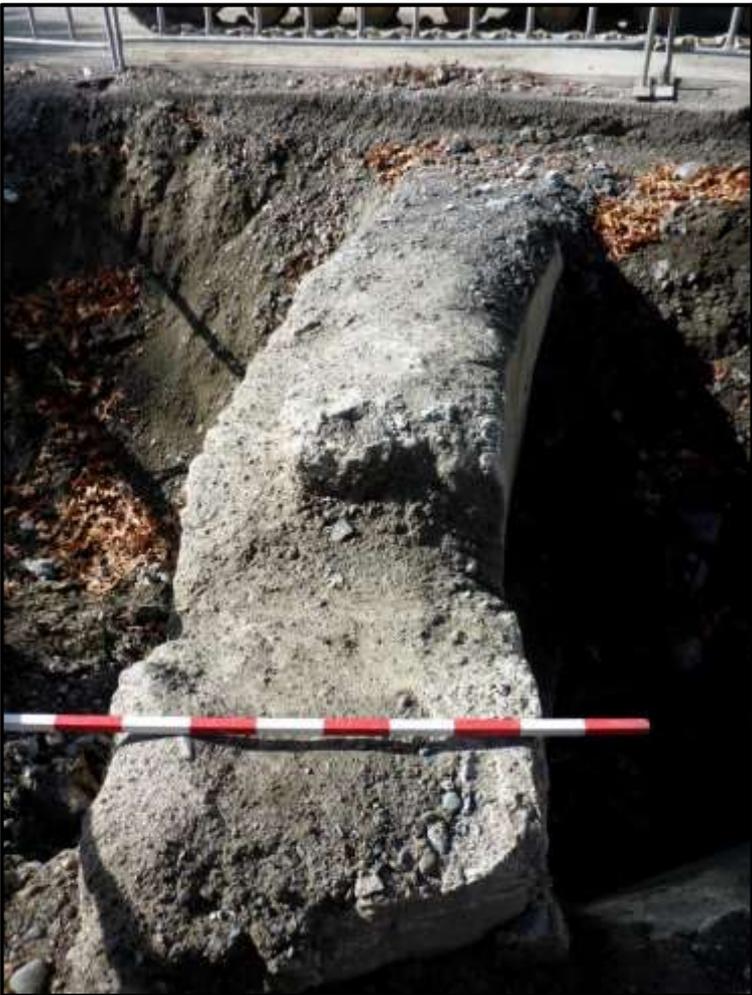
Figure 35. Feature 4, part of the wing wall at the eastern end of the bridge, looking east.

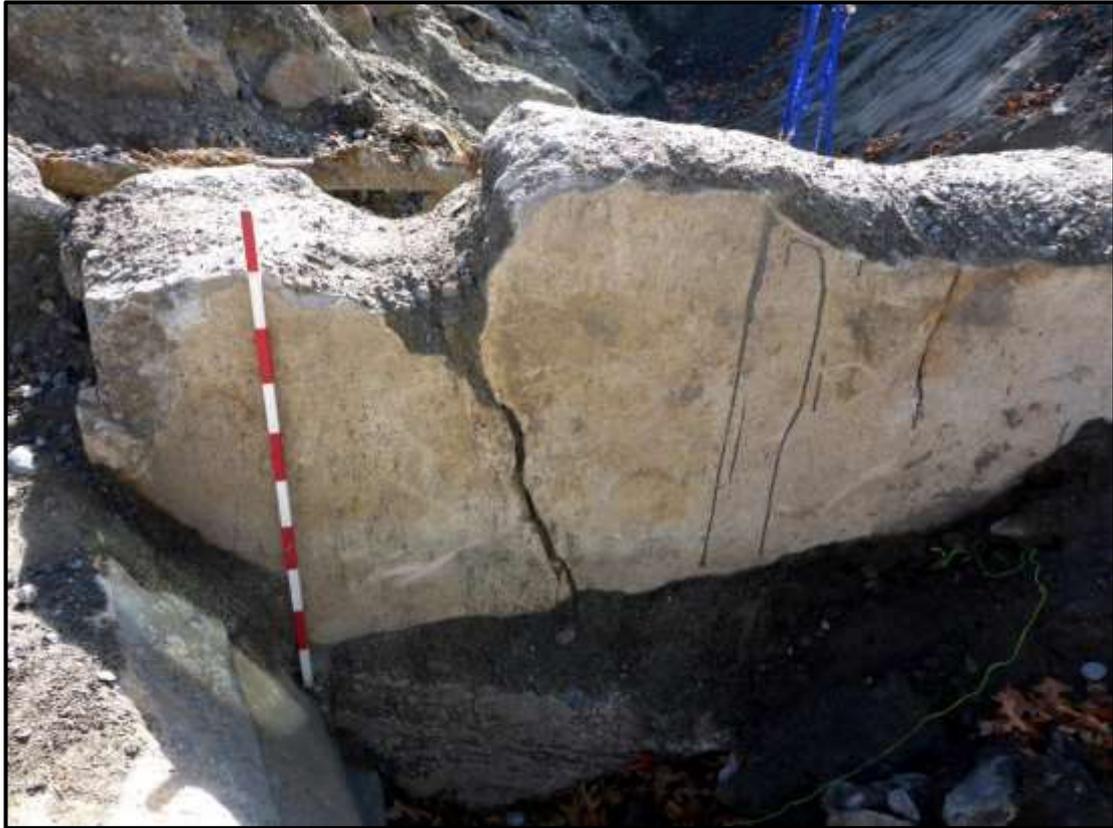
Figure 36. The wing wall at the eastern end of the bridge, looking north.

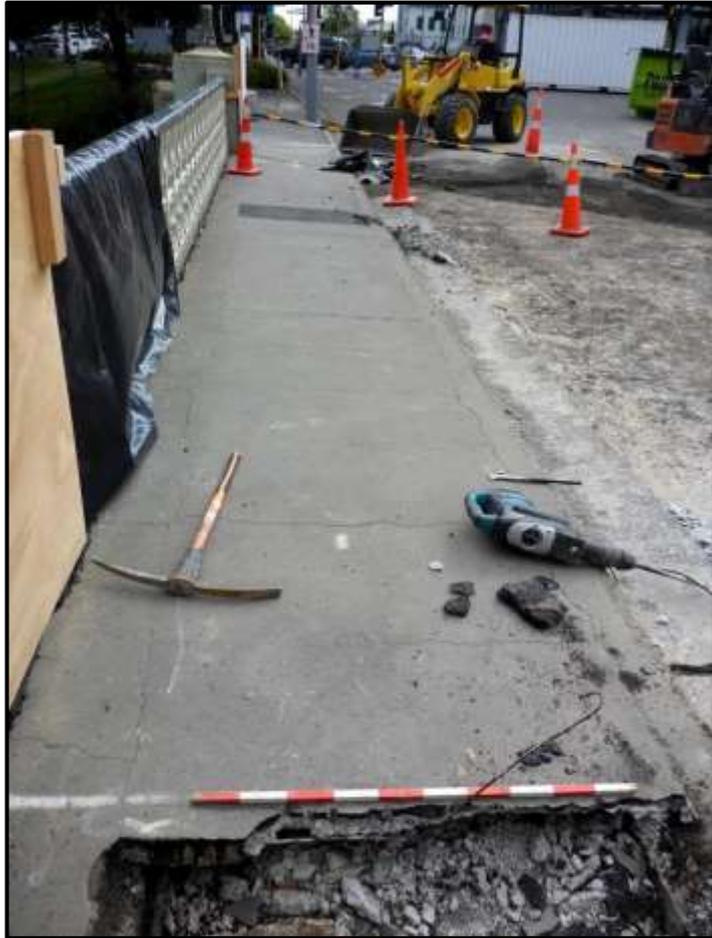
During the removal of the footpath on the bridge extension, newspaper dating to 1939 (Feature 5) was uncovered (Figure 37). The feature was located underneath a 25 mm thick asphalt layer and was affixed to the underside of pre-cast concrete panels that formed the footpath deck (Figure 38). The concrete had probably been poured in newspaper lined moulds. A date of 27 October 1939, near the outbreak of World War II, was visible on one newspaper, confirmed by a search in Papers Past (Figure 39 and Figure 40). The feature likely extended the length of the footpath, around 17 m, but earthworks were not monitored as the feature dated after 1900. The 1939 date of the newspapers places the construction of the footpath about three years after the completion of the bridge extension. The footpath that existed until the 1939 footpath may have been of a temporary nature or else the footpath was not constructed until 1939.

Figure 37. Footpath on the bridge extension during removal, looking west.

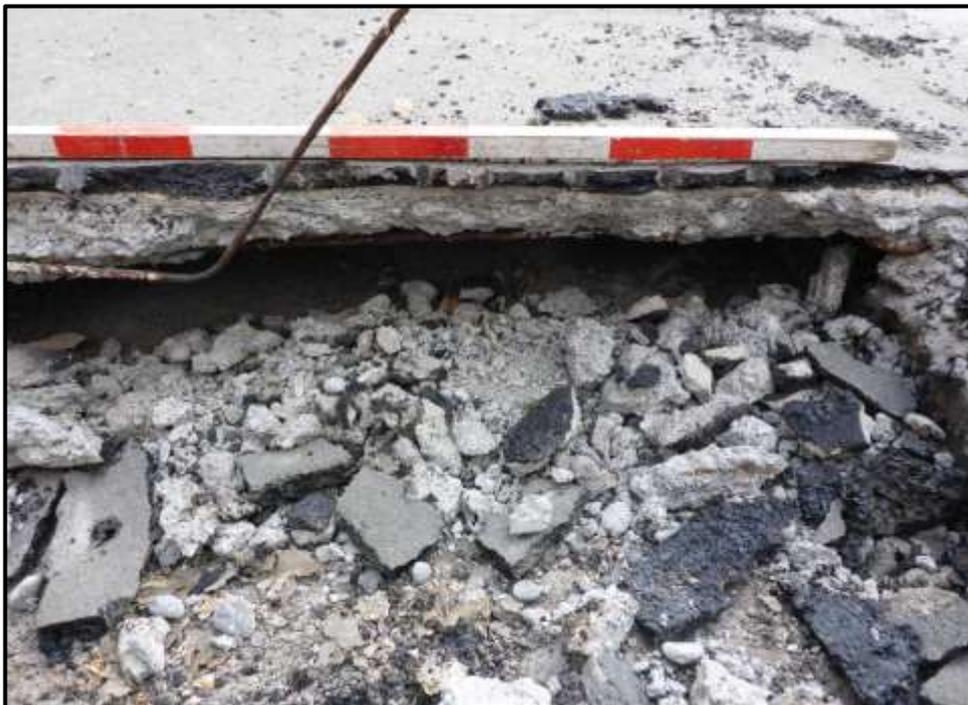
Figure 38. Profile of the footpath, showing the modern asphalt and pre-cast concrete panels, looking west.

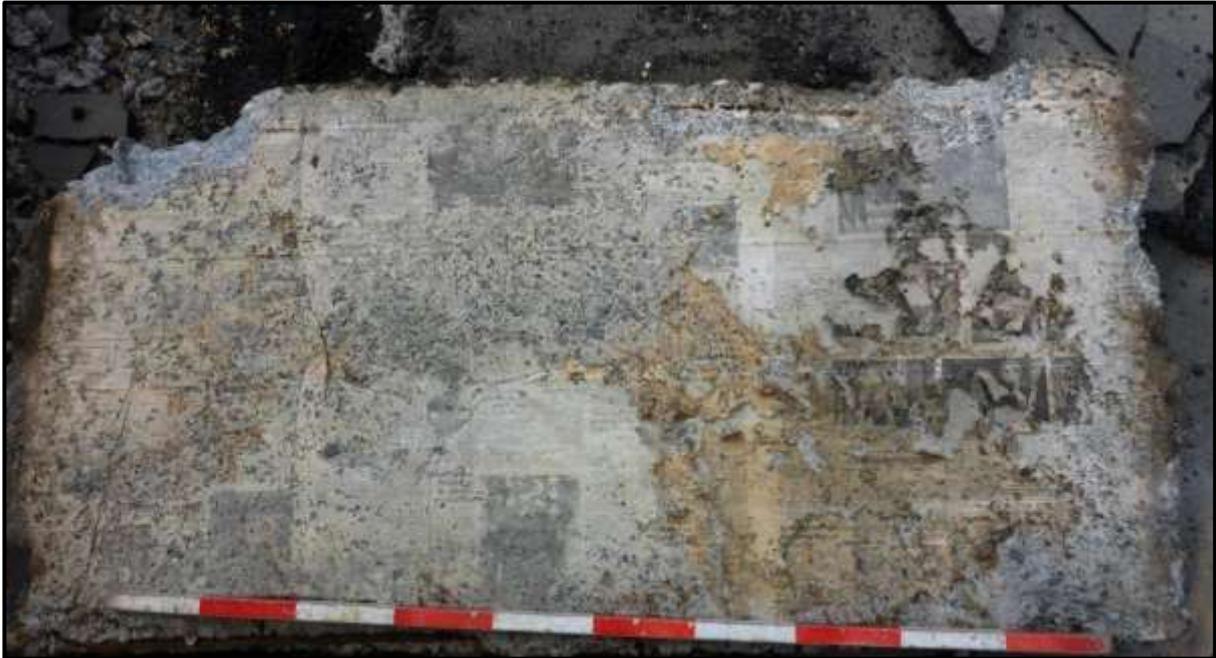
Figure 39. Detail of the 1939 newspaper on one of the pre-cast concrete panels.

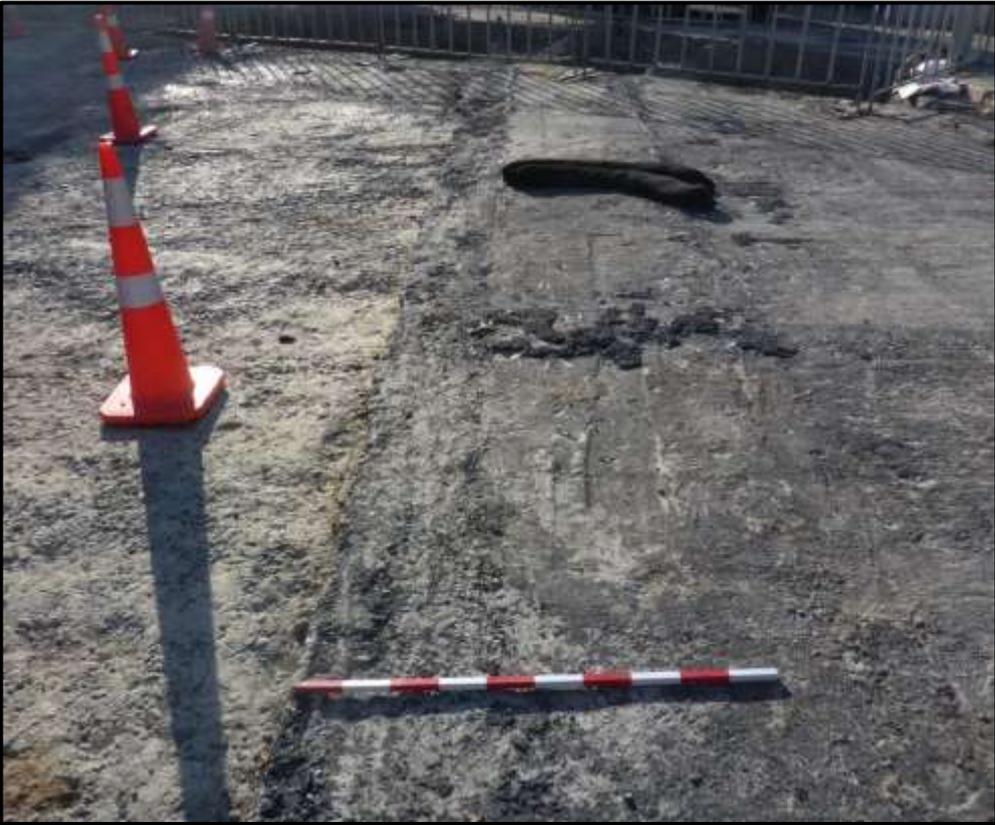
Feature 6 consisted of the footprints of shoes or boots on the concrete deck of the 1936 bridge extension (Figure 41, Figure 42, and Figure 43). The footprints were haphazardly placed across the

extension and appeared to originate from different shoes. The feature was probably created during the construction of the concrete deck in 1936 by the workers.

Figure 41. Overview of the bridge extension (right) with the 1886 concrete decking (left) where Feature 6 was located, looking east.

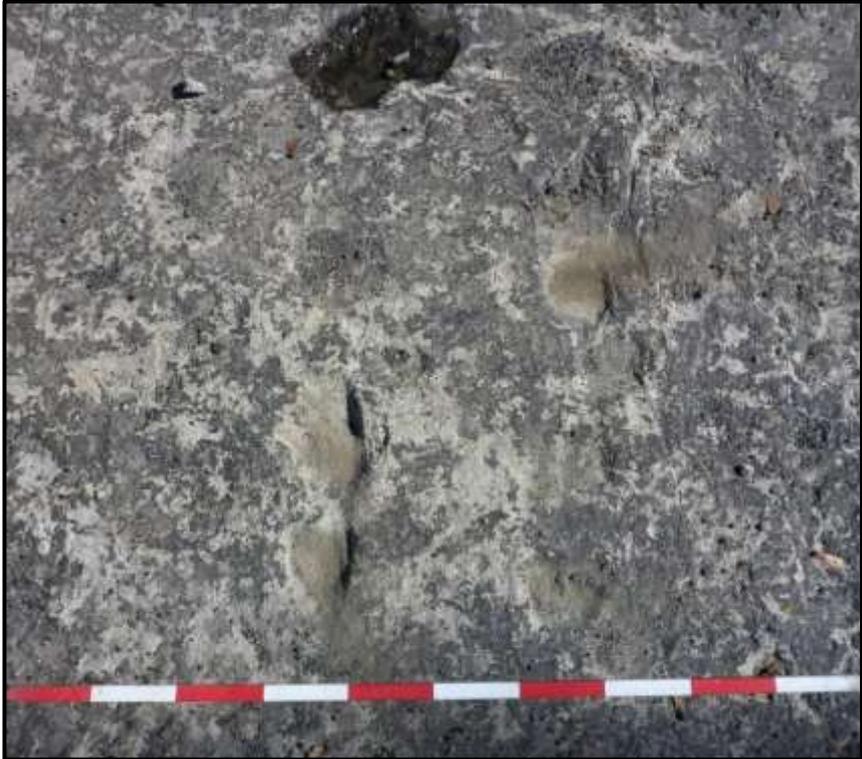
Figure 42. Footprints in the bridge extension.

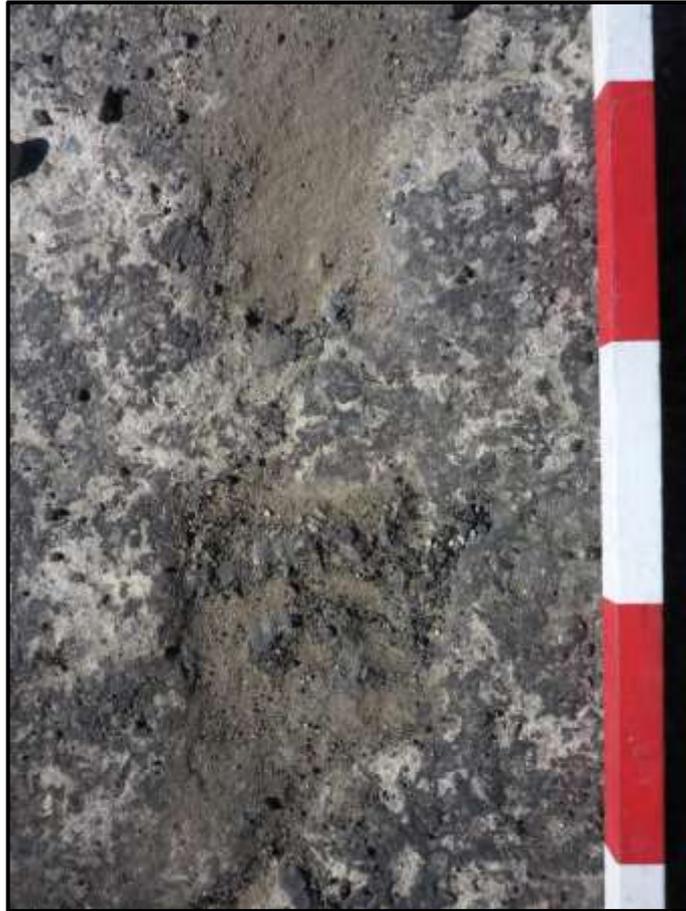
Figure 43. Detail of footprint in bridge extension.

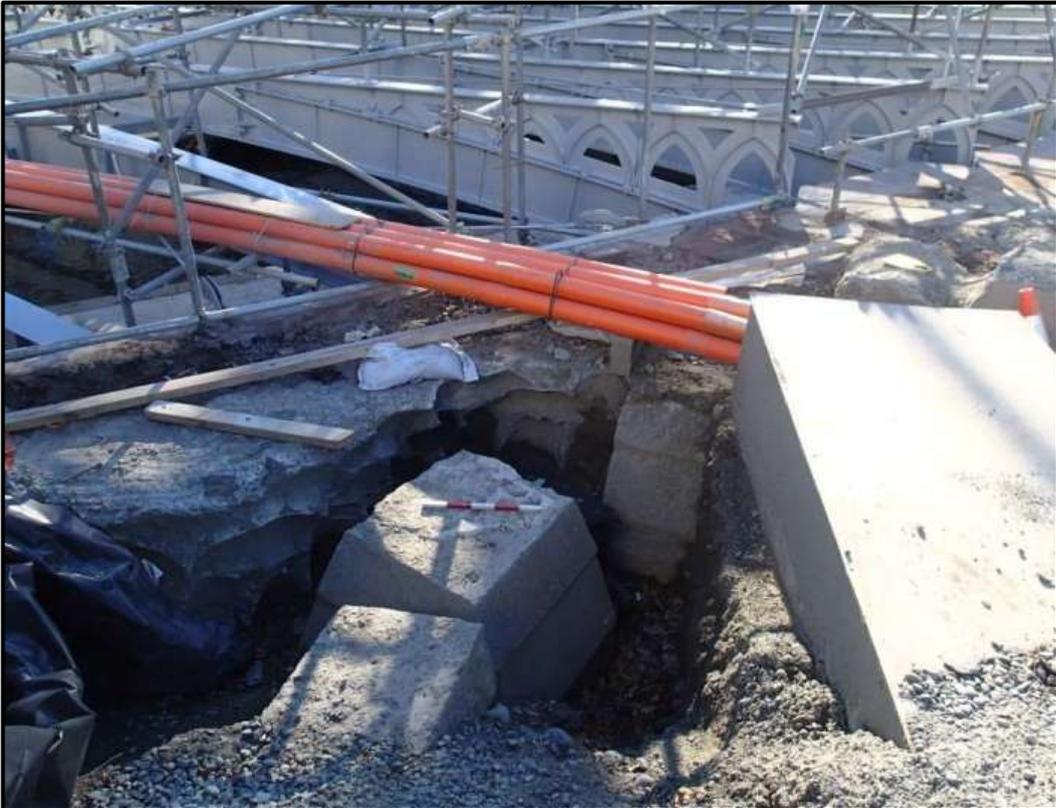
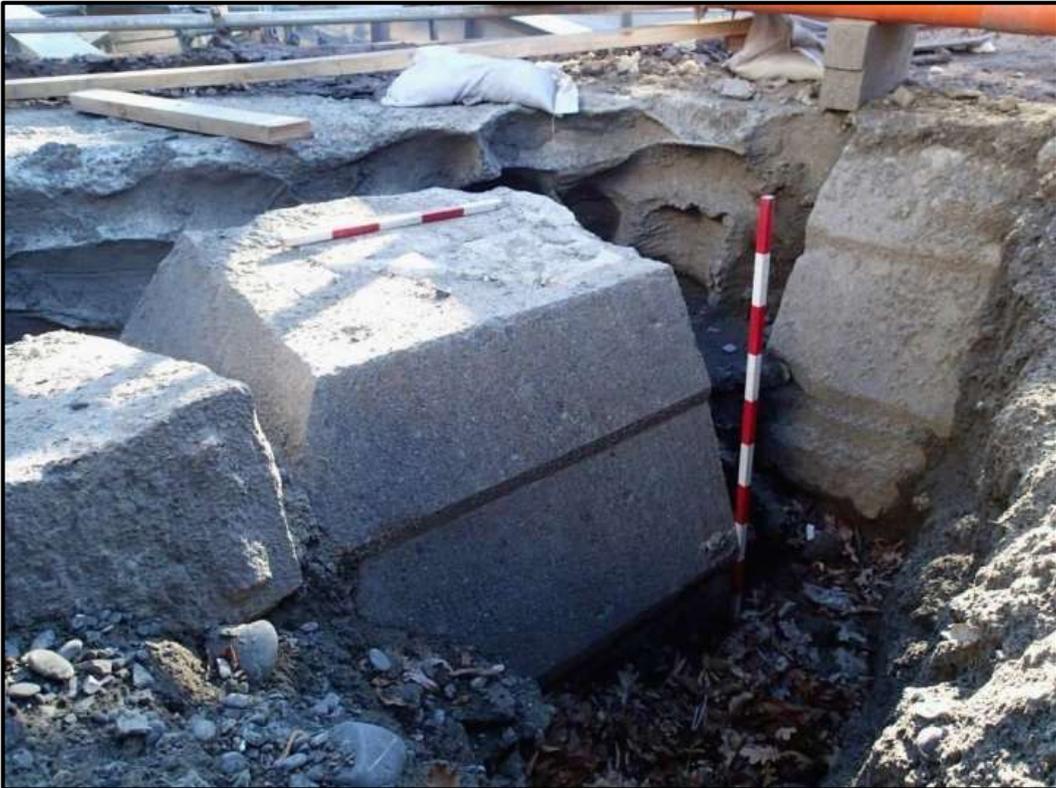
Features 7 and 8 were additional blocks of Mt Somers limestone from the pier that stood adjacent to the eastern wing wall. Both were uncovered later on in the project when additional earthworks to expose the abutment and approaches of the 1939 extension were carried out on the eastern side of the bridge (Figure 44 and Figure 45). The features were located immediately south of Features 2 and 4. Both features were in a secondary context as they were located outside the boundaries of the 1886 bridge and next to the 1936 bridge extension. It is likely that both formed part of the same stone pier that was demolished at the time of the widening. Rather than being removed from site at the time of widening, these displaced stone blocks were buried or backfilled into the adjacent area excavated to form the abutments of the extension. Both were tapered in form and had bevelled edges.

Feature 7 was similar to Feature 2 where it was located. It measured 1.1 m by 900 mm and approximately 850 mm in depth.

Feature 8 was a small concrete abutment located immediately southeast of Feature 7. The feature measured 600 mm by 600 mm and was approximately 500 mm in depth.

Figure 44. Features 7 and 8, Mt Somers stone pier units in a secondary context, looking northwest.

Figure 45. Features 7 and 8, looking north-northwest.

The features were not able to be left in situ and were carefully removed to the Christchurch City Council's Pages Road storage yard for potential adaptive reuse.
