Lessons learned from one of New Zealand's most challenging civil engineering projects: rebuilding the earthquake damaged pipes, roads, bridges and retaining walls in the city of Christchurch 2011 - 2016.

Beca Heritage Week Armagh Street and Colombo Street bridges - posters

ARMAGH STREET BRIDGE REPAIR

COLOMBO STREET BRIDGE REPAIR

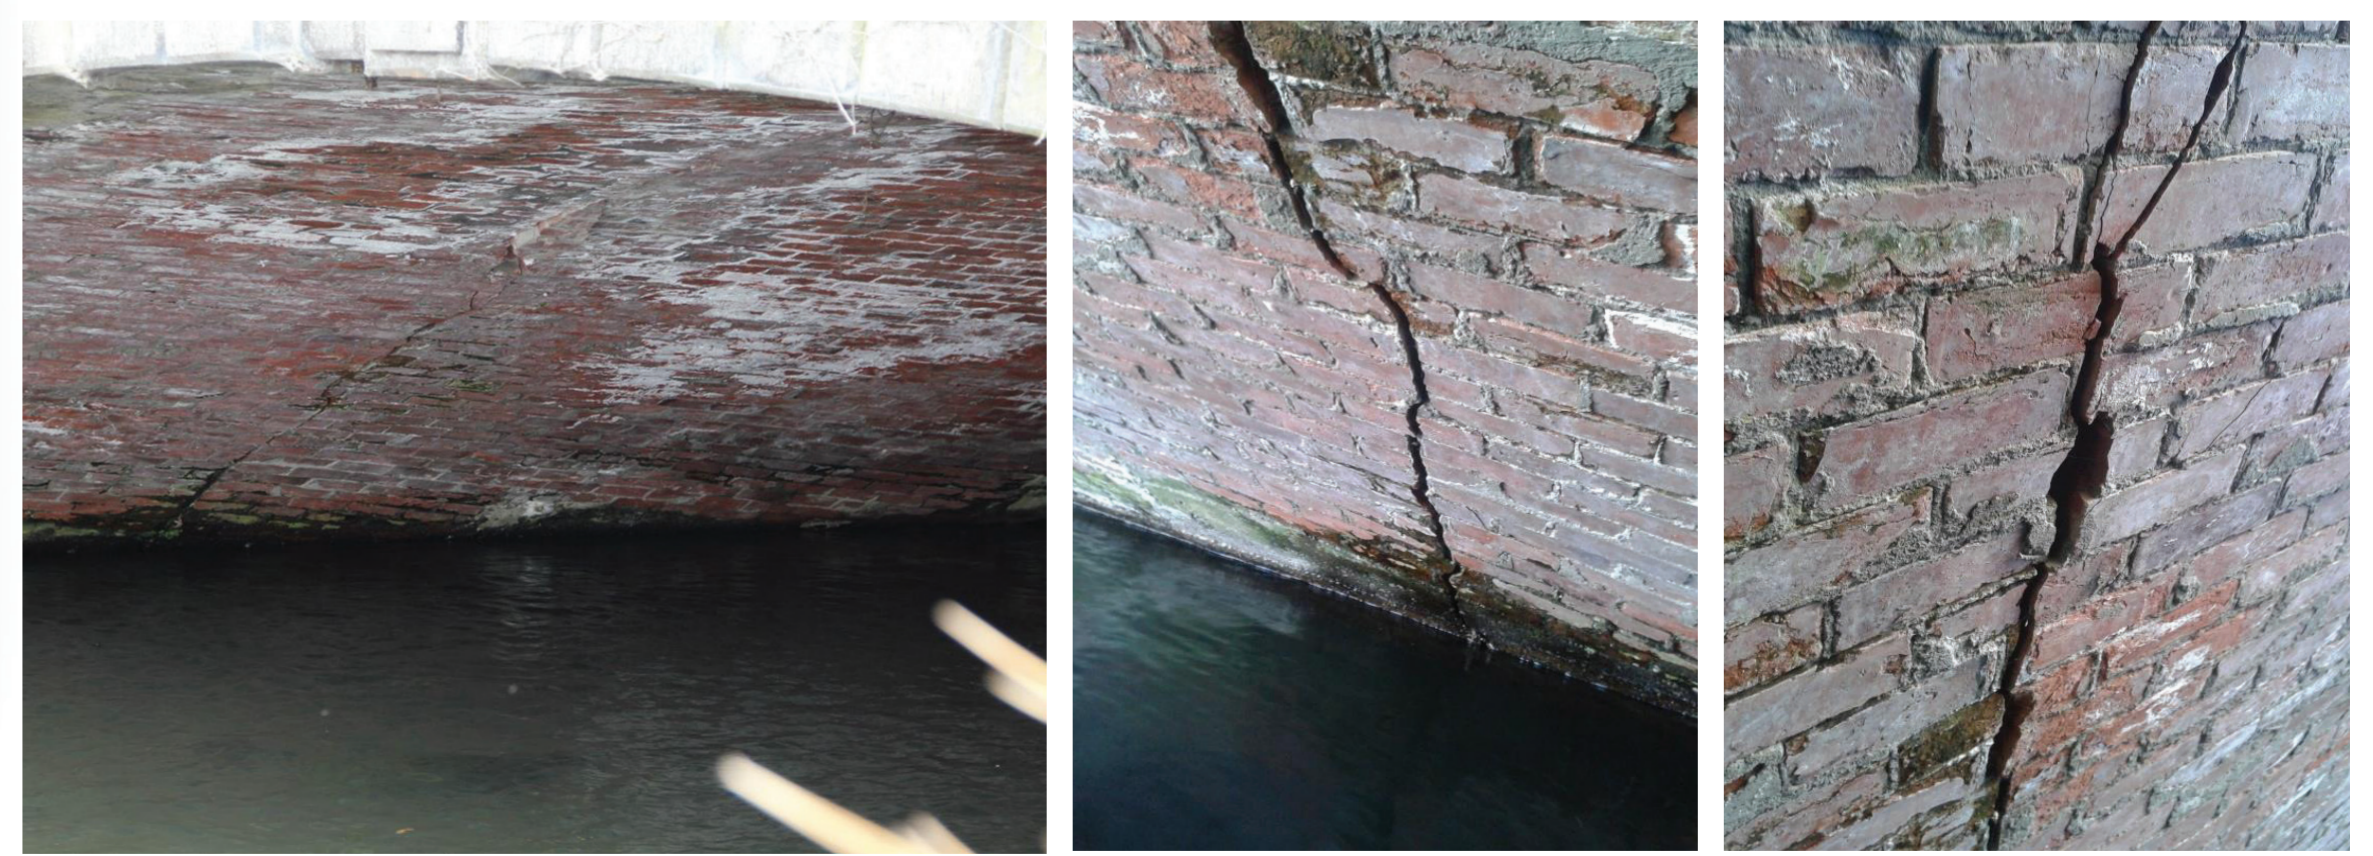
The Armagh Street bridge suffered significant damage in the February 2011 earthquake. Downer, as part of the Stronger Christchurch Infrastructure Rebuild Team (SCIRT) repaired damaged sections of the bridge.

Images show cracking to the brickwork beneath the Armagh Street bridge.

helifix ties are steel rods that are used to stitch together the cracks in the brickwork.

- Diagonal and horizontal helifix ties* were installed across the cracking in the bridge.
- A block of detached brickwork was removed and re-constructed using matching brickwork and mortar.
- The road surface and footpaths were repaired.
- A temporary hydro-barrier dam was installed to create a dry working area beneath the bridge.
- The existing guardrail will be removed, repaired and reinstalled.
- Throughout the repairs the bridge will be closed to vehicle traffic.
- The bridge is expected to be open to traffic by mid-November 2014.

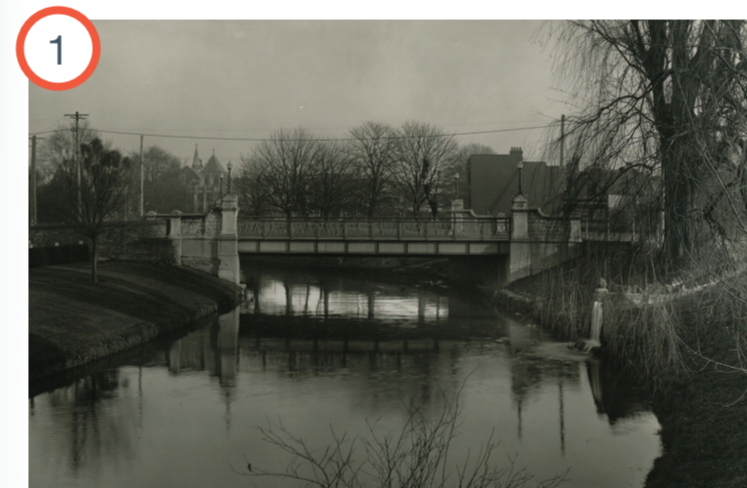
- 1 The bridge without Victorian decorative elements.
- 2 The bridge under construction.
- 3 The bridge under construction.
- 4 The bridge before the February 2011 earthquake.
- 5 The bridge showing the warped balustrade following the February 2011 earthquake.

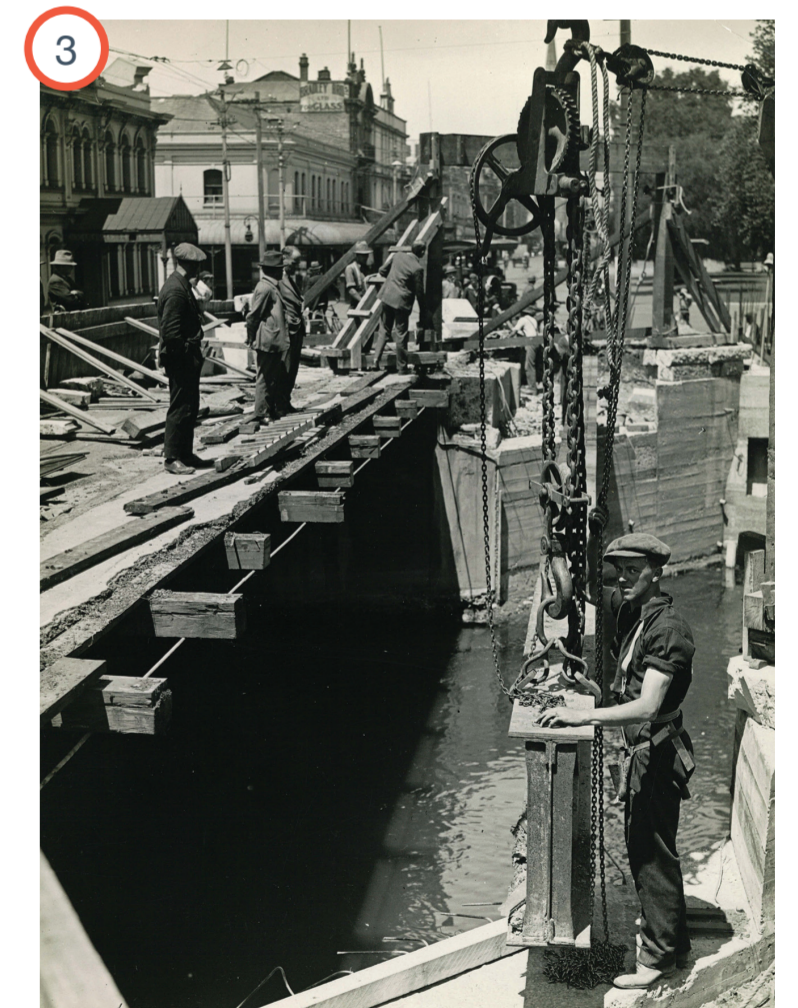
The Colombo Street Footbridge sustained significant damage in the February 2011 earthquake. Downer, as part of the Stronger Christchurch Infrastructure Rebuild Team, repaired damaged sections of the bridge.

- The ground was injected with cement to harden it and provide strength against future earthquakes.
- The damaged bridge foundations were demolished and then reconstructed.
- The services that run beneath the bridge were repaired. Services included water and gas mains.
- The existing handrail were removed, repaired and reinstated.
- The cracks in the bridge foundation were repaired.
