Central City Asset Assessment Report

Condition Assessment of Horizontal Infrastructure within the Central City

Investigation Report

Date: 11th May 2012

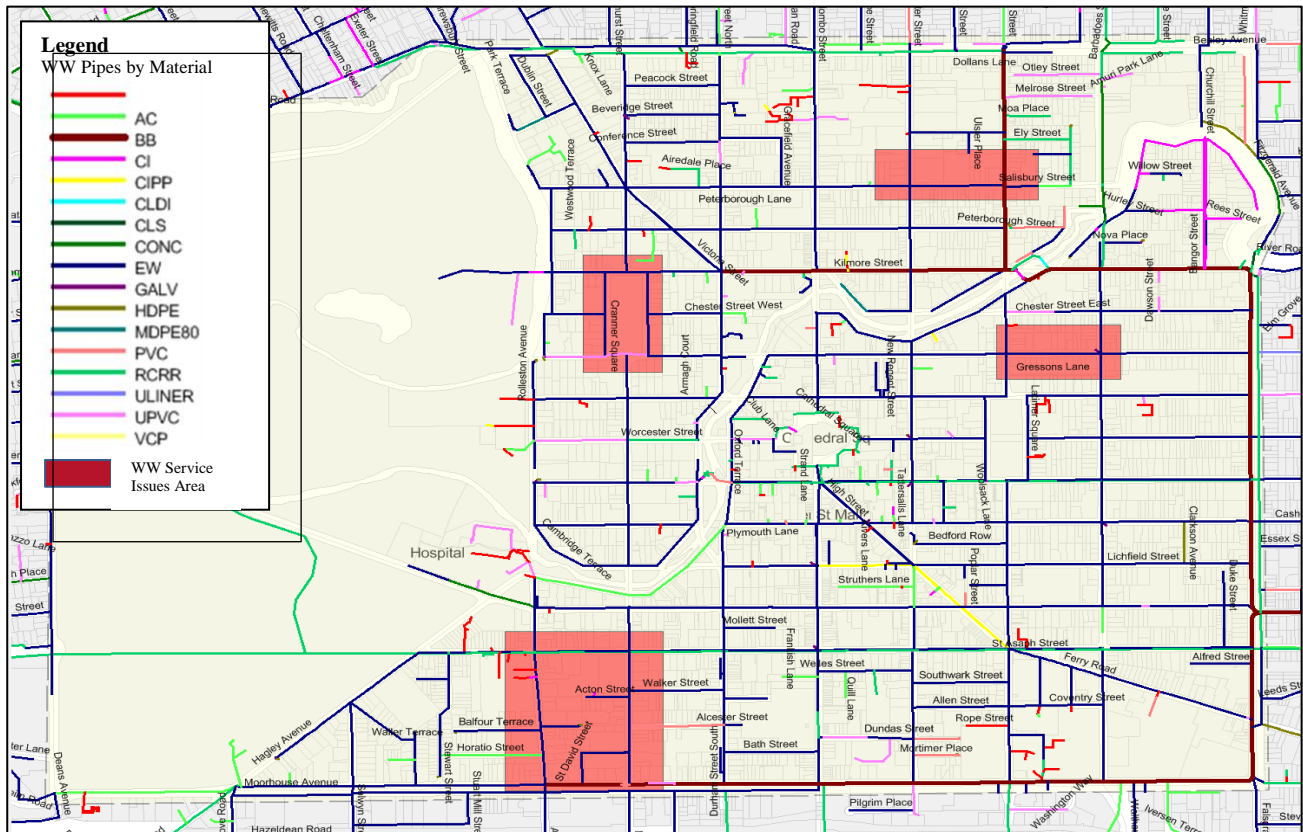
Figure 6 Wastewater Reticulation Network by Material Type

The damage levels experienced within the central city area are generally due to the pipe material. The map below shows the reticulation system by material types with dark blue representing earthenware (EW) materials, red representing the brick barrels (BB) and green for newer pipework, constructed from reinforced concrete, rubber ringed pipework (RCRR).

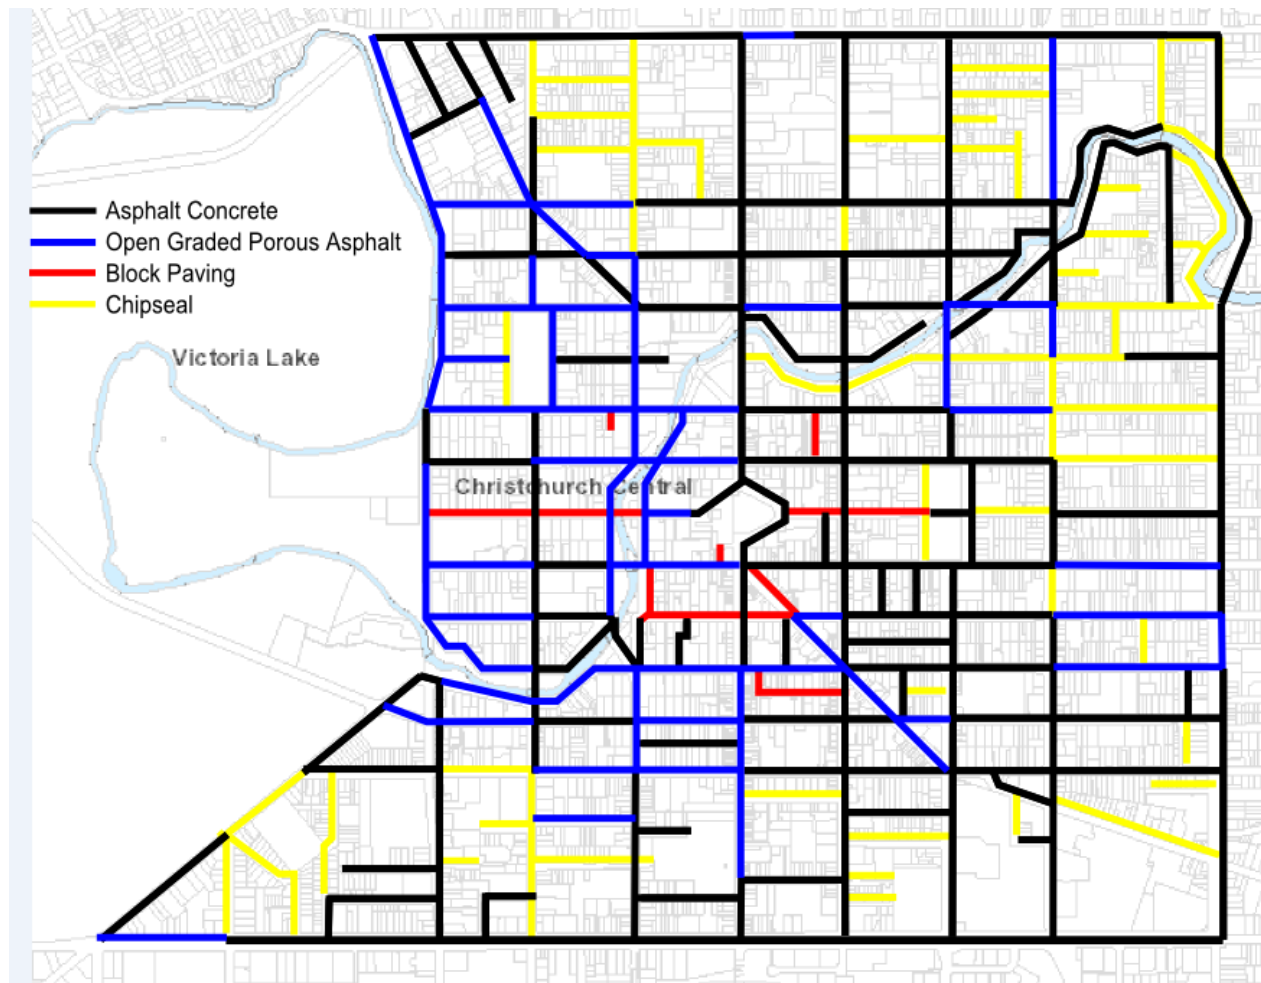
Figure 10 Road Surface Treatment Type

Unlike the WW and SW infrastructure, damage levels to roads, footpaths and cycleways has not been related to the material type of the asset. Rather, damage levels are more related to liquefaction, ground settlement and lateral spread across the central city. However, surface treatment type information is important for cost estimation for repairs. As shown in Figure 10 below, the majority of the central city is made up of Asphalt surfaces with pockets of Chipseal in isolated areas or individual seal lengths.
