Bridge of Remembrance Seismic Strengthening – New Zealand Concrete Industry Conference 2015

BRIDGE OF REMEMBRANCE SEISMIC STRENGTHENING

This paper highlights some of the design and construction challenges that were overcome in the seismic strengthening of the Triumphal Arch in Christchurch, a listed category 1 Historic Place. The project involved a complete change to the dynamics of the structure to allow a rocking motion to be induced to dissipate energy during a significant earthquake. The delivery team used a number of simple but effective techniques to overcome the challenges..

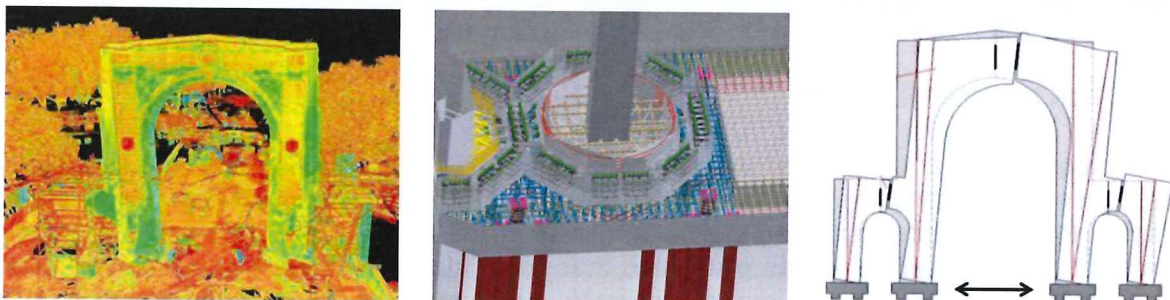
Figure 2. (L-R) External 3D Scan of Structure, 3D Modeling of Rocking Collar and Pile Cap, In-plane rocking motion induced by ground motion

One of the challenges faced was ensuring that the new steel reinforcing elements would be able to fit into the structure's internal voids. Utilizing the 3D Point Cloud Scanning enabled precise profiles of both the inside and outside surfaces of the structure to be generated. This eliminated the health and safety risk of lowering operatives inside the voids to confirm the internal dimensions. Following the scanning, a 3D-Model was produced of the existing structure using the scanned data and the new design elements were positioned in the model. This gave the delivery team the opportunity to verify the design before discovering discrepancies and clashes onsite that would cause costly delays to the program.

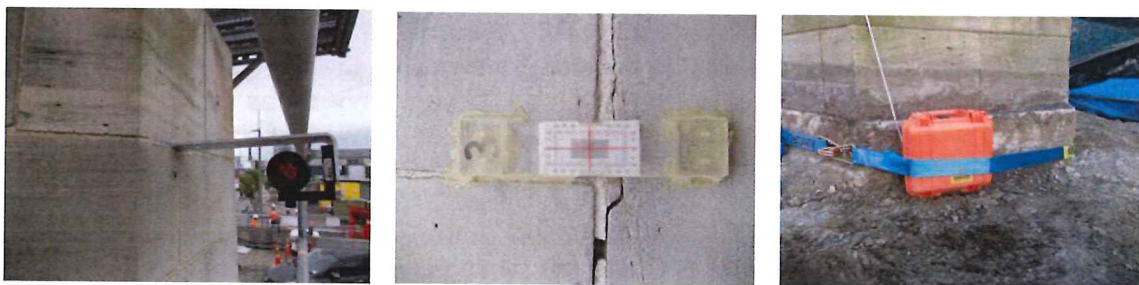
Before civil works commenced on the structure a monitoring system was set up to identify any slight movement of the structure and to ensure the safety of operatives working on the site. The system incorporated; computerised survey checks, visual monitoring of existing cracks and identification of newly formed cracking using base line records.

The survey system involved installing monitoring targets on the structure, back-sight targets on existing buildings in the vicinity of the structure and positioning a permanent plinth for a survey total station to be mounted to. The structure was monitored multiple times daily from the plinth and any movement in the structure was able to be determined immediately. Before mobilising onsite a thorough dilapidation photo survey of the whole structure was undertaken. This gave the delivery team the ability to compare suspected new cracks with the state of the structure before construction. To complement the photo record, a number of the large existing cracks on the structure had Tell-Tale crack monitors fixed across them. This was a low cost solution to identify any movement in the existing cracks. Vibration monitoring was also used during the piling operation to ensure the structure was not subjected to damaging vibrations. The German Standard Din4150-3:1991 was adopted for historic buildings and a peak particle velocity of 3mm/s was set in accordance with the Standard. Continuous monitoring was set up to feed alerts to a siren and light on site when vibrations 80% and 100% of the limit were transmitted to the structure.

Figure 3. (L-R) Survey Prism, Crack Tell-Tale Visual Monitor, Vibration Monitoring Sensor

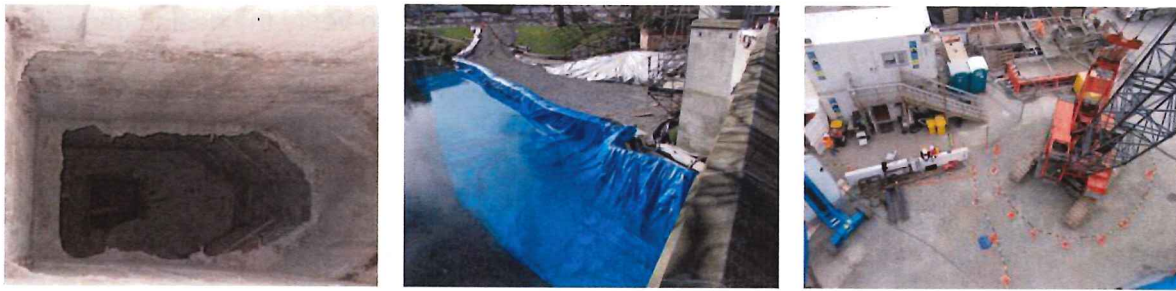
Figure 5. (L-R) Inside of Major Column, Access track and Dam, Site setup during Piling

Access to the north end of the structure was extremely difficult due to the proximity to the river. To enable construction work to be undertaken in this area, a temporary access track was installed down along the riverbank. Pre-cast concrete blocks were placed in the river to form a temporary retaining wall, bidim cloth placed over the bank and aggregate with geo-grid was used as infill to construct the track. A temporary dam was also setup around the track to enable the area to be dewatered. Water was pumped out of the dam through a sediment tank before being discharged into the river via the riverbank.

Less significant, but still important designs included; designing lifting eyes on all steel sections, positioning holes in the fabricated steel sections to allow concrete to flow in and out and calculating the allowable heights of concrete pours in the existing columns with considerations made for hydrostatic pressures.

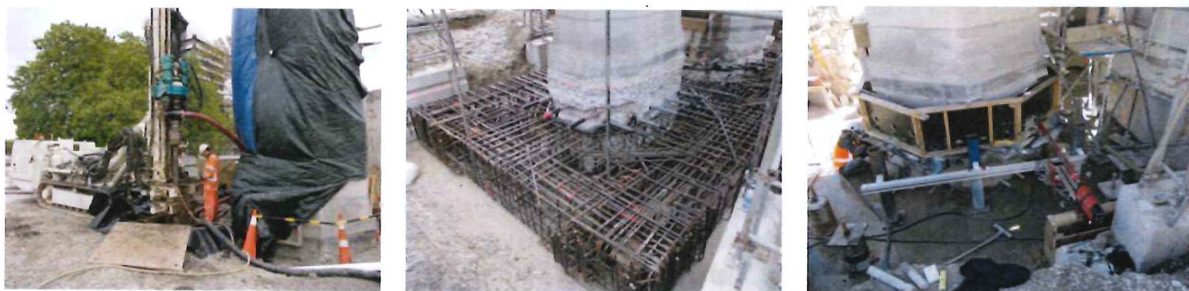
Figure 6. (L-R) Pilling Work, Pile Cap Reinforcement, Rocking Collar Coring

To overcome the sandy soils beneath the structure and the potential consequences associated with liquefaction, new piles were installed to replace the existing relatively shallow pad foundations. The initial design called for large diameter reinforced concrete bored piles which the delivery team had concerns about for a number of reasons. These included; the close proximity of the piles to the structure, the potentially damaging vibrations and heavy weight associated with large piling equipment and the limited space on site. The solution was to replace the single large diameter piles with smaller micro-pile clusters. Micro-Piling was a suitable alternative using of a smaller rig providing improved maneuverability and a low vibration drilling method. In total, 32 No. 300mmØ micro-piles were drilled to an approximate

The columns of the existing structure were founded independently on separate shallow foundations. To transfer the load from the structure to the new piles, two 900mm thick pile caps were constructed to create a single bearing slab surrounding all columns below the rocking collars. The construction of the main pile cap was not just a straightforward operation. There was risk of ground heave around the existing shallow foundations when excavating for the new pile cap. To mitigate this risk the excavation for the new slab had to be carried out in alternating bays, similar to underpinning, replacing the removed overburden pressures of excavated material with a lightly reinforced 150mm thick blinding slab.

The main pile cap construction involved the placement and tying of 30 tonnes of reinforcing steel consisting of over 250 different tagged items. A large number of DH32 bars were required in the bottom mat in long sections, which proved particularly difficult to install in the excavation. The reinforcing cage was already too congested to allow standard laps, so Ancon threaded couplers were utilised to provide full strength connections to multiple DH32 bars. To connect the pile cap to the structure, over 200 holes were cored horizontally into the base of the columns so that DH25 L-Dowels could be epoxied in. Starter bars for the rocking collar perimeter retaining walls also had to be hung inside the congested steel cage with couplers positioned at the finished concrete height with zero tolerance for misalignment.

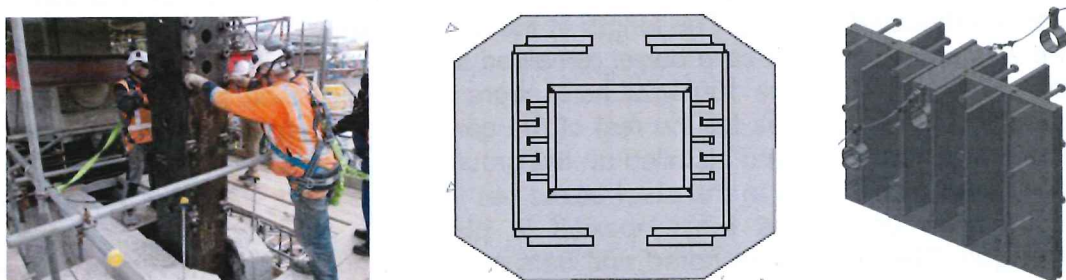
Figure 7. (L-R) Positioning Steel Box, Steel Box Configuration, Sliding Joint Assembly

A fundamental element of the rocking mechanism was the construction of a vertical sliding joint detail at the crown of each of the three arches to allow the in-plane rocking. This involved cutting the arches in half vertically and installing a stainless steel plate sliding assembly. The construction of the sliding joints also involved the horizontal post-tensioning of the arches through the sliding plates. The post tensioning system provided the strength across the arches, while still allowing the sliding plates to function in earthquakes. A bespoke post-tensioning system was detailed to allow future controlled de-stressing or load testing of strands following a significant earthquake.

The sliding plate assemblies were installed in two stages to reduce the need for temporary propping of the arches during installation. Stage one involved installing the main sliding plate, post tensioning elements and pouring concrete into the arch cavity. Once the concrete had reached its 28-day strength, the arch was post-tensioned. Construction of stage two could begin after post tensioning by removing the stonework around the center of the arch. With stones removed, the concrete walls of the arch were removed to expose the stage one plate. The second stage of the plate was connected to the first stage and new concrete poured. The stones were replaced and a new mortar joint was cut into the stones at the joint position.
