Seismically Induced Shear of a Concrete Reservoir in the February 2011 Christchurch Earthquake: Investigations and Response

ANZ 2015 // 22-25 February 2015

Marcus Gibson – Associate Geotechnical Engineer Beca Ltd / SCIRT

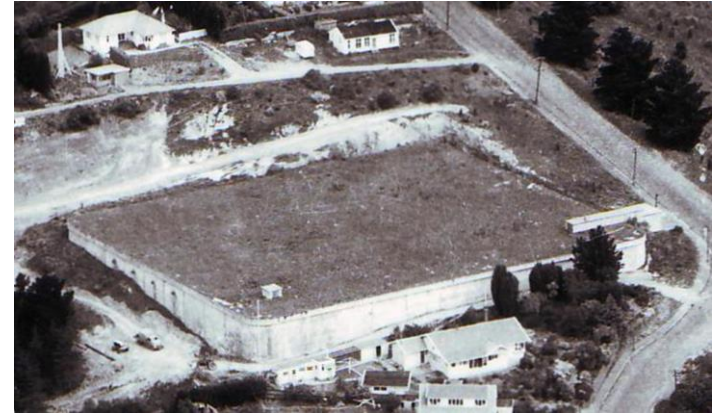
Huntsbury No. 1 Reservoir

- Circa 1954
- 36,000 m³ capacity
- Reinforced concrete
- M_w 6.2 EQ 22 February 2011
- Damage → complete functional failure
