The Strengthening of Heritage Bridges - Construction Challenges

A conference paper prepared for the 4th Australasian Engineering Heritage Conference which outlines the challenges faced by SCIRT when repairing the Armagh Bridge, Colombo Bridge and Antigua Bridge.

The Strengthening of Heritage Bridges – Construction Challenges

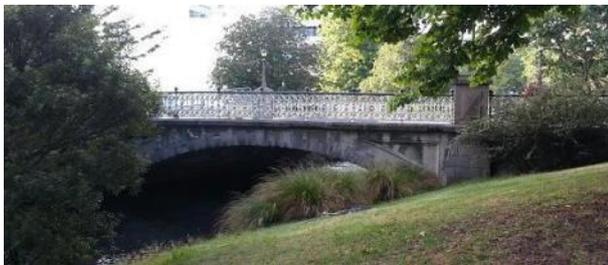
Figure 1. Armagh Bridge

The Feb 2011 seismic event caused a longitudinal crack in the arch soffit measuring up to 20 mm in width. The crack was visible in the soffit but did not present through the layers of basecourse and sealing to the road surface.

The repairs specified included investigation and reporting on the extent of the crack, repairs to the crack itself, refurbishment of the cast iron balustrading and repairs to the footpaths and road surface.

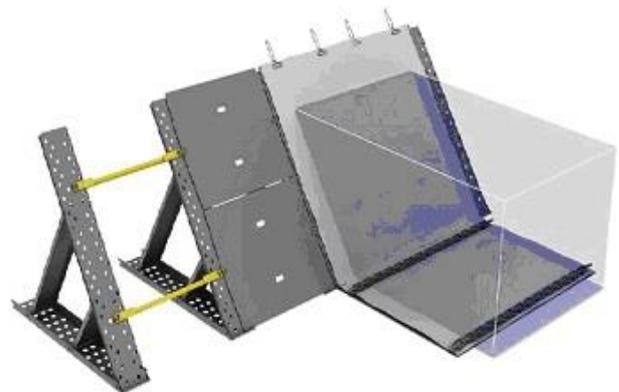
Figure 3. Proprietary A-Frames – courtesy Hydro Response Ltd.

Several methods have been used in the past to hold back the water and create a dry working space. These include sheetpiling and water filled inflatable rubber dams. Neither of these methods was suitable for Armagh Bridge – there was no headroom to drive sheetpiling and a rubber dam would have been too bulky.

The method used was to erect a set of proprietary steel A-frames supporting aluminium panels to

form a wall or dam around the work area. A continuous plastic sheet material was then laid over the panels by workers wearing waders and secured in place. The water isolated in the “working area” side was then pumped out and as this was done, the weight of the water on the “river” side pressed the plastic down, sealing it on to the river bed. It was still necessary to run a small pump in the work area to contend with leakage but this presented no difficulty.

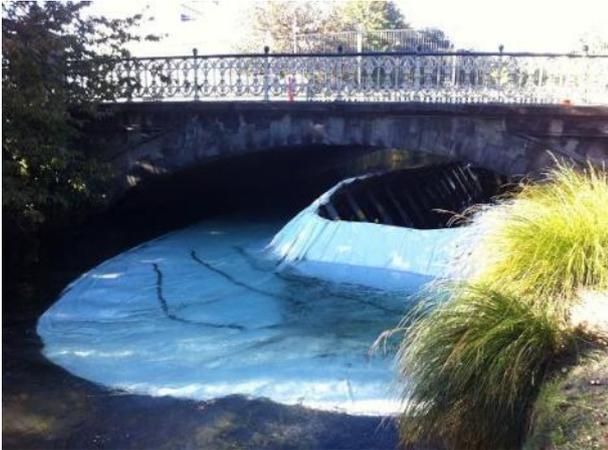
Figure 4. The Hydro Response dam in place.

There was a flood event during the course of the repair work which overtopped the dam. Work was suspended for 2 days and the retaining structure reinstated within 4 hours of water returning to normal levels.

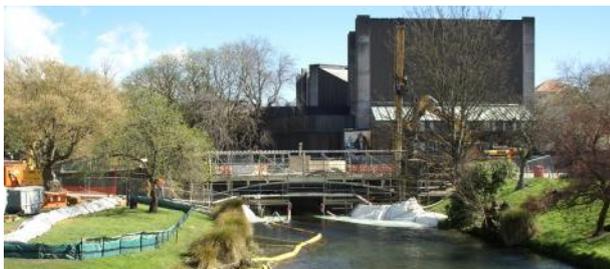
diameter grout column was formed. Difficulties arose when the buried brick remains were encountered just 1 to 1.5 m below river bed level – contrary to what was shown on the as-built drawings. This also led to concerns that the high pressure grouting would permeate under the abutment and into the watercourse, contaminating the river. It was therefore decided to create a dammed area between the abutment and the river, providing a controlled decontamination zone to cater for this possibility.

Figure 10. Hydro Response water dams were also used for Colombo Bridge.

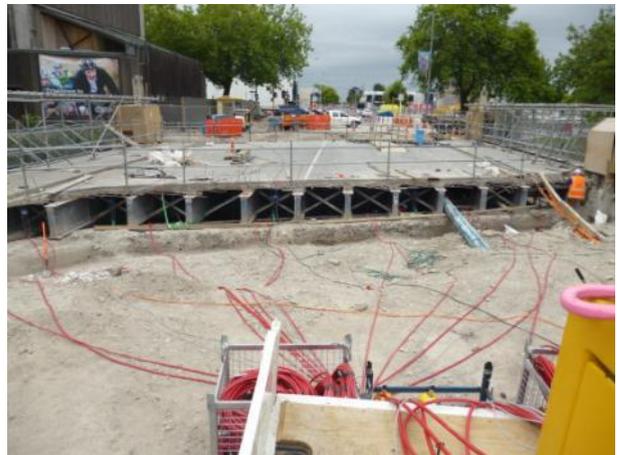
Jacking of the bridge was carried out with all 7 jacks operated from a panel which could instantly report jack loads and displacements. The jacking was carefully monitored by engineers to ensure that the bridge was raised evenly and that none of the temporary works pedestals were overloaded. Packing members consisting of short heavy walled steel RHS sections were cut to length on the day and welded in place.

Figure 12. Hydraulic lines connecting the synchronised jacking control unit to the jacks shown in Figure 11

An inspection regime was put in place whilst the bridge deck was propped up to monitor the pedestals and the continuous beam. No movement of the temporary works was observed during the course of the repairs despite the vibrations from heavy plant.

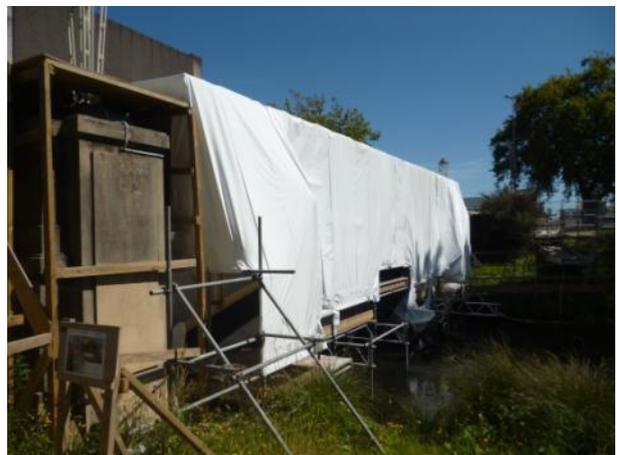
Grit blasting and painting of a historical structure poses many environmental, health and safety and quality threats. This is mainly due to the lead based paint which can become extremely harmful when it becomes airborne during grit blasting.

Figure 13 Shrink wrap encapsulation of bridge

In order to mitigate the risks associated with lead based paint, a bounded encapsulation of the outer girder was formed using shrink wrap hugged to the scaffolding. This stopped the contaminated garnet from entering the watercourse and allowed for an effective clean up after blasting. An exclusion zone was established around the confines of the encapsulation with only blasting and painting operatives with the appropriate PPE permitted entry.

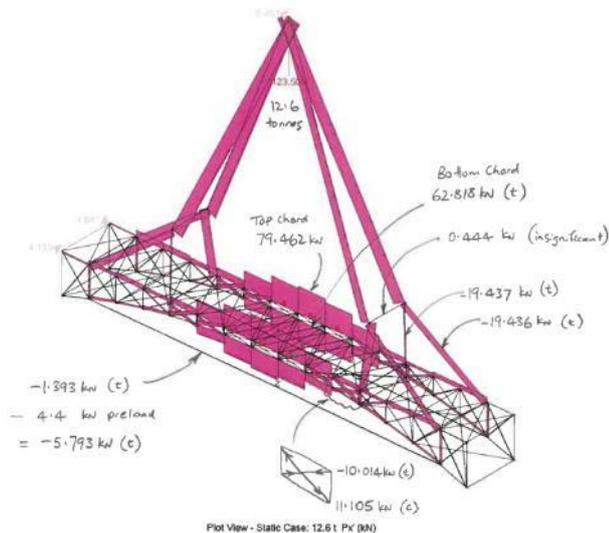
The structure consisted of a pair of trusses fabricated from rolled steel (or possibly wrought iron) angle and tee section members. The two trusses were braced together and anchored into the concrete abutments. The structure had a timber deck and timber handrails. Lateral spreading caused the trusses to hog in the centre by approximately 400mm. Furthermore, the structure had fallen into a state of disrepair prior to the earthquake and several of the riveted joints and members had rusted and failed either before or during the earthquake.

Figure 18. Analysis of the lift using "Multiframe"

- Remove all of the existing timber deck and any other superimposed loads such as services (pipes & cables)
- Undertake a detailed inspection of the damaged structure along with a review of the SCIRT designer's reports
- Investigate possible crane lifting positions and crane setup locations for the site
- Analyse the member forces under the proposed lifting arrangement
- Finalize the method and execute the lift.

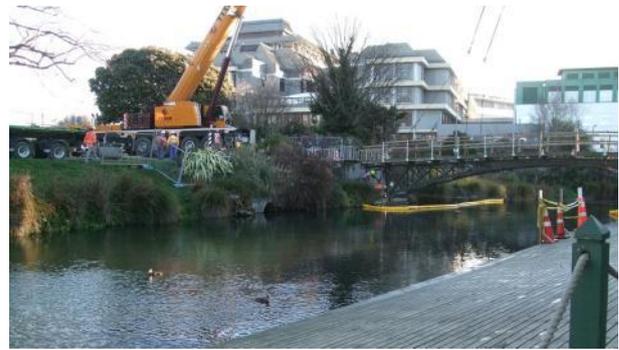
Figure 19 The crane was set up on the South bank

A 200tonne crane was set up on the south bank of the Avon and rigging was set up for the lift. The design called for a pair of bowstring chords to be installed for each truss with a load cell connected to each bowstring.

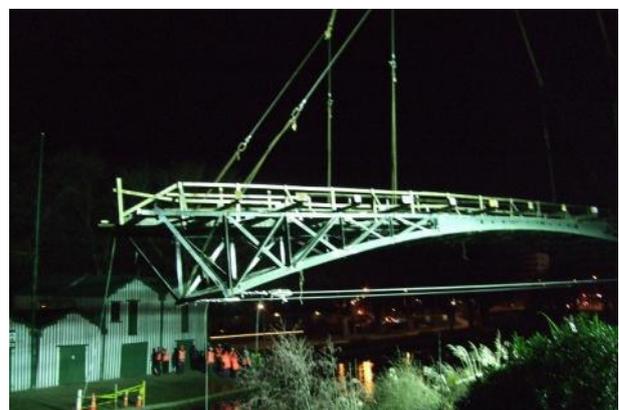
Figure 21. Successful lifting out of the bridge. Note the bowstring wires with tior and load cell.

The removal of the bridge from its abutments was thus carried out incrementally with careful monitoring and gradual release of the tension in the bowstrings. Small bites of steel were cut from the bottom chords as the remainder of the structure straightened itself, gradually relieving the built-up compression forces.
