Lessons learned from one of New Zealand's most challenging civil engineering projects: rebuilding the earthquake damaged pipes, roads, bridges and retaining walls in the city of Christchurch 2011 - 2016.

Armagh Street bridge – award application

An award application for the Civil Contractors NZ Hirepool Construction Excellence Awards 2015 which details Downer's approach to repairing the Armagh Street bridge.

Armagh Street Bridge Repairs

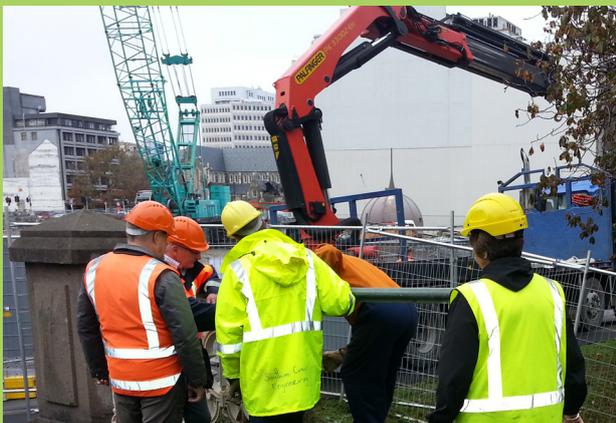
CCC asset managers, along with Heritage Consultants and subcontractors dismantling the 130 year old balustrade panels

Undertaking the balustrade panel refurbishment was a task with numerous unknowns for both the client and Downer. There were no drawings or as-built information of the panels and they hadn't been altered since their installation in 1883. To ensure each piece went back into its exact position a numbering system was generated and boxes made to keep track. We provided the client with updated drawings for the panels and details of how we reinstalled the pieces which was above and beyond their expectations. Our work around the balustrades exceeded client expectations and helped to build a good relationship between us.

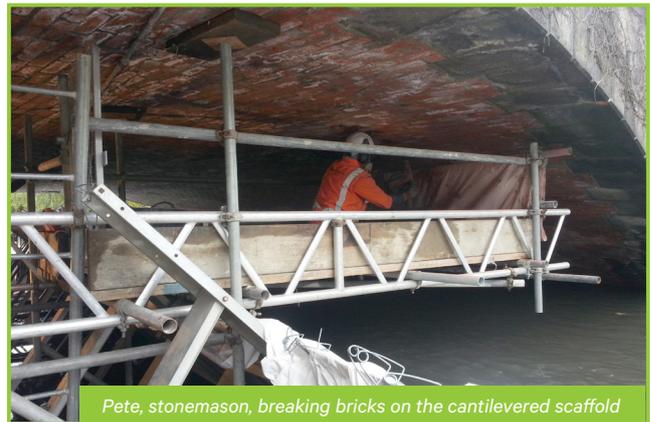
Pete, stonemason, breaking bricks on the cantilevered scaffold

As the repairs were to be completed from underneath the bridge, a key health and safety risk was bricks and debris falling onto workers. To prevent this we developed a propping structure, designed to support ‘a tonne of bricks’. This structure involved anchoring three channel supports into the concrete abutments and using Acrow props on different angles to account for the shape of the brick barrel. Each channel held three props and a plywood sheeting system was placed on top of these props. As work progressed, sections of plywood were removed to enable us to move along the crack.

This innovative scaffolding design, combined with the coffer dams, enabled us to reach the full length of the main crack whilst only having the western abutment side of the Avon River dammed. We cantilevered a scaffold platform, using props and screw jacks to overhang the coffer dam. By completing all of the repairs to the crack barrel from one side of the river, we were able to complete both the surface and eastern abutment repairs simultaneously, accelerating the programme.

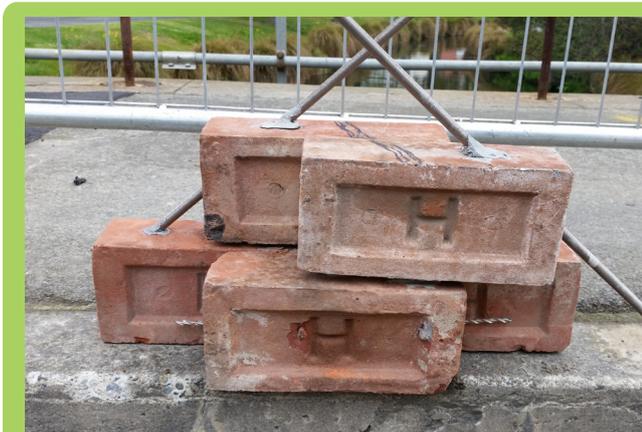
Brick diorama showing cross pinning and stitching

The core structural repairs to the crack were completed by crack stitching and cross pinning. This work involved using 12mm stainless steel threaded rods drilled into the brick at a 45° angle.

We installed 6mm stainless steel Helifix bars in the mortar joints to tie the new brickwork into the old. The injection of the crack required a specific mix of cementitious grout. With our subcontractor BBR Contech, we tested and designed a low strength mix, to match the strength of surrounding brickwork, typically around 11MPa, to ensure the new brickwork does not attract higher loads which has potential to cause damage to the brickwork.

The cross pinning work involved coring 48 880mm long holes on a 45° angle crossing the crack. The brick barrel is only 750mm thick (confirmed by two core samples taking during the design stage). Mapping out the direction of the core holes put the core direction straight into the outer 66kV. This meant an increased and significant risk of electrocution to operatives whilst performing repairs which, at that voltage, would almost certainly mean fatalities. It would also mean significant outages for consumers and issues for asset owner Orion. Switching off the power and removing the cables simply wasn't an option. The network could not sustain these cables being out of service due to loading issues.

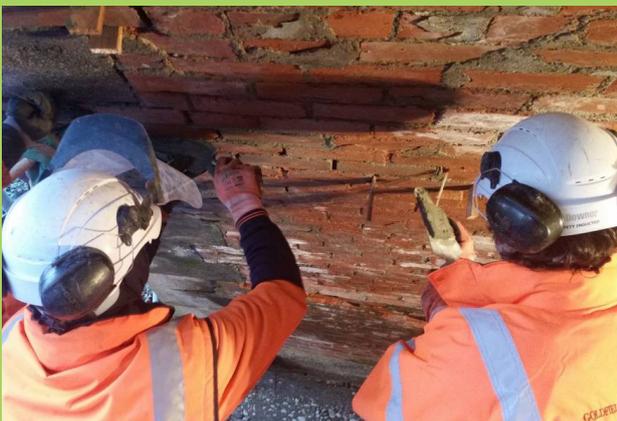
The Goldfield Stone team, placing mortar around newly installed bricks

There was a risk in finding suitable replacement bricks for the bridge barrel. The original bricks were in imperial measure, and are no longer in production. We phoned around demolition companies and identified an old brick building marked for demolition on nearby Colombo St. Goldfield Stone went to inspect the bricks and found they were the same dimensions, colour and a very good match for strength. The heritage consultants approved this match.

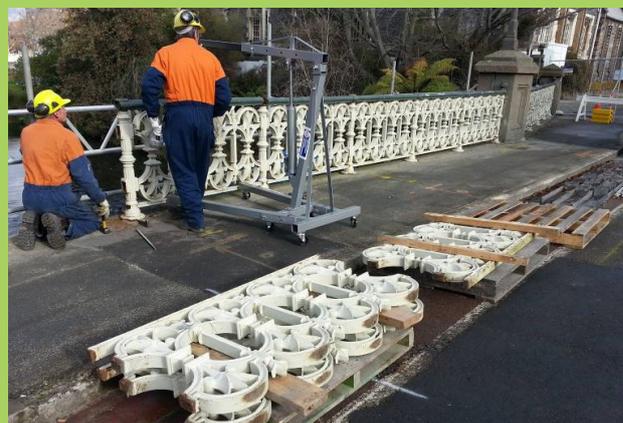
SCE dismantling the balustrade puzzle

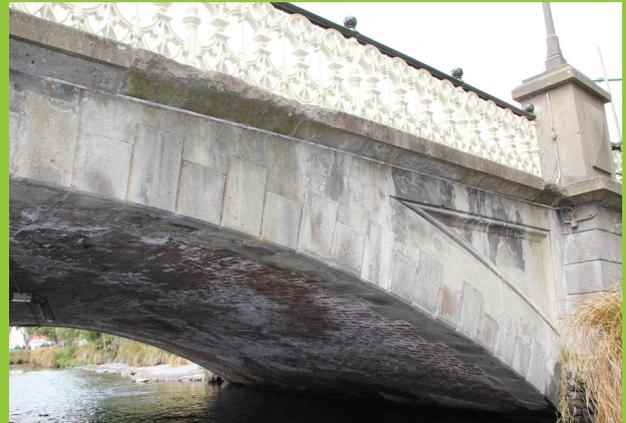
The completed brick work

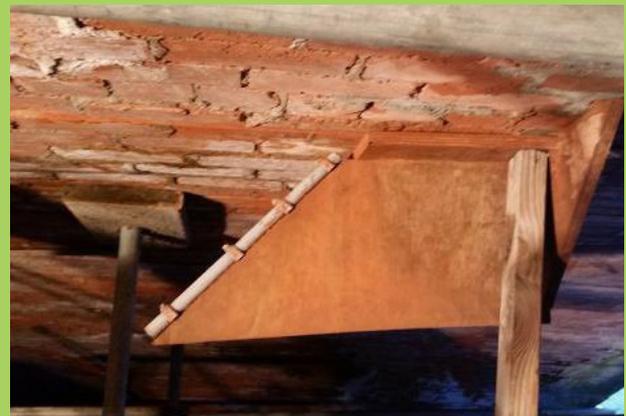
Drill guide in action

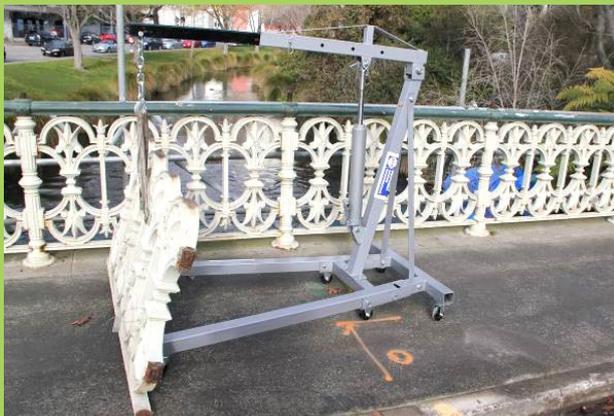
Modified engine hoist lifting a balustrade panel.

Another complex risk was around the repairs to the cast iron balustrade. As this would always be in the public eye we wanted to complete repairs so they were imperceptible. A common technique generally used was brazing and was favoured by the consultant initially. However, with the number of repairs required this would have been extremely costly for the client. SCE submitted another product for review which was a Eutectic system (metal powder spray), which was faster and more cost effective. SCE repaired a section using each method for heritage review and it was decided to use the Eutectic system. This innovation saved time and money for the client.
