Lessons learned from one of New Zealand's most challenging civil engineering projects: rebuilding the earthquake damaged pipes, roads, bridges and retaining walls in the city of Christchurch 2011 - 2016.

Asset Investigation Management Plan

A plan which outlines how SCIRT is to carry out condition investigations and analysis.

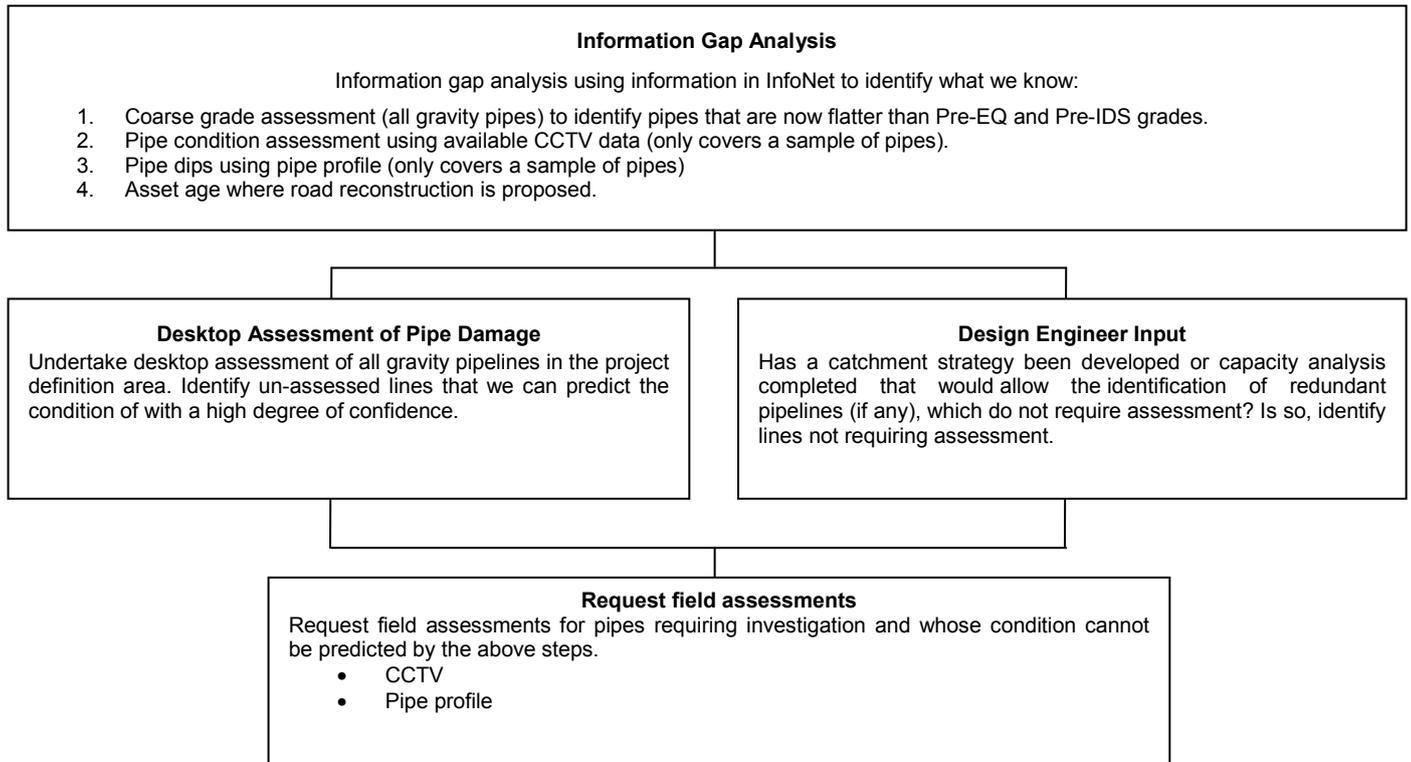
The sequence of gravity pipe assessment for each new Project Definition Area is as follows:

Stage 1 of the investigation is to analyse the invert level information collected (at the manhole) compared to earlier (pre-earthquake) invert levels (and cross referenced to ground level settlement from bench mark surveys and LiDAR data) may indicate whether settlement and/or manhole floatation has occurred. This desk top study may be sufficient of its self to determine whether the catchment or sub-catchment being considered, or parts thereof, has changed hydraulically and hence may not meet the original design criteria, and will indicate further investigation is required.

Stage 2, in those sections failing to meet the design criteria, is to investigate the gradient of the pipelines immediately adjacent to the manhole, specifically, by inspecting inside each manhole to determine pipe displacements relative to the manhole and pipe gradient at "say" 1 m intervals away from the manhole (out 5 m) using profile meter, level sonde or gradient measure. This investigation is expected to be able to be carried out while the pipes are in operation (flowing less than full).
