Lessons learned from one of New Zealand's most challenging civil engineering projects: rebuilding the earthquake damaged pipes, roads, bridges and retaining walls in the city of Christchurch 2011 - 2016.

## Christchurch Natural Disaster Response and Recovery presentation notes

**Story:** Asset Assessment

**Theme:** Programme Management

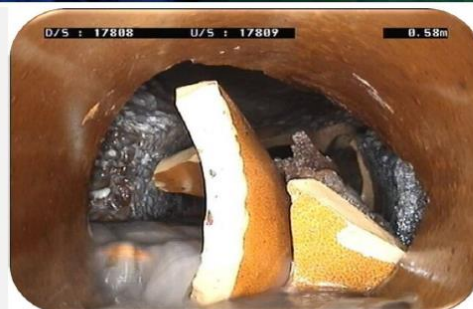
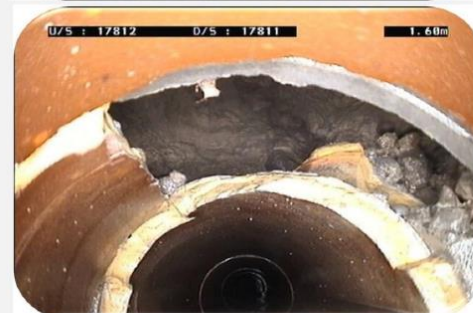
# Establishing Condition of the Asset

This is to demonstrate some of the logistical issues being faced during pipe assessment. The top left photo shows part of the 400,000 m<sup>3</sup> of liquefaction material removed from streets and pipes during the recovery period.

Delivery teams provided numerous innovations and initiatives to achieve a result if not always compliant with the specification. Here a camera is being floated down a pipe where it was not possible to reduce the flow.

Night work was always problematic along with associated TMP. This was an essential part of the programme to achieve productivity as well as undertake inspections during times of lower flow

The sheer volume of plant needed on site at times to support assessment and pipe cleaning provided significant logistical issues on its own.
