Lessons learned from one of New Zealand's most challenging civil engineering projects: rebuilding the earthquake damaged pipes, roads, bridges and retaining walls in the city of Christchurch 2011 - 2016.

Real asset in innovative damage assessment

A document which outlines SCIRT's post-earthquake asset assessment process.

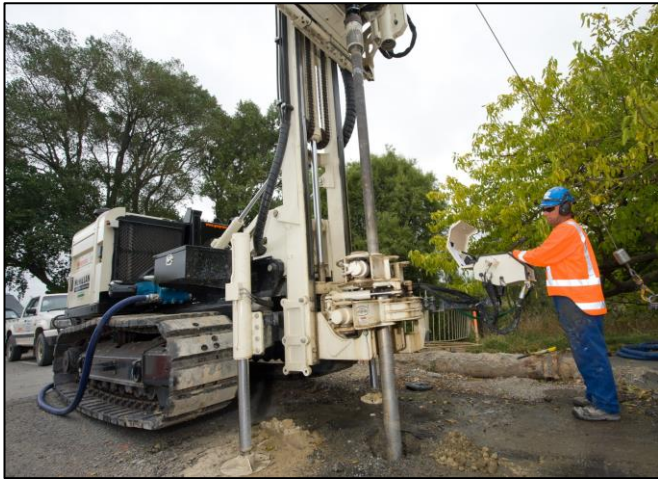
Sonic dig: A worker uses a sonic rig to cut boreholes to test ground conditions in Fitzgerald Avenue.

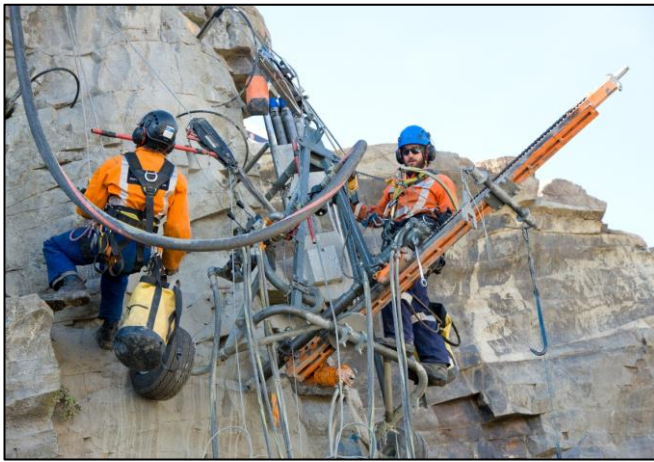
Heights of discovery: Workers carry out rock mapping and drilling in Rangitira Terrace.

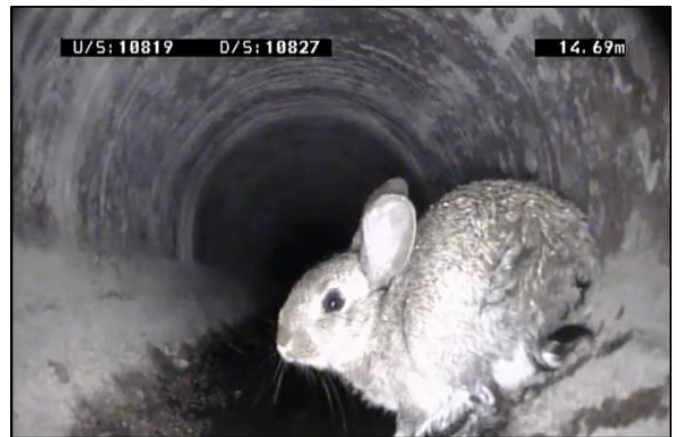
No burrowing required: SCIRT CCTV reveals an interloper in the storm water system.

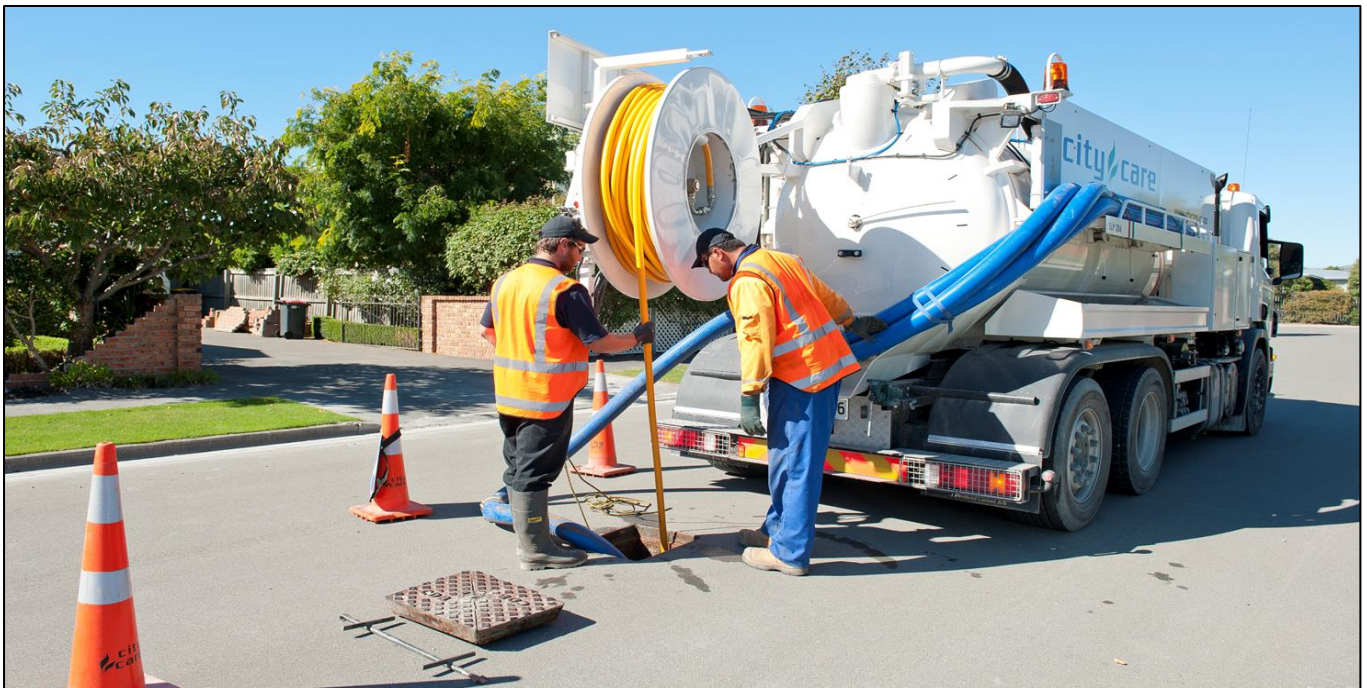
Time for a close-up: Work crews use CCTV to check for underground damage.

1. The cost of CCTV was very high post-earthquake.
2. The quality assurance of CCTV was important.
3. It was important to implement systems early to limit escalation.
4. Contractor performance should be monitored (especially with no-risk contracts).
5. Collect X, Y coordinates during CCTV inspection.
6. Choose a secure online solution for the storage and management of the footage.
7. Always consider the integration with a client management system.
