Lessons learned from one of New Zealand's most challenging civil engineering projects: rebuilding the earthquake damaged pipes, roads, bridges and retaining walls in the city of Christchurch 2011 - 2016.

Earthquake recovery versus routine maintenance of the waste water network in Christchurch

A paper published in the Journal of Structural Integrity and Maintenance, 2016, Vol. 1, No. 2, 88-93 which outlines the importance of asset registers and level of service in the wake of a disaster.

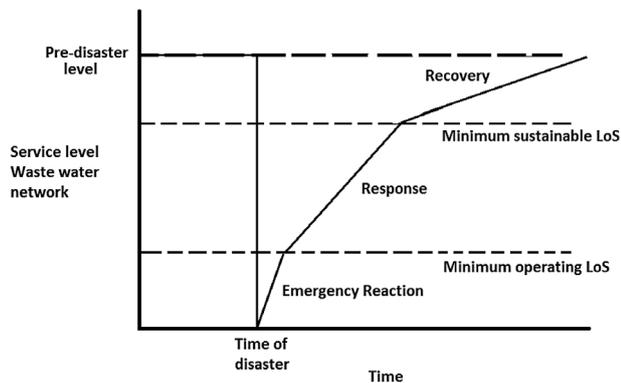
After disasters, the performance level of infrastructure can drop as low as zero during or straight after the event. The immediate emergency response is targeted at bringing the performance level of infrastructure back to a minimum performance capacity or minimum level of service (LoS). This is then followed by a more organized 'Response' period to bring the performance

Figure 1. Timeline showing the service level of a wastewater network after a disaster versus time (after Alexander, 2014).

levels up to a minimum sustainable level. It is during the longer 'Recovery' phase that the performance levels are restored to the same routine level as prior to the event (Alexander, 2014).

Horizontal infrastructure is inherently vulnerable to geological hazards. Due to its linear extent, it is at an increased risk of suffering damage in a natural disaster like an earthquake that comes with changes in geological formations (Free, Anderson, Milloy, & Milian, 2006). Besides the direct effects of the actual disaster, the loss of infrastructure can cause a significant impact on the physiological and economic well-being of communities. Reconstruction projects should therefore aim to reduce the vulnerability of societies through building back better infrastructure (Palliyaguru & Dilanthi, 2008). Moreover, a lack of resilience in infrastructure can lead to ongoing disruptions, poor recovery following a disaster and also increases the likelihood of permanent loss of the infrastructure (Hudson, Cormie, Tufton, & Inglis, 2012). According to the Centre for Resilience of Critical Infrastructure (University of Toronto, n.d.) 'resilience in infrastructure' is the ability of the operations to respond to and absorb the effects of shocks and stresses and recover as rapidly as possible. According to Alexander (2014), a natural disaster can be shown in the performance levels of infrastructure against time (Figure 1).

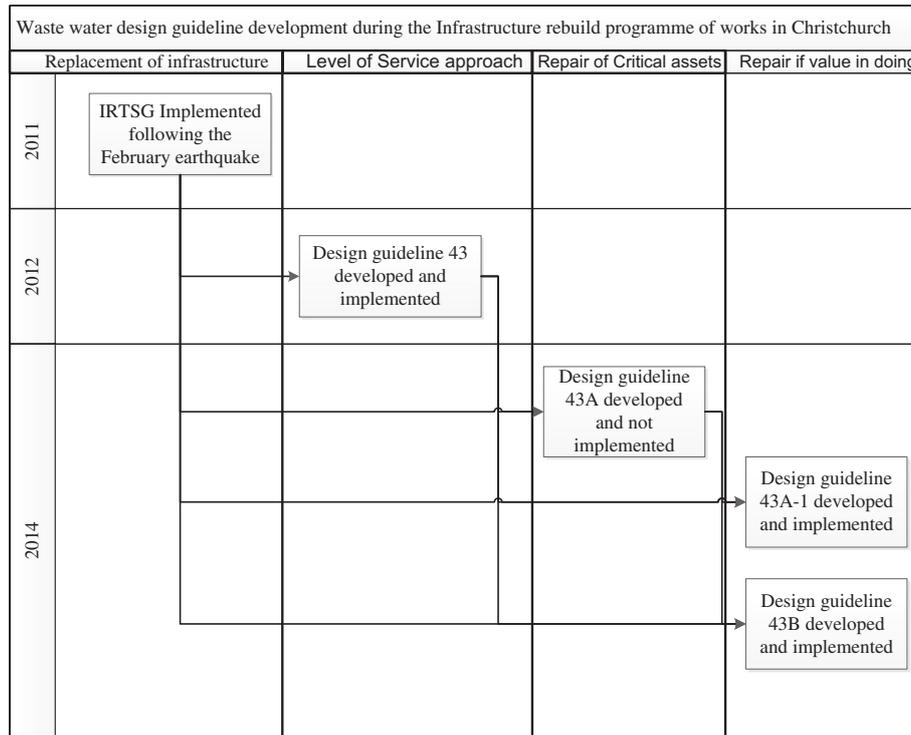
Figure 2. Development of wastewater design guidelines used during the Christchurch rebuild.

During the SCIRT rebuild programme, several wastewater design guidelines were developed, approved and implemented during various stages within the programme as outlined in Figure 2.
