Lessons learned from one of New Zealand's most challenging civil engineering projects: rebuilding the earthquake damaged pipes, roads, bridges and retaining walls in the city of Christchurch 2011 - 2016.

## Safety first – thanks to Bill Perry

A document which describes the purpose of the Bill Perry Safety Awards and outlines each winning submission.

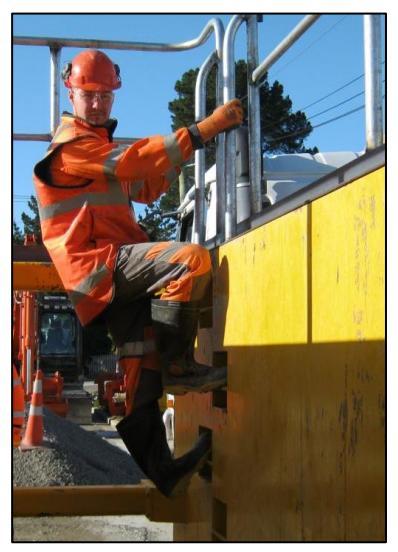
A second initiative used a safety railing for trench shields. This robust, clip-on device protected workers from falling into a trench, as well as having an extension to the internal ladder to make trenches easier to access. A hinged gate could be closed during work breaks to secure the trench.

Protective shield: A worker uses trench safety railings.

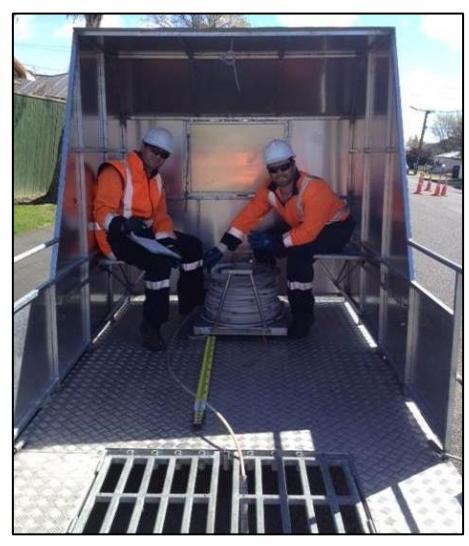
own trailer to house a pipe profilometer, eliminating the need to lift the pressure machine on and off the truck for each pipe assessment. The trailer covered the manhole, protecting technicians from traffic as well as providing protection from the weather. The team also designed an ingenious manhole hatch in the trailer's floor that eliminated the risk of slipping or falling down an open manhole. The handrails and non-slip floor surface were further safety features.

Trailblazers: An innovative pipe profilometer trailer boosts site safety.

Pipe profiling measured the ups and downs of underground pipes between manholes. A device was sent through the pipe. It sent depth readings back to the profilometer trailer to help determine the appropriate level of repair for each length of pipe.

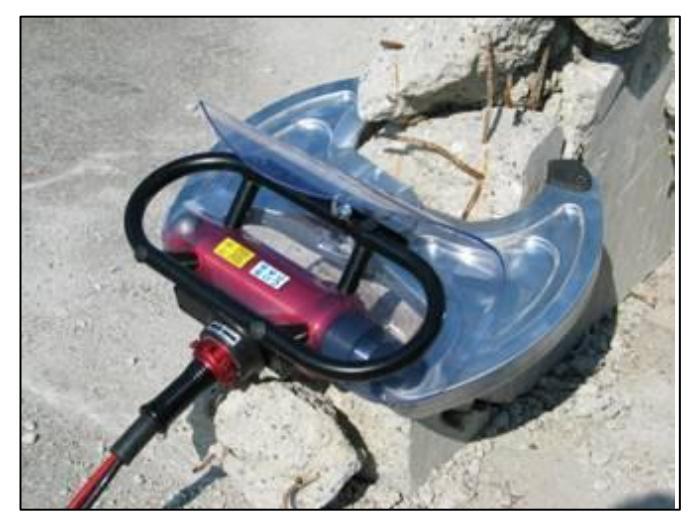
Downer also used a modified hand-held jaw crusher to remove concrete slabs from inside the columns. This method also reduced the need for crew to enter a confined space. Work in confined spaces could not always be avoided. The crew needed to access the base of the structure to remove some concrete from inside the columns. A rescue plan was trialled with the help of a dummy specially created for the job.

Concrete approach: A remotely operated hydraulic jaw crusher has proved invaluable for tight spaces.

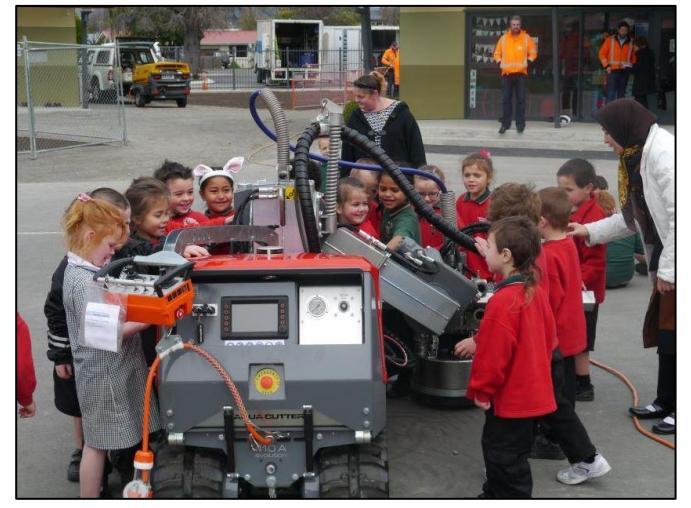
flow rate required to carry out the repairs combined with using a long handheld lance would pose a serious risk to an operator's safety. The solution was the purchase by CTNZ (Concrete Treatments NZ) of an automated robotic hydro excavation tool. "Geo" had the ability to be used remotely, replacing handheld lancing. The robot's compact nature allowed it to enter and repair the box culvert safely and efficiently.

Using "Geo" meant that crew members weren't placed in an unsafe position to deal with flying concrete debris in a restricted space. The robot was the only one available in the southern hemisphere.

Crowd pleaser: "Geo", an automated robotic hydro excavation tool, on show at a primary school.

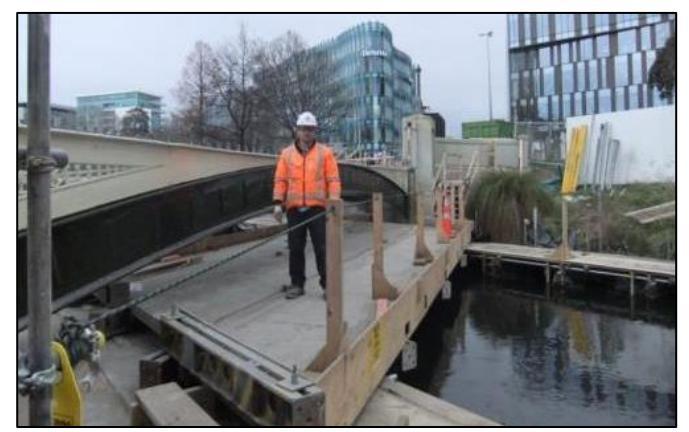
with four mobile work platforms running on rails placed on top of the remaining scaffolding. The mobile platforms did not require supporting legs into the river and so allowed the river to flow freely underneath.

The mobile platforms could span the river and move on the rails back and forward across the width of the bridge. They had built-in kickboards and safety rails around the edges and could be efficiently and safely removed in about 20 minutes if there was a flood risk.

Bridging a need: A mobile work platform in operation at the Gloucester Street Bridge.

The mobile platforms were designed to collect any environmental contamination and prevent it from entering the river.
