Manchester Street Water Mains, Christchurch: Report on Archaeological Monitoring

A report which details the archaeological investigations carried out during the course of SCIRT project 11185, water main renewal work on Manchester Street.

MANCHESTER STREET WATER MAINS, CHRISTCHURCH: REPORT ON ARCHAEOLOGICAL MONITORING

SCIRT 11185

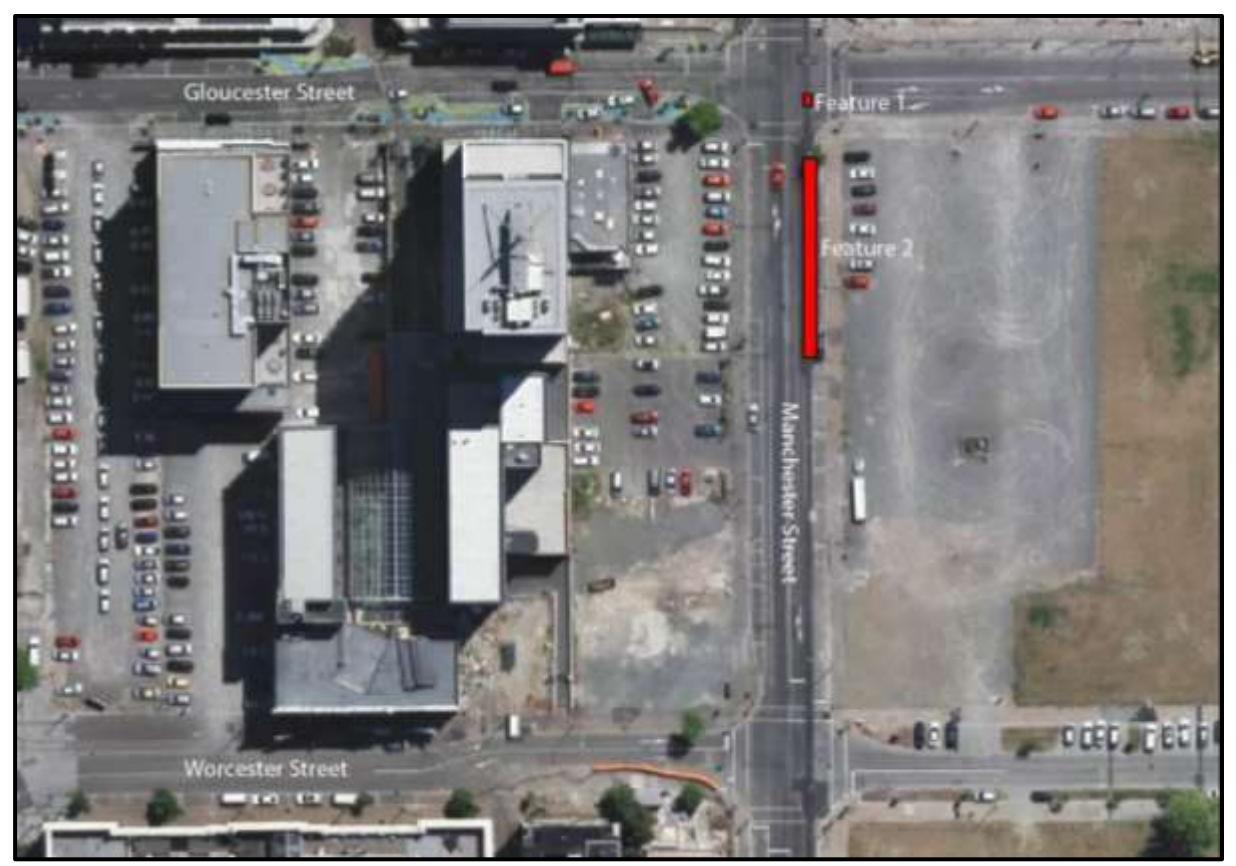
Figure 2. 2016 aerial imagery of the Manchester/Gloucester Street intersection and environs, showing the location of the two archaeological features uncovered during July 2015 excavations for the new Manchester Street water mains pipe. Image: Canterbury Maps.

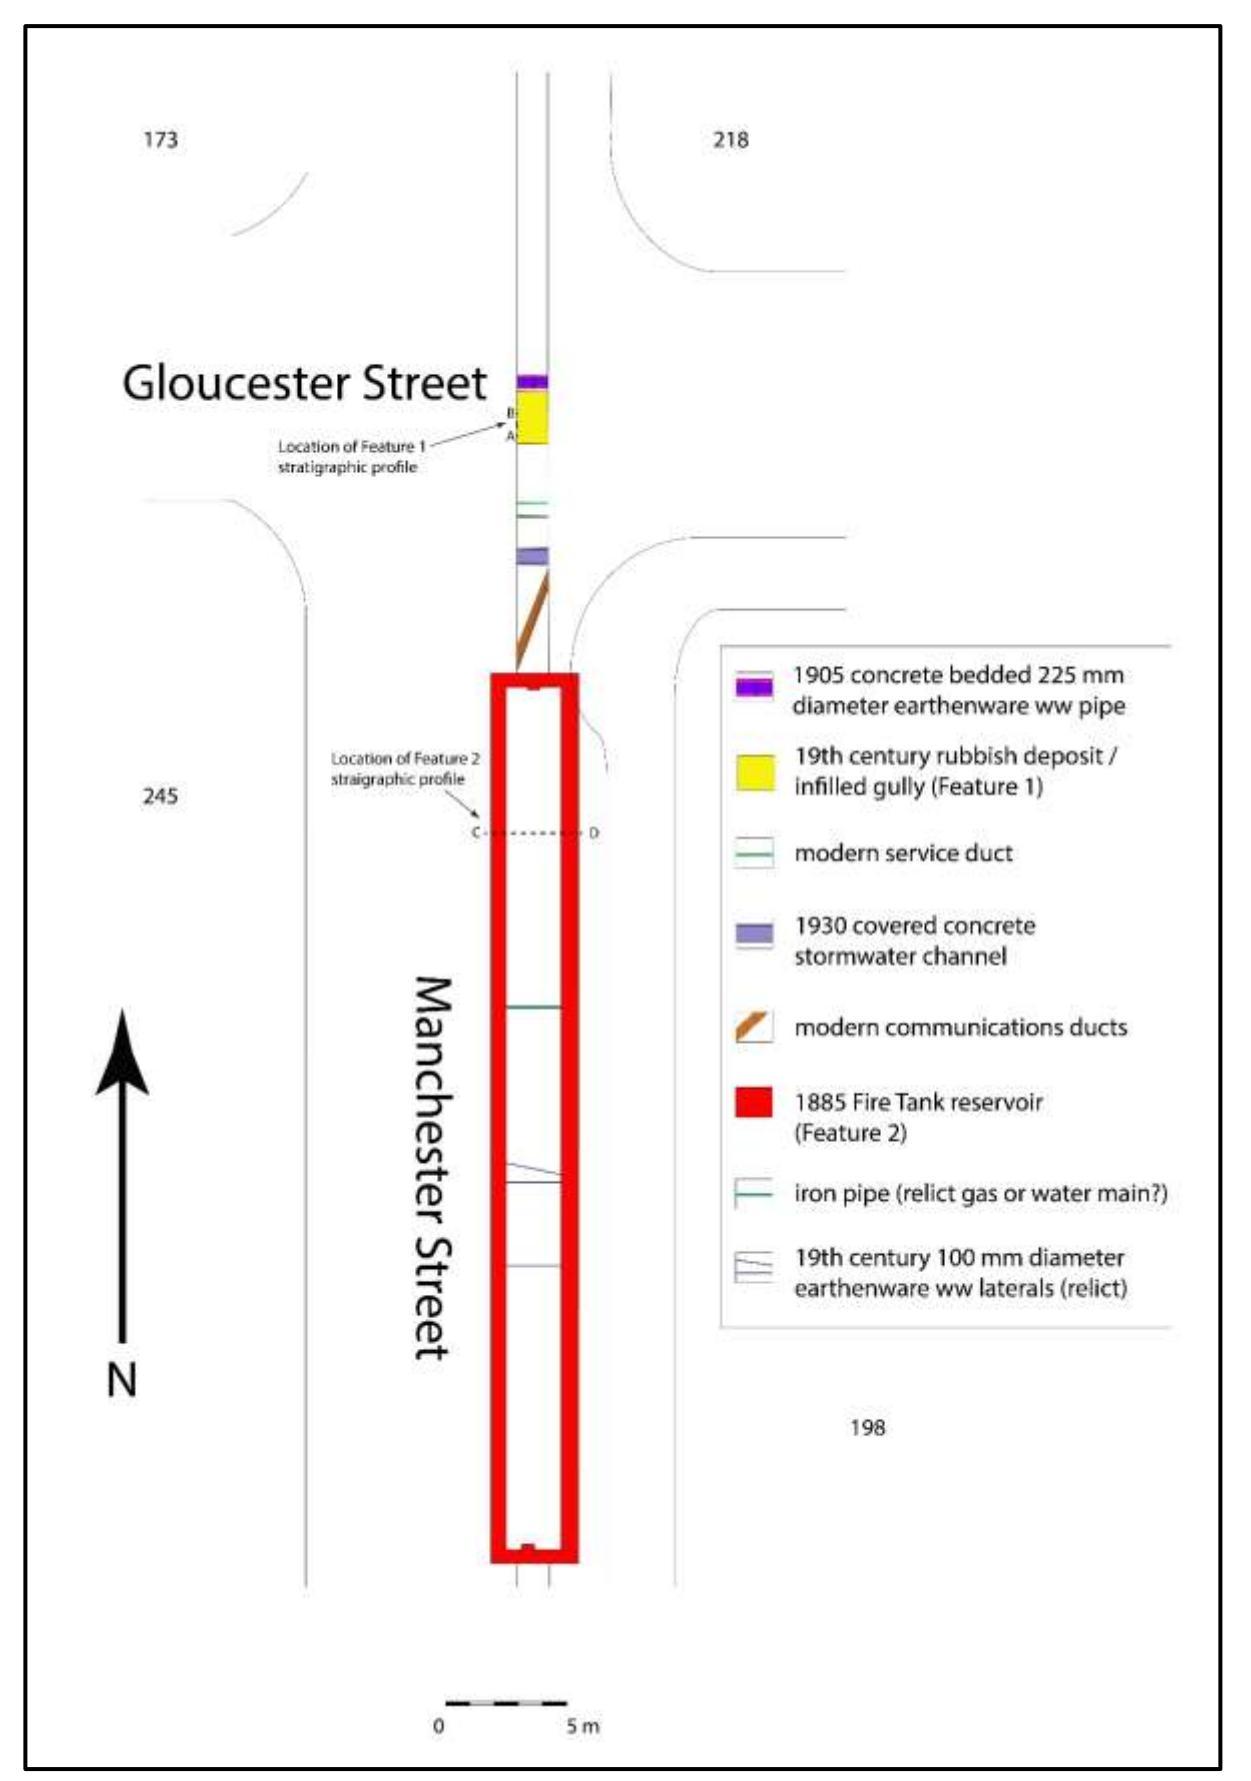
Figure 3. Plan showing the location of the two features uncovered on Manchester Street, and the locations of the stratigraphic profile drawings.

Excavations for the installation of approximately 600 m of 300 mm diameter water mains pipe on Manchester Street (between Armagh Street in the north and Lichfield Street in the south) took place from July to October 2015, with Trenching Dynamix as the main earthworks and pipe installation subcontractor. Located along the eastern side of the Manchester Street roadway, this trench was approximately 1.2 m wide and excavated to 1.5 m depth. Two features were uncovered during the course of this work: Feature 1, a 19th century rubbish deposit in an infilled river channel/gully; and Feature 2, an 1885 fire tank reservoir. Both of these features were located close to the Manchester/Gloucester Street intersection, and both were investigated by Hamish Williams from Underground Overground Archaeology from 27 July to 3 August 2015 (Figure 3).
