Lessons learned from one of New Zealand's most challenging civil engineering projects: rebuilding the earthquake damaged pipes, roads, bridges and retaining walls in the city of Christchurch 2011 - 2016.

# Triumphal Arch and Bridge of Remembrance communication updates

A series of communication updates provided by SCIRT's Downer Delivery Team to the Christchurch City Council. These updates detailed the progress of the Arch and Bridge restoration.

# Triumphal Arch and Bridge of Remembrance June Update

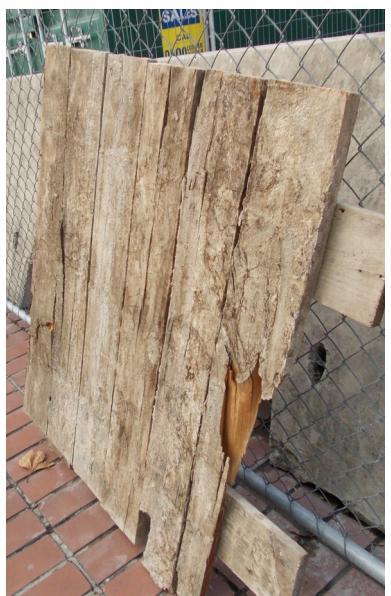
The team on-site has been busy removing the timber formwork inside the arch which will be replaced with steel casing. We are now 90% of the way through this removal.

Image one: original wooden form

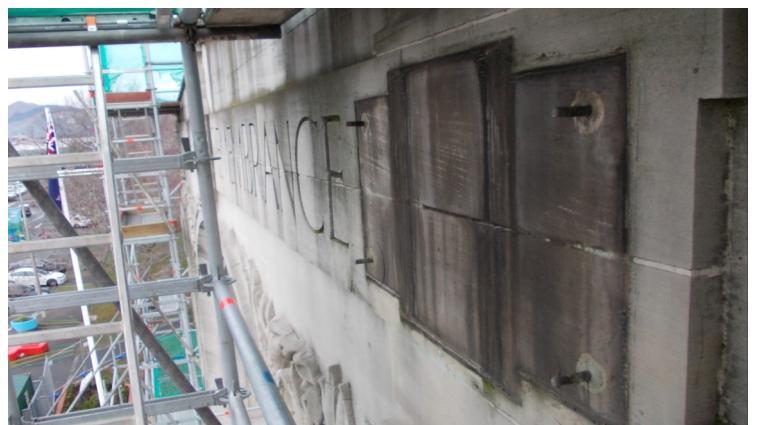
The bronze plaques on the arch have been removed and taken away for historic preservation

Image two: where the plaques were removed

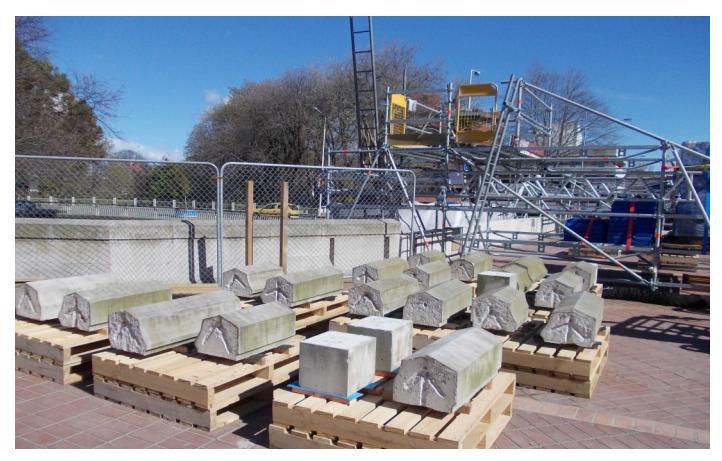
Capping stone removed from the north parapet

Capping stones have been removed off the parapets to access lower stones that need to be realigned. There are a small

- Work continues on replacing stone that has been removed.
- To strengthen the parapets 1.2m stainless steel pins are to be drilled and installed through several layers of stone. The caps will then be put back in place.
- Damaged stone around the Northwest abutment will be removed.

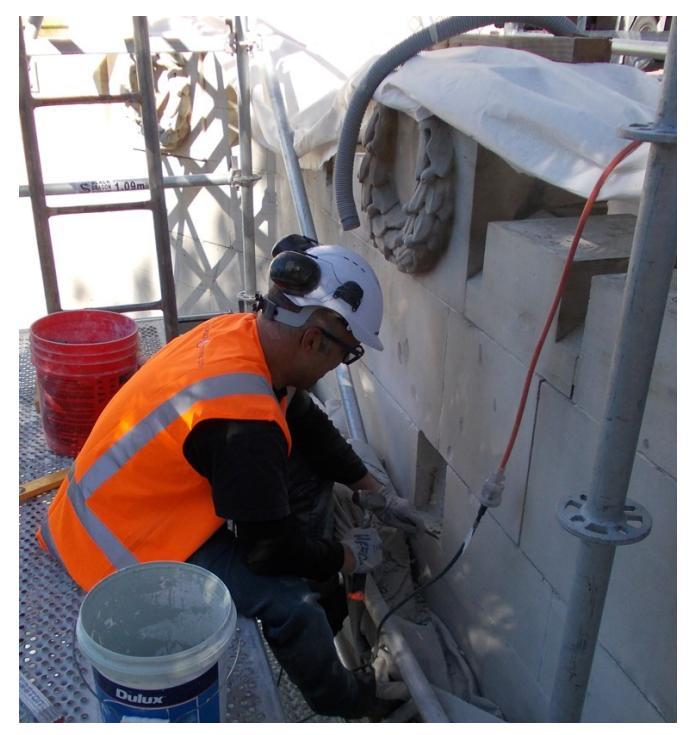
A stonemason imploding a damaged stone.

number of stones situated at the base of the parapets that are damaged. These are surrounded by many undamaged stones. The stone masons are carefully removing the damaged stone using a method called imploding. Imploding is where the stone is collapsed inwardly enabling the undamaged stone to remain intact.

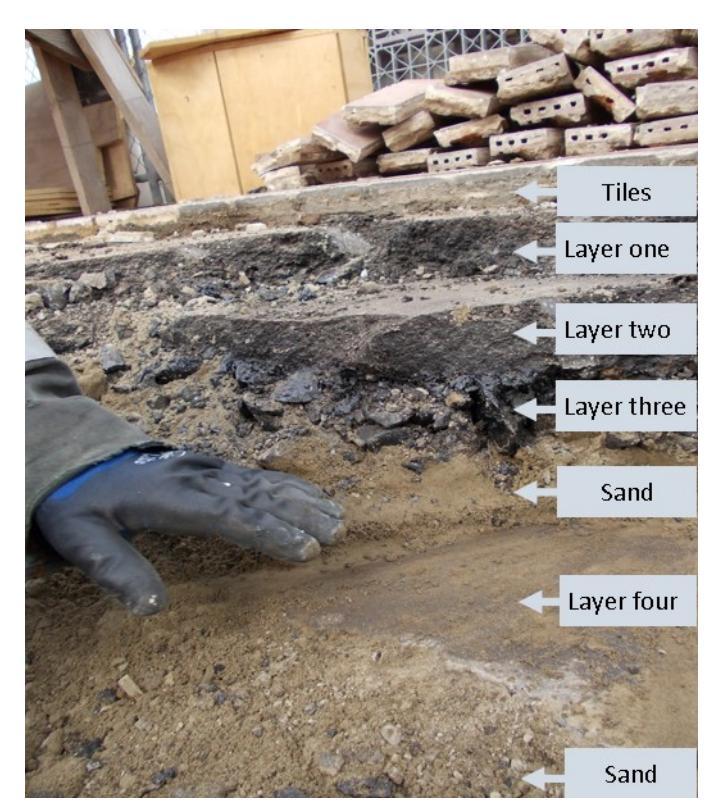
The scaffolding that was in place for the initial investigation works has been deconstructed. The tiles and coal tar around the base of the arch is now being removed in preparation for piling and foundation work.

Layers of coal tar and sand under the tiles

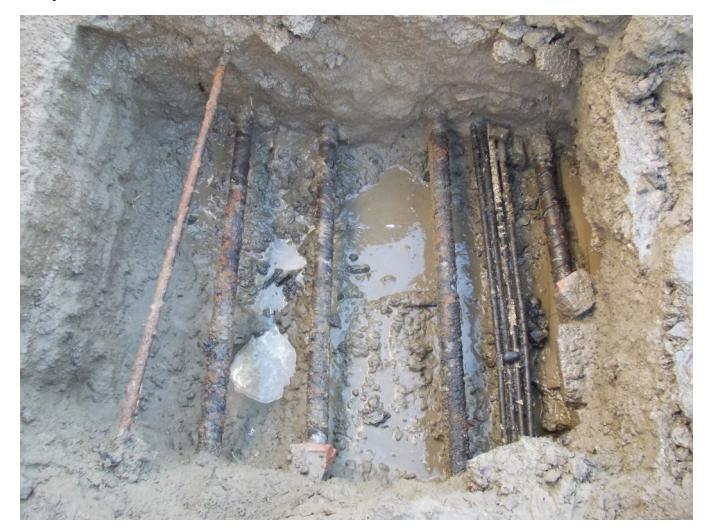
Four high voltage cables alongside other services in the excavation hole

Pile testing was deferred until Orion's four high voltage power cables were relocated away from where the new piles are to be inserted. These cables have now been re-laid further away from the Triumphal Arch foundations towards the east entrance of the Bridge.

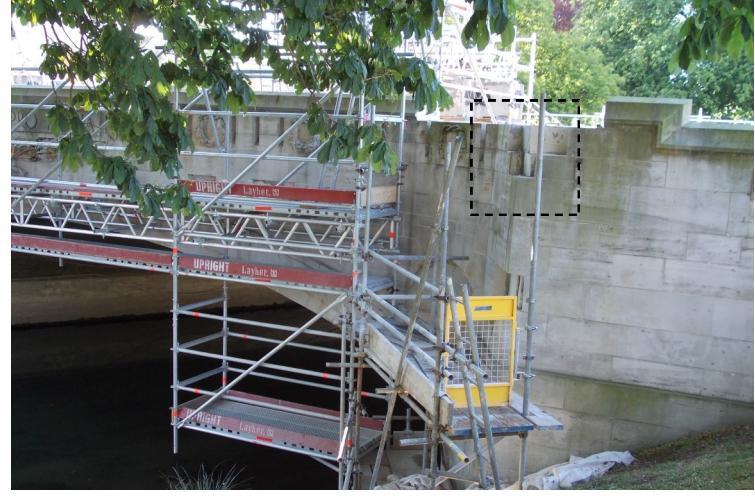
- On the south parapet all the stainless steel pins have been installed. Now this is completed the capping stones can be replaced.
- All the capping stones on the north parapet have been replaced.
- There is a large crack on the northwest abutment of the Bridge that can be seen from Remembrance Park. Half of the stone around this crack has been removed. Once all the stone has been removed we will investigate the extent of damage to the concrete interior of the abutment. Cracks found in the concrete will then be repaired. Stone that is in good condition and stone that is repairable will then be re-laid.

Northwest abutment

The stone around the crack on the northwest abutment has been completely removed. The cracks in the concrete that sit behind the stone can now be repaired by the crack injection method. Work on the large crack on the southwest abutment is due to start in the New year.

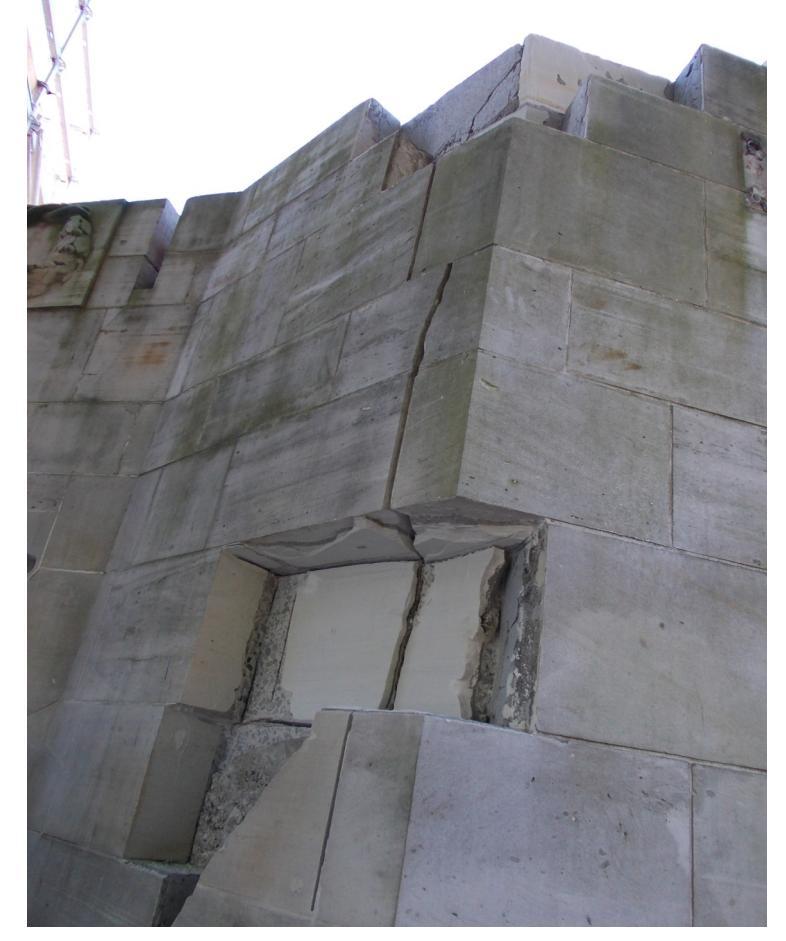
Close up view of crack

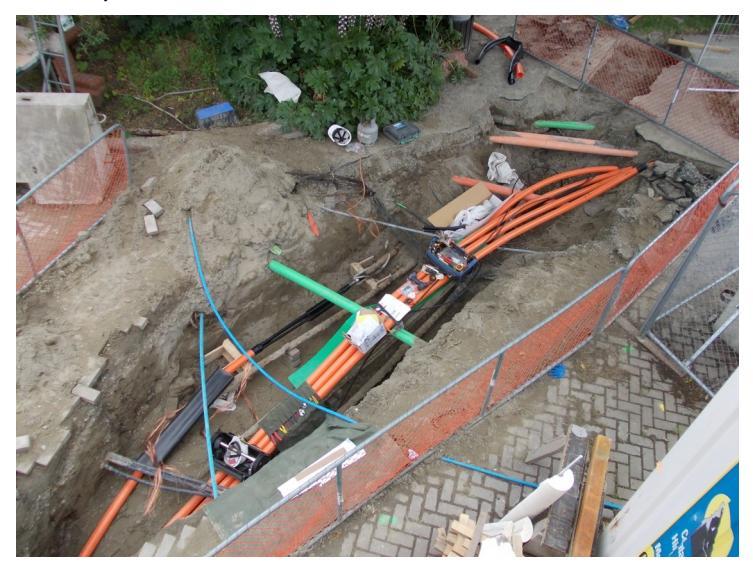
Jointing the four high voltage cables

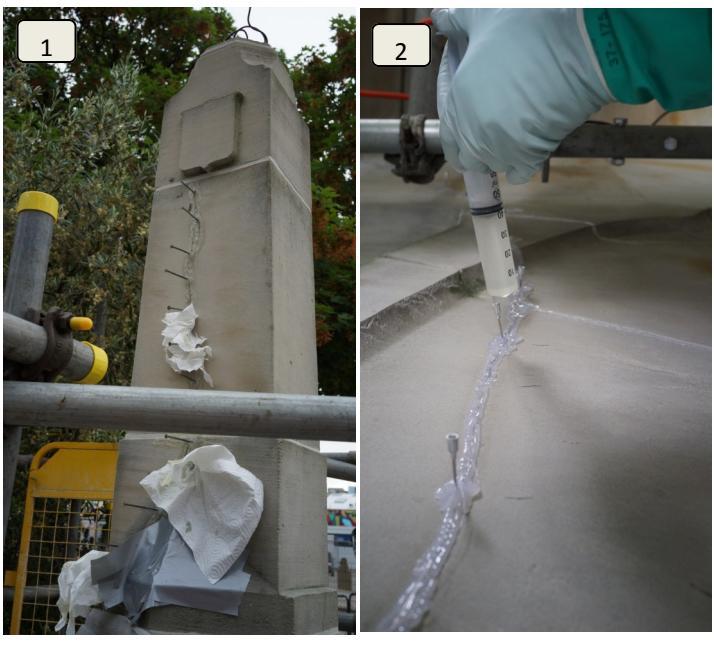
1—The crack in the lighting column after being injected.2- A close up view of the crack injection method.

The stone on the northeast lighting column has been repaired using crack injection. It was planned to deconstruct this stone but when investigated the damage was found to be less severe.

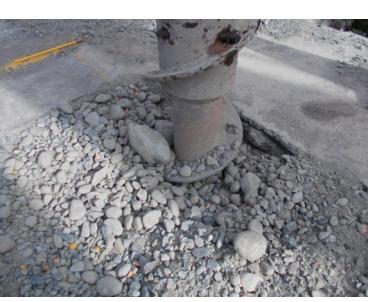
- The screw pile is the best type of pile to install.
- The ground conditions are suitable for the piles to penetrate through the various layers.
- The pile is load tested to ensure the designed behaviour is achieved and will therefore support the arch.

Ground conditions encountered at test pile location.

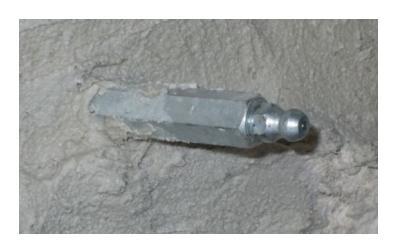
Grease nipple sealed into the concrete crack. The grout is injected through this nipple.

Work is progressing on the west abutment. The stone has been removed to expose cracks in the concrete. The cracks have been cleaned out and sealed in preparation for being injected with grout. Α number of grease nipples are inserted into the concrete inject the to grout specifically into the crack cavities.

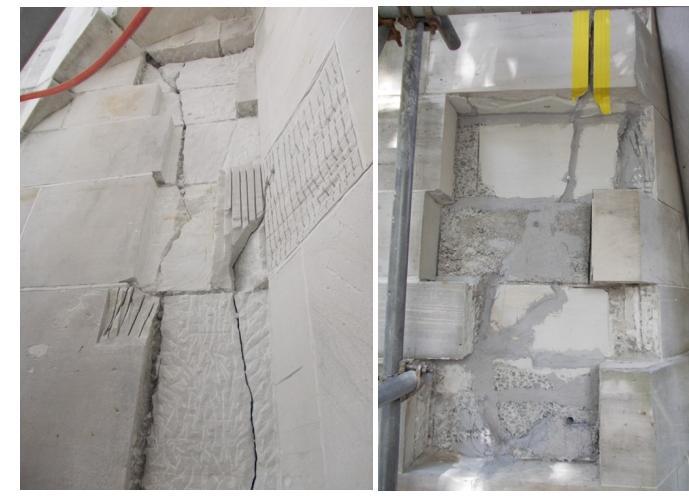
Crack is exposed in the concrete layer below the stone.

Crack is sealed in preparation for grout injection.

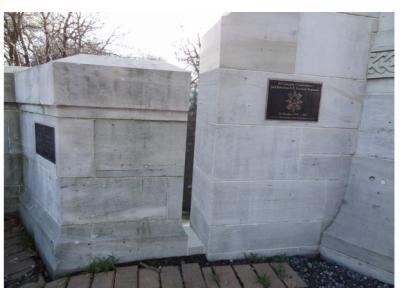
The work on the Bridge almost completed is except for the northeast wing wall. One of the design strategies to prevent damage and cracking in the event of a seismic event is to cut stone creating the а space between the

Example of the cut between the bridge balustrade and the arch.

bridge balustrade and the arch column. The northeast wing wall will be repaired at the same time as this piece of work.

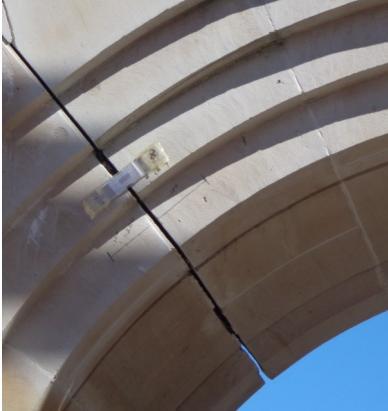
has set limits specific <sup>A crack monitor on the minor arch</sup> to work on heritage

Tell tails have been placed on all visible cracks. These are to monitor any changes in the cracks due to the ongoing work.

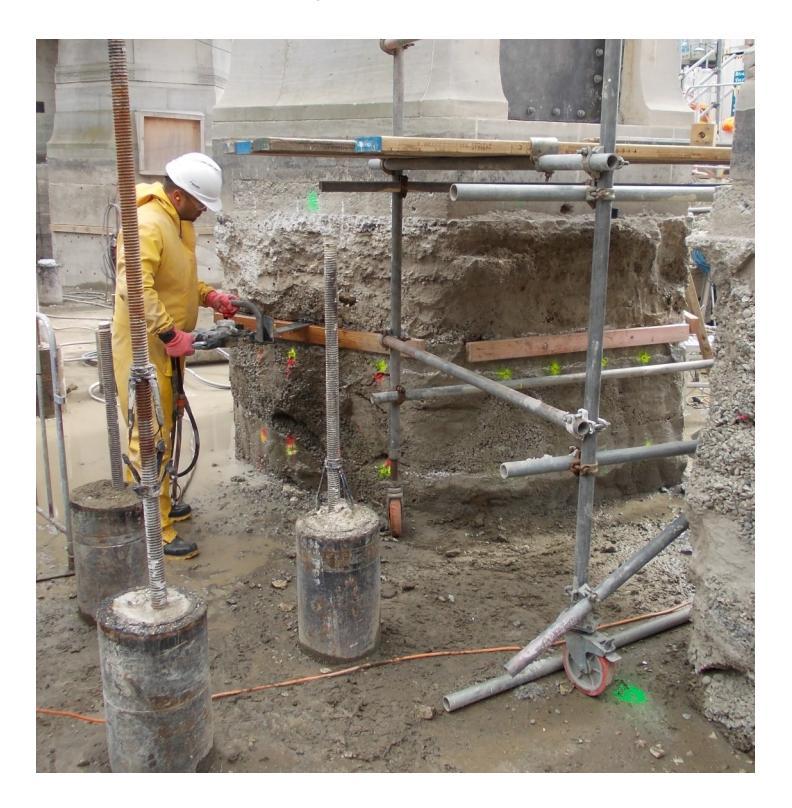
There has been good progress with the work on the Triumphal Arch. We have installed all 32 piles to a depth of 25 meters. These foundation piles have been cut down to their final height.

Saw cutting the debonding cut into the major column. In front are three installed piles cut to their final height

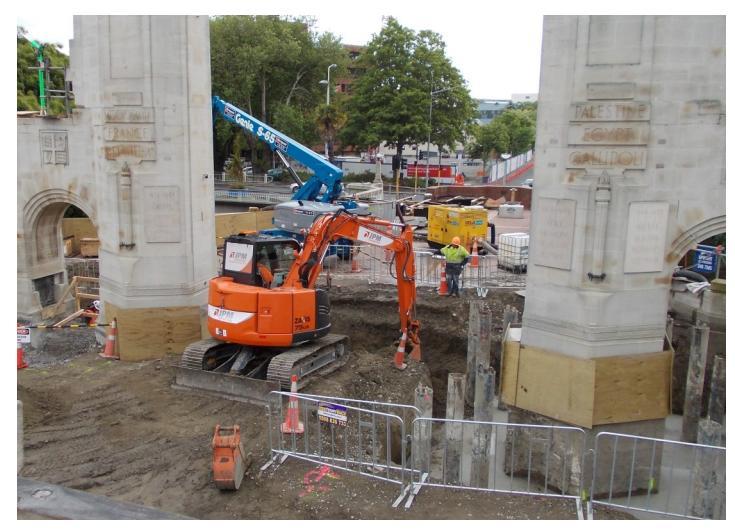
The area around the base of each column has been excavated to a depth of two meters. Over 200 cubic meters of material has been taken out of this area. A concrete floor was then laid to create a work area. This excavation has created the space to continue the work on the foundations.

Excavating around the base of the Arch

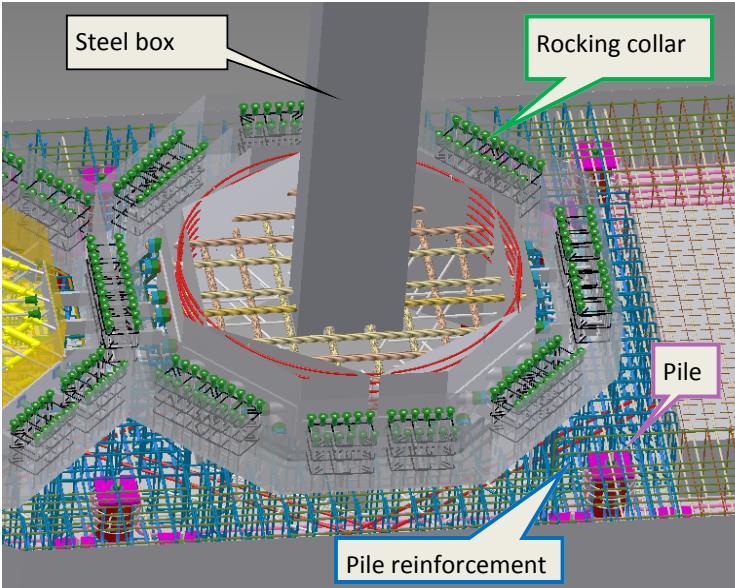
- Cutting around the circumference of each column with a 300mm cut to create the rocking collar. This will "debond" each column and enable it to rock if there is a seismic event. This has been completed on the two major columns.
- Access hatches have been cut in each column. This enables a construction worker to be on the floor inside the column. The floor is being lowered to assist with the rocking collar system.

3D modelling of the pile cap and rocking collar

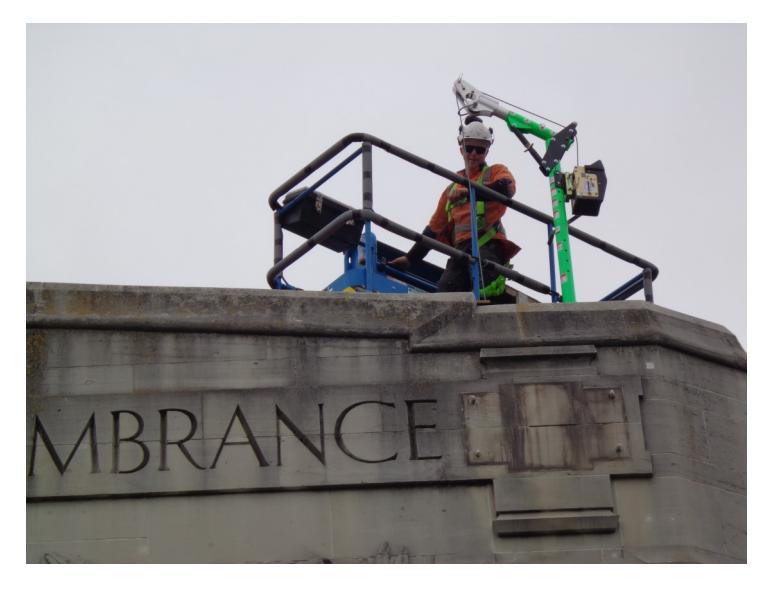
- When one of the crew is inside a column he wears a safety harness attached to a winch that sits on top of the arch. This is a safety system designed to lift the person out in the event that he cannot access the hatch.
- A test plate has been trialled inside a column. The placement of this plate is critical as it will line up the steel box when it is inserted.

Above - Manning the winch at the top of the arch while one of the crew are inside the column Below - the test plate inside a column

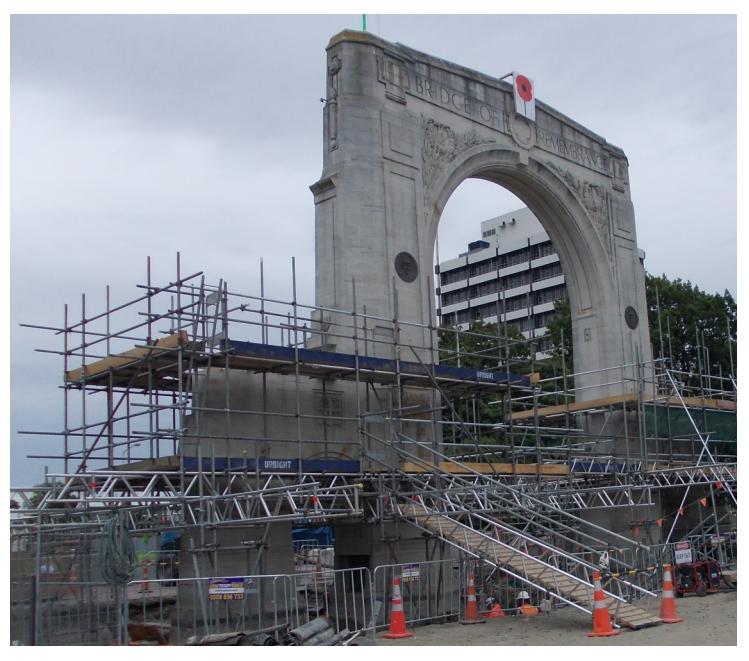
Scaffold has been set up which allows work to be done at three levels simultaneously. While crew are working at height, a stone mason is removing stone at ground level and work is continuing in the excavated space below ground.

Scaffold erected around the Triumphal Arch

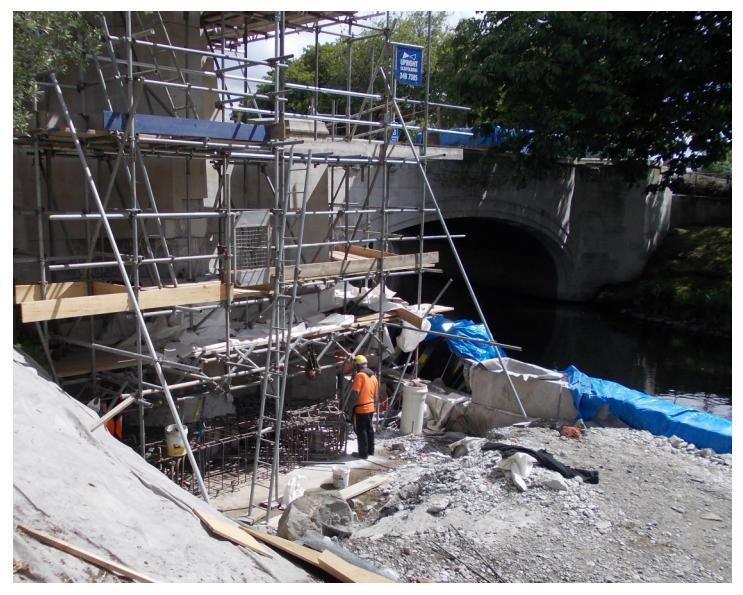
To work on the north column the area around the base has had to become dry. A dewatering set up has been in place that pumps the water away from the column base into a sediment tank on the Bridge. The water is then discharged onto the south riverbank. It is filtered through bidim cloth, which removes any further sediment and softens the flow of the water when it re-enters the river.

The dewatered site on the north side of the Arch

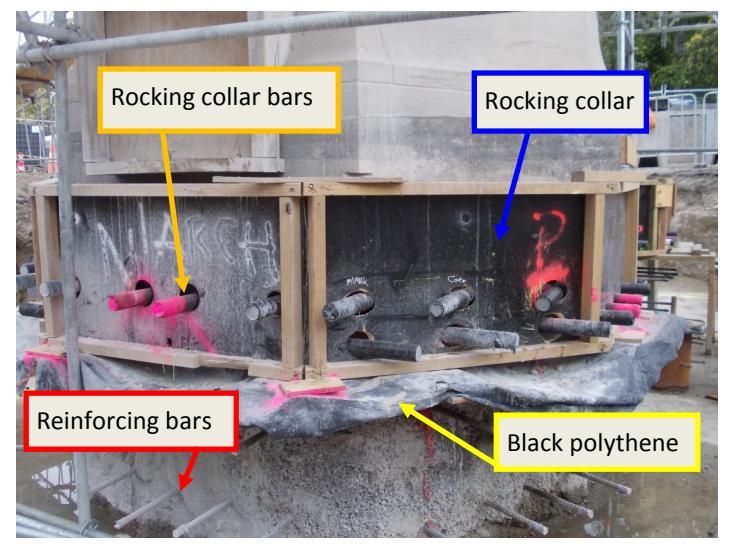
Above - installing the rocking collar Below—epoxying the rocking collar bars into the drilled cores

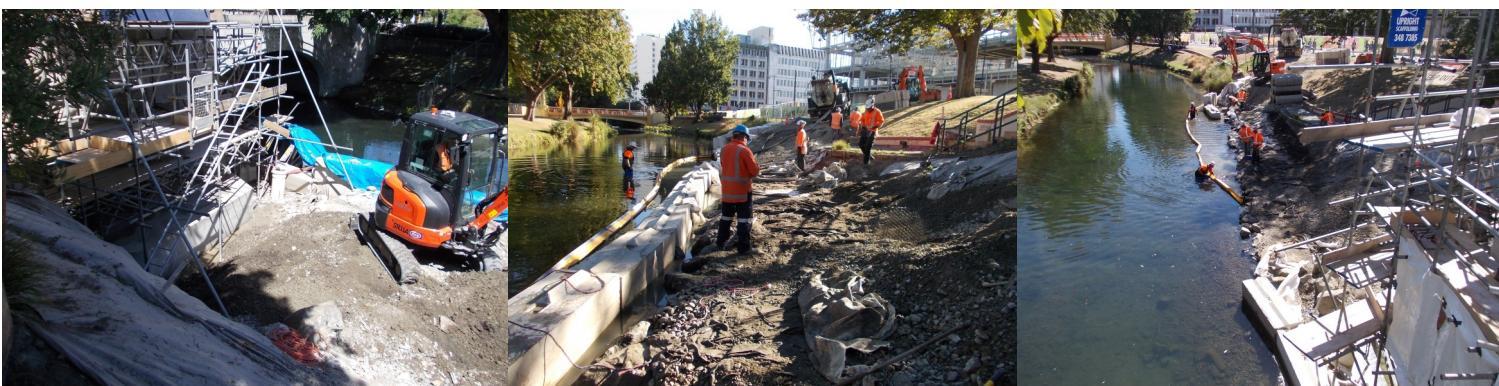
On the north side of the arch the column extends down beside the river. The temporary piling platform that was installed to build the low level pile cap around this column has now been removed. This work placed us close to the river bank. We installed systems to keep sediment out of the river and protect the river bank. Managing environmental impacts is a high priority for all SCIRT work.

Work on the north pile cap beside the Avon river. The yellow silt boom and the concrete blocks protect the river from silt run off

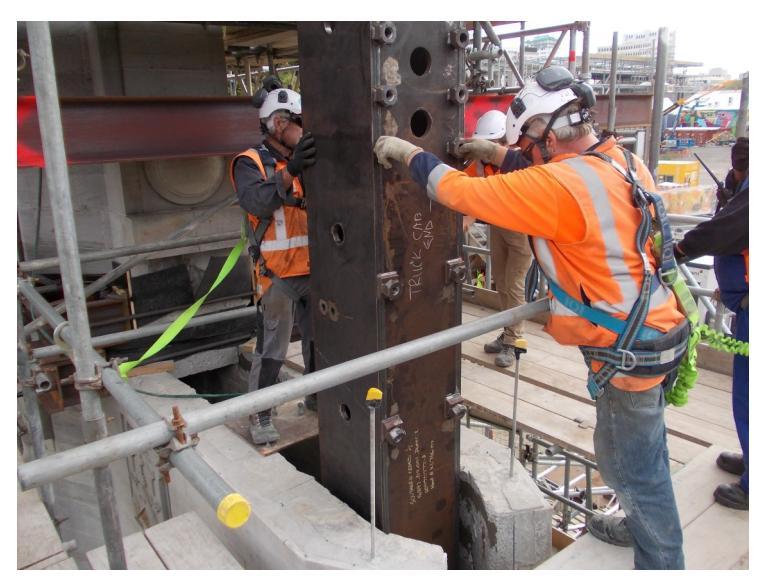
The major columns are different and will have two steel channels lifted in first. Then the steel box will be inserted. These will all be located on the steel plate at the bottom of the column. This work is to be done in the next month.

Lowering the first steel box inside the south minor arch

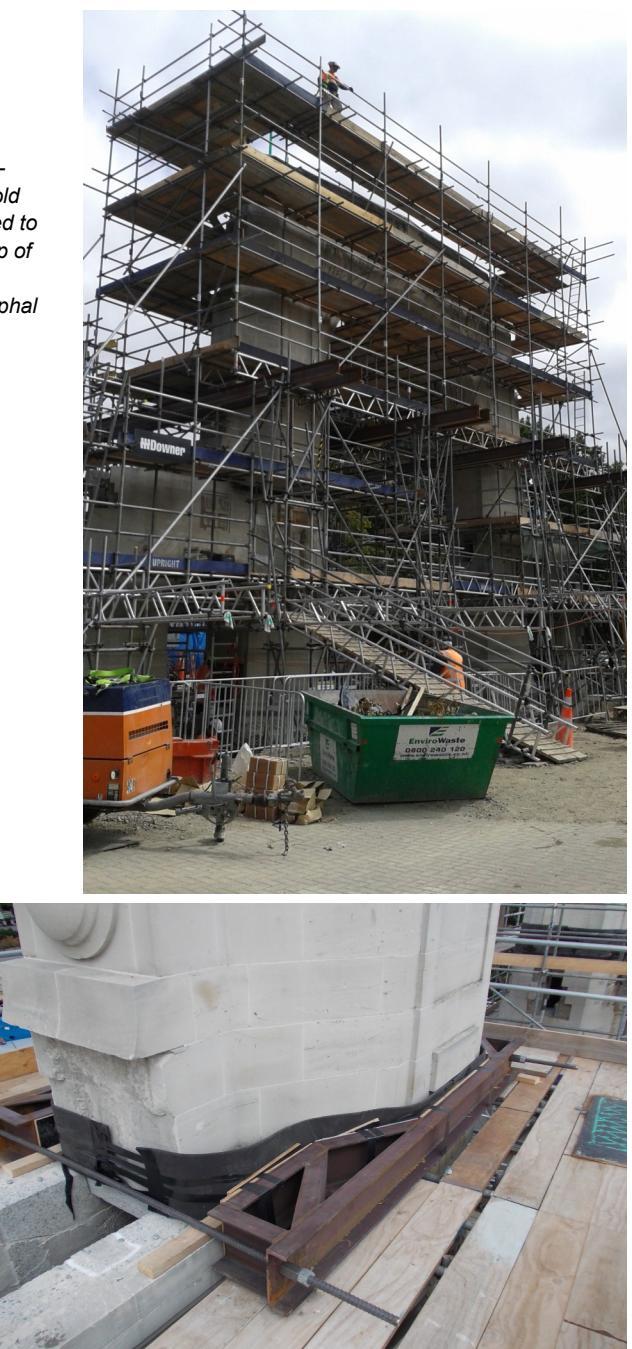
Two steel clamps have been installed around the major columns. These are situated above the minor arch level and will reinforce the stone where additional cracking has been found in the concrete layer behind the stone. These clamps will also give additional temporary strengthening to the columns while other work is being carried out inside the major columns. These clamps have been designed to spread the load and protect the arch.

A steel clamp fitted around the major column

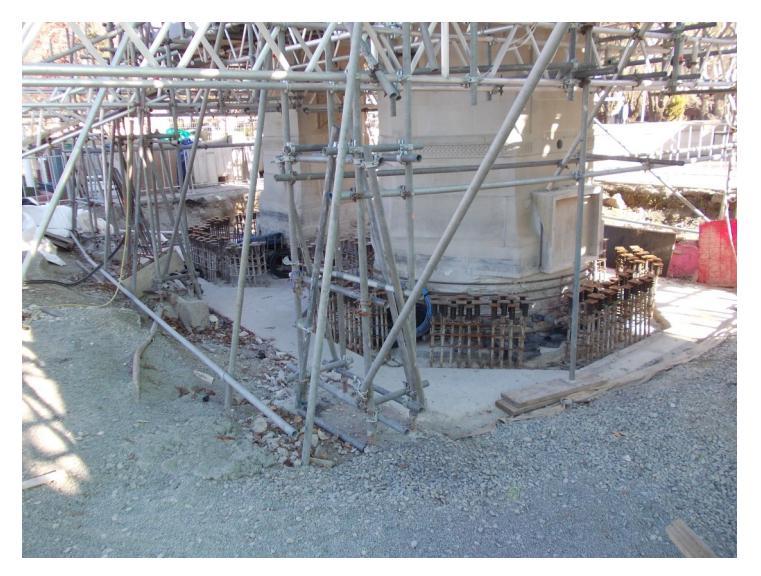
The foundations, the structural steel work and most of the post tensioning systems are completed. When the hexagonal concrete reinforced perimeter walls that surround the exterior of the rocking collars are completed we will fill in the last metre to level the ground around the base of the Arch. The perimeter walls will complete the rocking collar design ensuring all four columns rock in the same plane in the event of seismic movement.

Reinforced steel surrounds the rocking collars to build the perimeter walls.

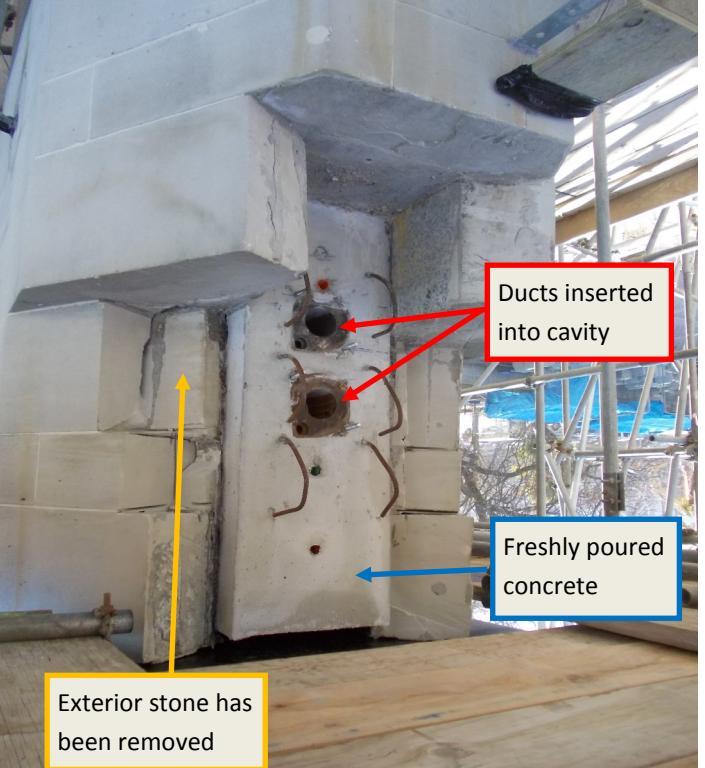
We have completed installing the post tensioning system in both minor arches. Post tensioning is a system of inserting and anchoring 12.5mm steel strands across the top section of each arch. These strands will hold each arch in place after the sliding joint cuts are completed, like a rubber band. The post tensioning strands replace the structural tension that is lost when the sliding joint cuts are done.

the cavity and around the ducts. Finally five post tensioning strands are inserted into each duct. They are anchored at each end and then pulled, tensioned, at a specified force through one anchor.

Exterior stone has been removed to allow access to the internal cavity. The ducts have been positioned for the post tensioning strands to be inserted. Freshly poured concrete now fills the cavity.

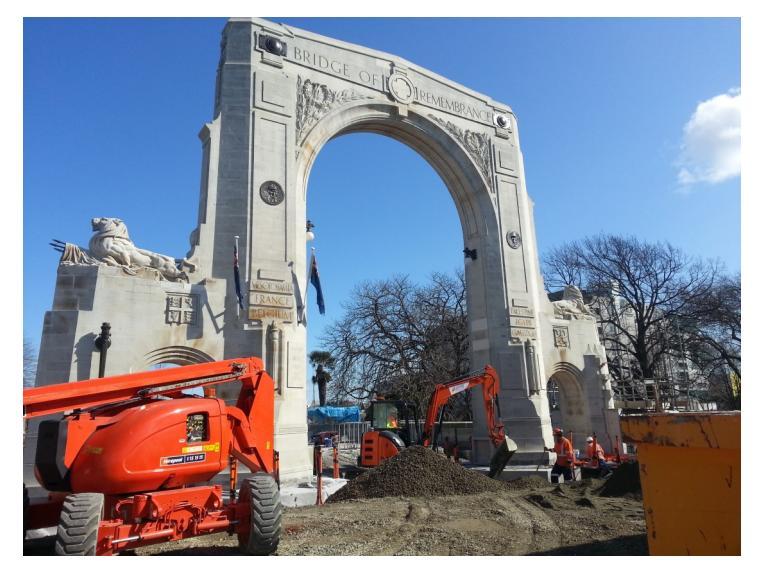
The scaffolding has been taken down in two stages. Initially it was reduced to the minor arch level to give better access for work in this area. Now the scaffold has been completely removed revealing the completed arch.

The Triumphal Arch standing proud with scaffold removed. Final earthworks are being completed at the base.

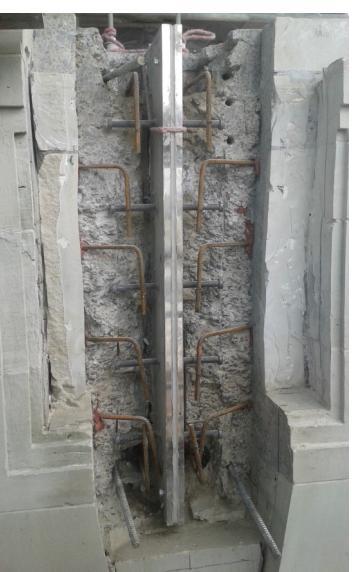
Right - One of the sliding joints installed in the arch. The two steel plates are surrounded by concrete. The stone is then replaced to complete the installation.

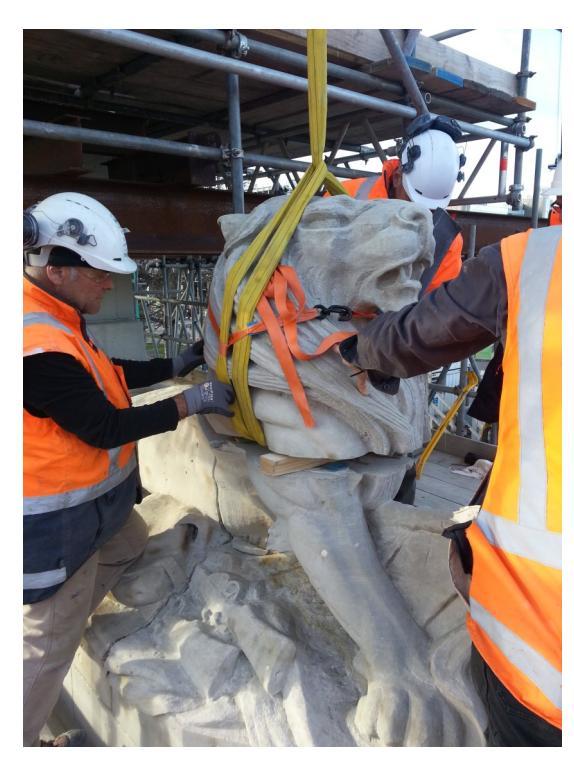
The lions were originally carved in six pieces. Some of the earthquake included damage cracking along these joins as well as spalling or chipping of the stone. The tail ends. that are attached to the main arch structure, shattered.

The south lion ready for repairs. The rear end is missing waiting for a new piece to be carved.

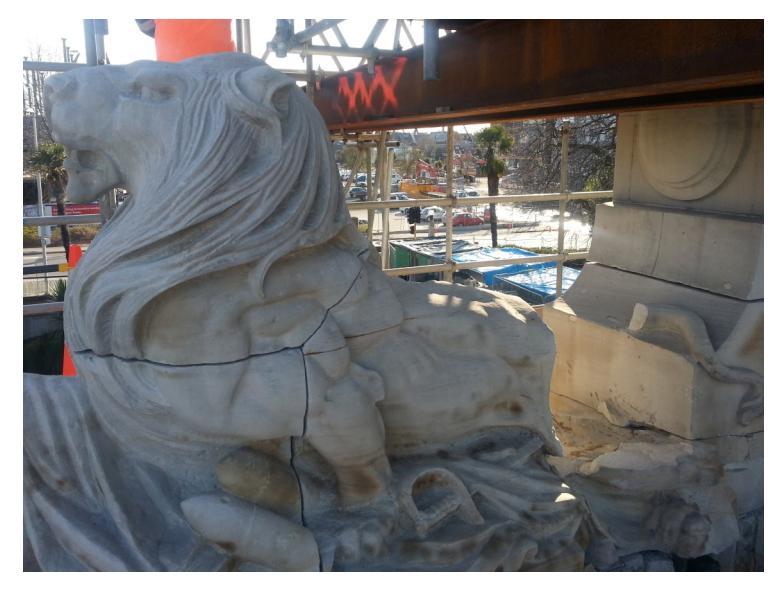
The return of the lions was a slow process as each piece was carefully put in place to ensure they were not damaged.

The completed northern lion proudly sitting on the arch.
