Lessons learned from one of New Zealand's most challenging civil engineering projects: rebuilding the earthquake damaged pipes, roads, bridges and retaining walls in the city of Christchurch 2011 - 2016.

Examples of SCIRT Safety Alerts – Critical Risk 1 – Service Strikes

SCIRT CRITICAL RISK 1: "Working around Live Services"

Working around fragile pipes

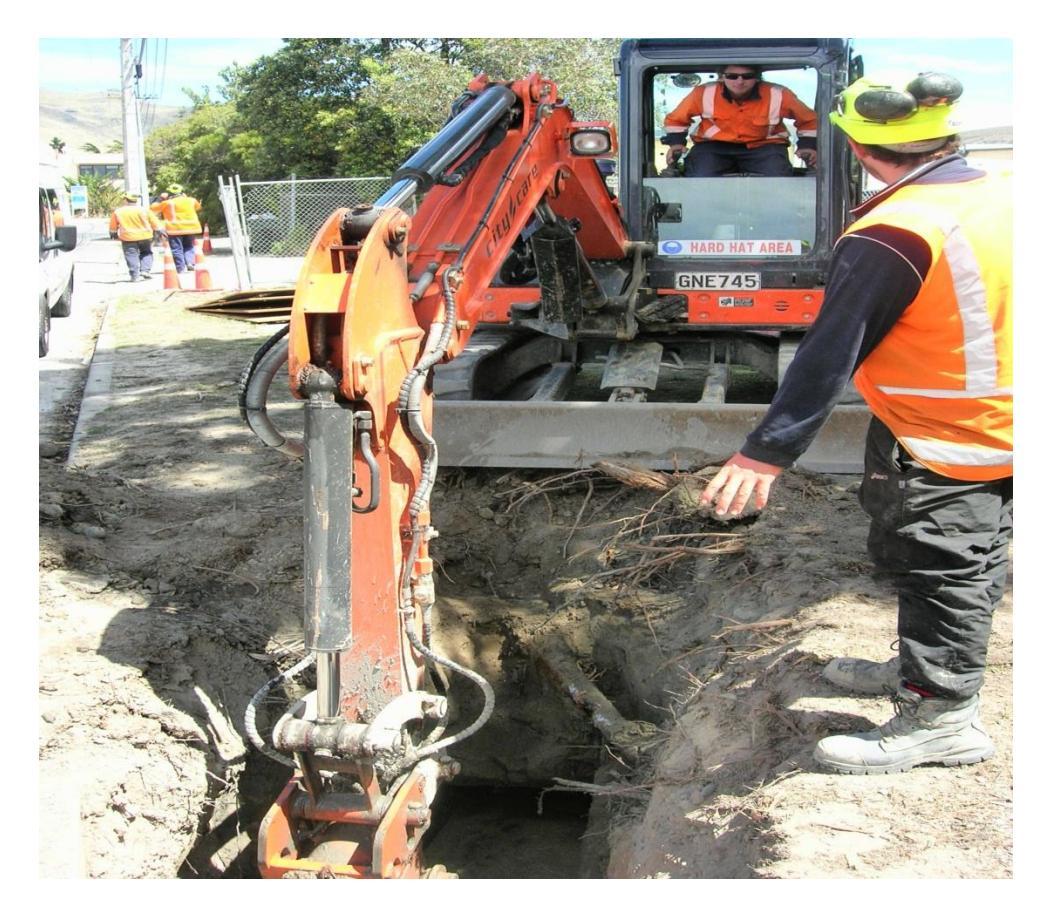
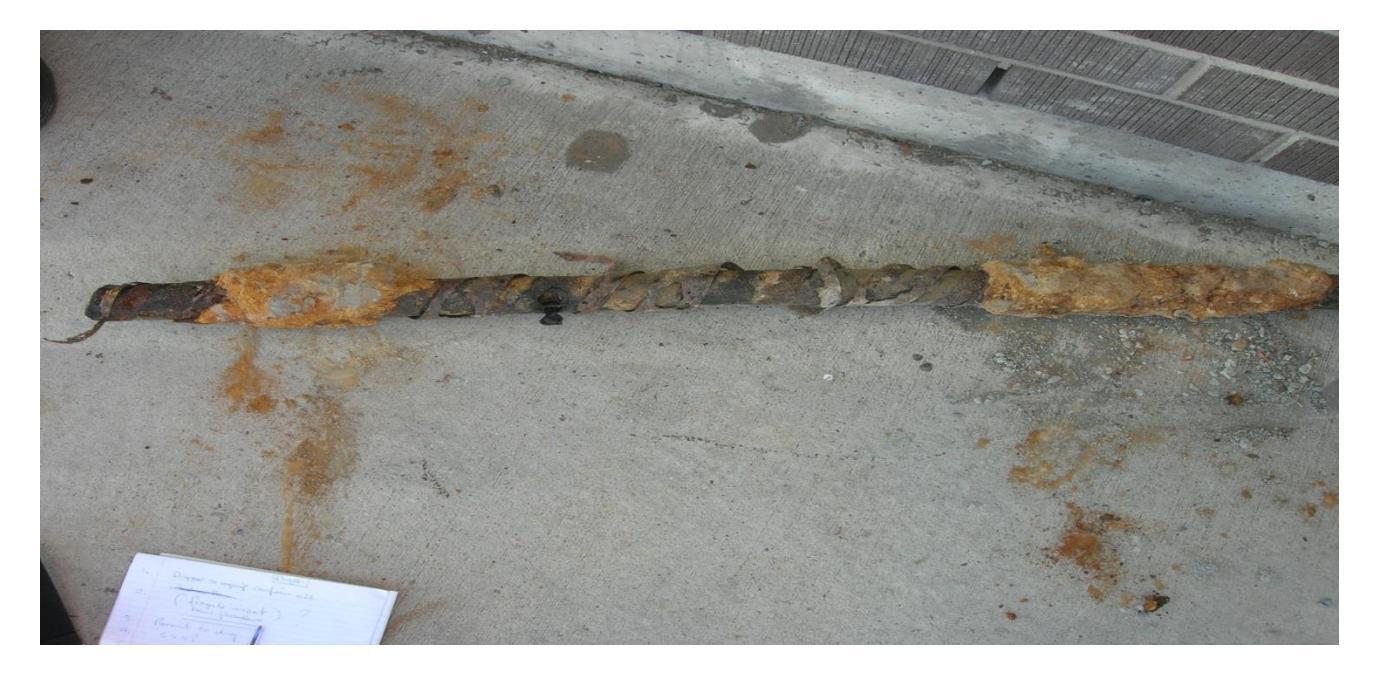
A Service strike causing power outage (flash/minor explosion/sparks/smoke) when breaking underneath an exposed and clearly marked 11kv underground cable. As the excavator worked beneath the exposed cable, the crew hand dug around the cable. Tree roots were in the direct vicinity and an Arborist was on hand.

- PILCA (paper insulated leaded cable armoured), generally 40-50 years old and in a fragile condition
- Hard ground condition and tree roots close to cable may have diverted crew's attention.

- May have done better by supporting any exposed length over 1.0m?
- Crew may not have been fully aware of the dangerous nature of 11kv cable-particularly in a fragile condition.
- No extra precautions taken.

Hydrovac is acceptable for pipes of this nature.

We are getting Orion to speak to crews and encouraging PM/SE to call in lines company representatives.

We are looking to introduce fragile infrastructure (pipes of this nature) into the risk assessment from design stage when age of pipes should be known.

We need to assess aged pipes of this nature carefully before digging and if we come across unexpectedly, stop work, talk with the crew and reassess!

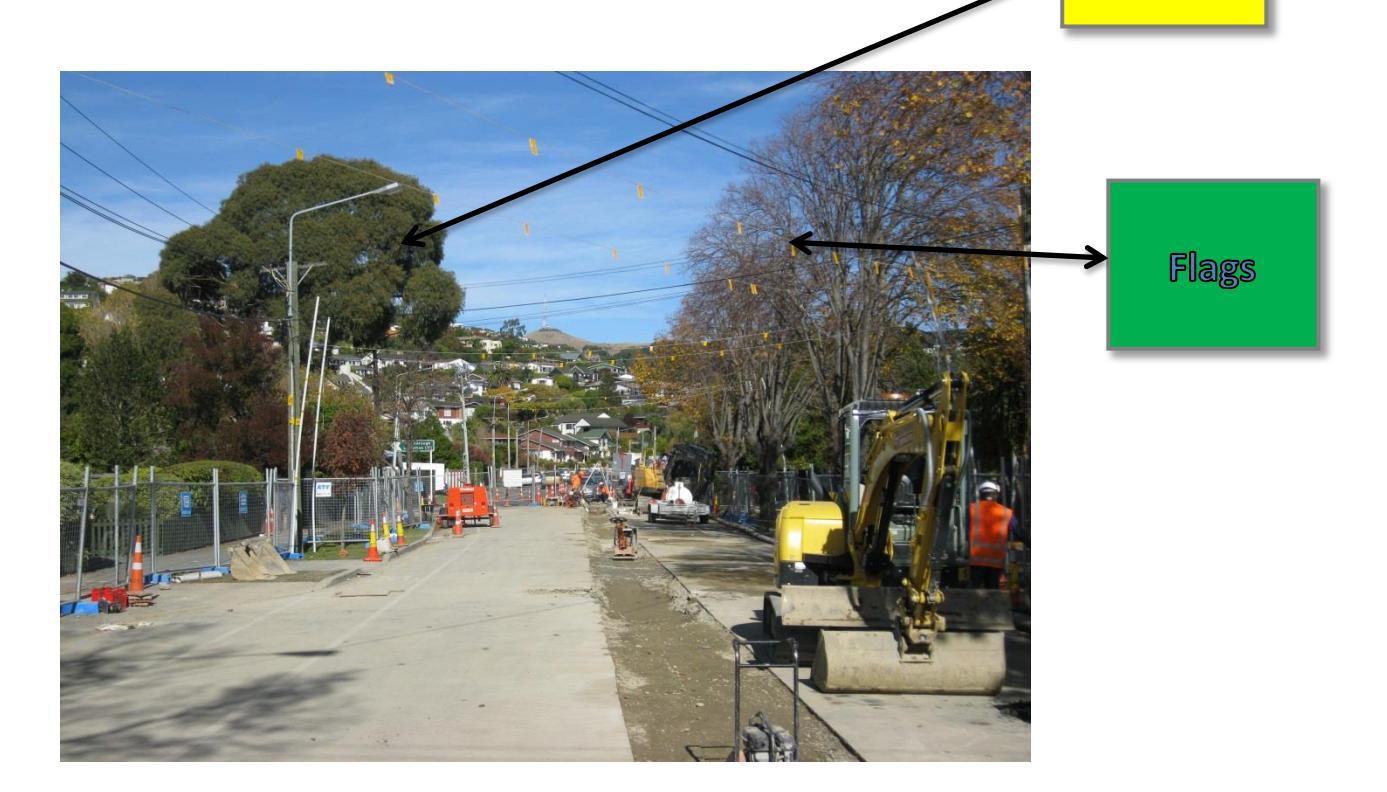
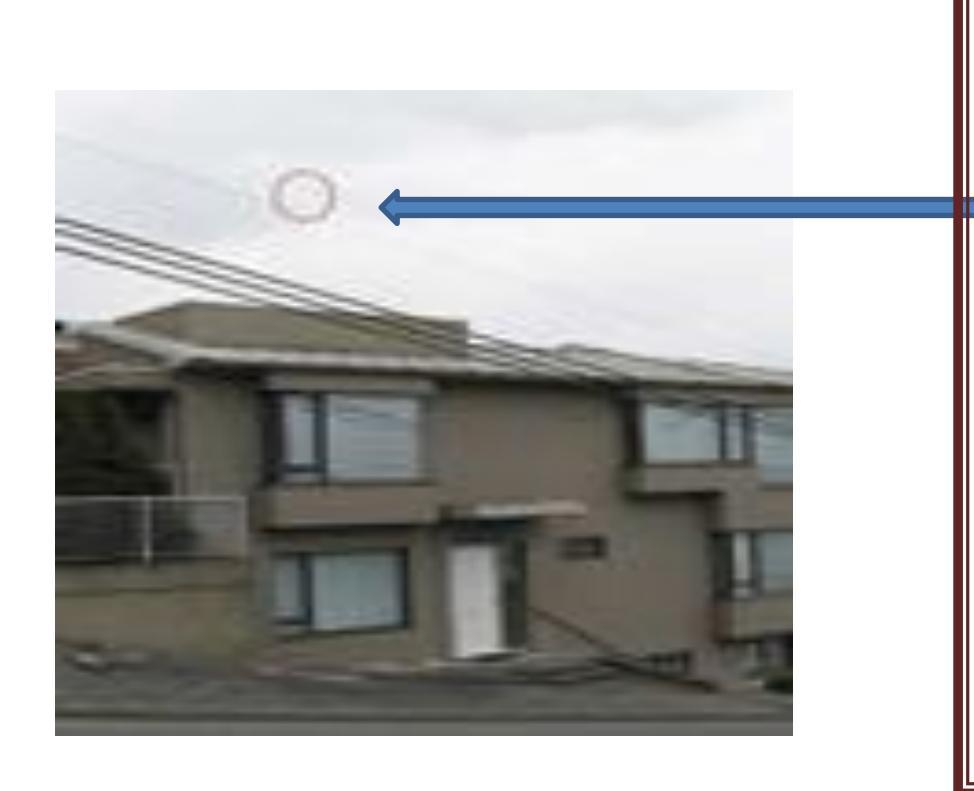
Shifting an excavator, spun around, thought he had enough room between boom and overhead cables. Spotter was 'busy' and operator thought he could do the shift with-out him. Clipped overhead 400v power line, twisted cables, broke one and shorted the power.

Poles

- SOP not followed regarding use of a spotter
- Human error-used own judgement!
- No warning flags (pole/lines)

Difficult to see overheads! Keep safe and always use your Spotter!

- 1. It is almost impossible for operators to accurately judge the exact distance from the end of their boom to an overhead line-especially when repositioning.
- 2. People have limitations in their ability to perceive distance and depth of objects under various conditions.
- 3. Overhead lines can be very difficult to identify.
- 4. You must have a spotter to tell you the limits of your approach distance.

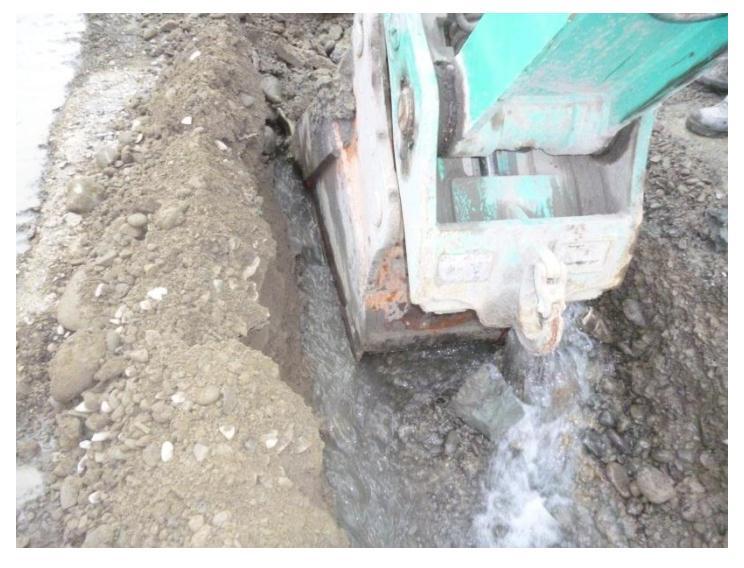
On the 8th of July an excavator came into contact with an underground water main causing it to break. The crew had discussed services crossing the trench line during the daily pre-start and had signed off on the service drawings. The road markings were swept

away in the morning and were not re-marked resulting in a loss of demarcation on the service. This event was very unfortunate for the crew involved as they had not had a service strike for over 2 years.

- Human error
- Failure to re-mark services in the ground.

<u>Hazard Identified:</u> Working in close proximity to underground services. This service strike proves the importance of demarcation of known services in the ground and maintaining the visibility of the markings at all times.

- Ensure service markings are maintained and re-marked at all times.
- A good idea have a "service marking paint only" box situated in the site office for when re-marking is required

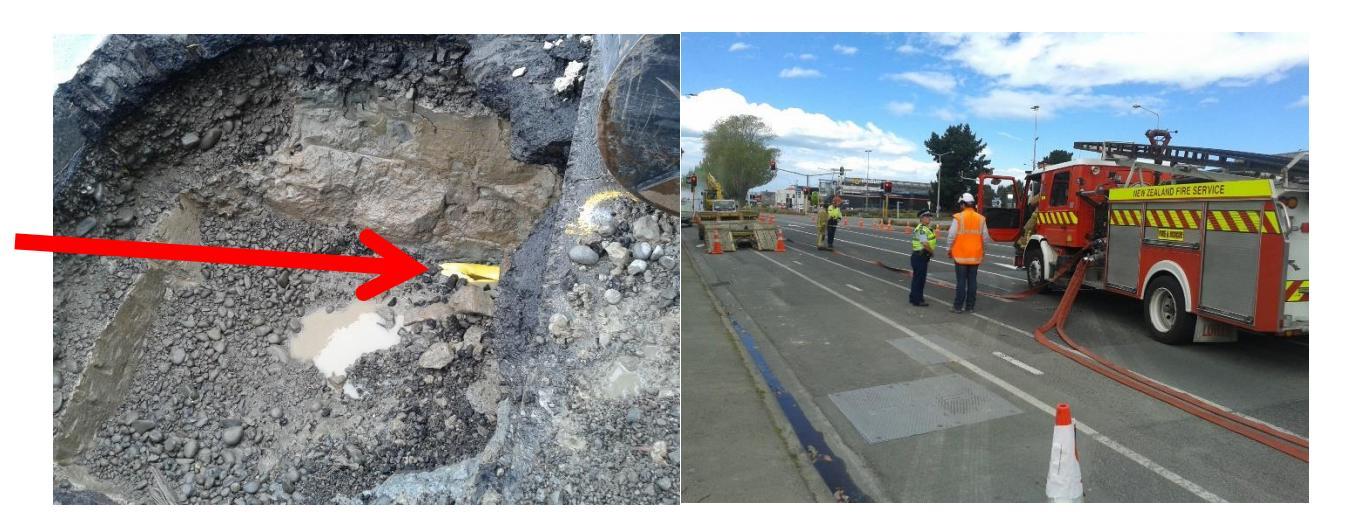
On October 29, 2014 a crew were excavating to install a SW man hole on the corner of Barbadoes St and Moorhouse Ave. The spotter heard a hissing sound and saw a yellow duct as the excavator bucket came into contact with a 150 mm PE gas main. The excavator was turned off and the crew evacuated site whilst calling the fire brigade. No one was injured but the incident prompted the evacuation of nearby CPIT and schools, and had a considerable impact on traffic as both avenues were shut until the site was secured.

- The design drawings did not confirm the position of the services accurate to a minimum of Level B

- The Contact Energy as built Service Plans were misinterpreted as they lacked a legend and inaccurately represented the PE gas main
- There was no debrief against the service plans between the GPR operative, the Site Engineer and Operator/ Foreman.
- The Operator had not signed on to Part B of the Excavation Permit, Excavation Permit Part A and Part B were incomplete;

- Ensure training for issuing, completing, signing on to Excavation Permit is rolled out to all personnel involved in the process.
- Ensure personnel are trained to reading service plans through SCIRT or equivalent module
- Streamline administrative process for sourcing service plans
- Communicate critical findings with SCIRT ECI and Design Leads
- Communicate with Contact Energy the critical findings, so they can be considered by Contact Energy for future issuing of Service Plans.
- Formally suggest use of tracer wire in PE drilled pipes

OUR ADVICE: If you have any doubt when reading a Service plan, contact the Asset owner. They will come out and mark it or provide a stand over!

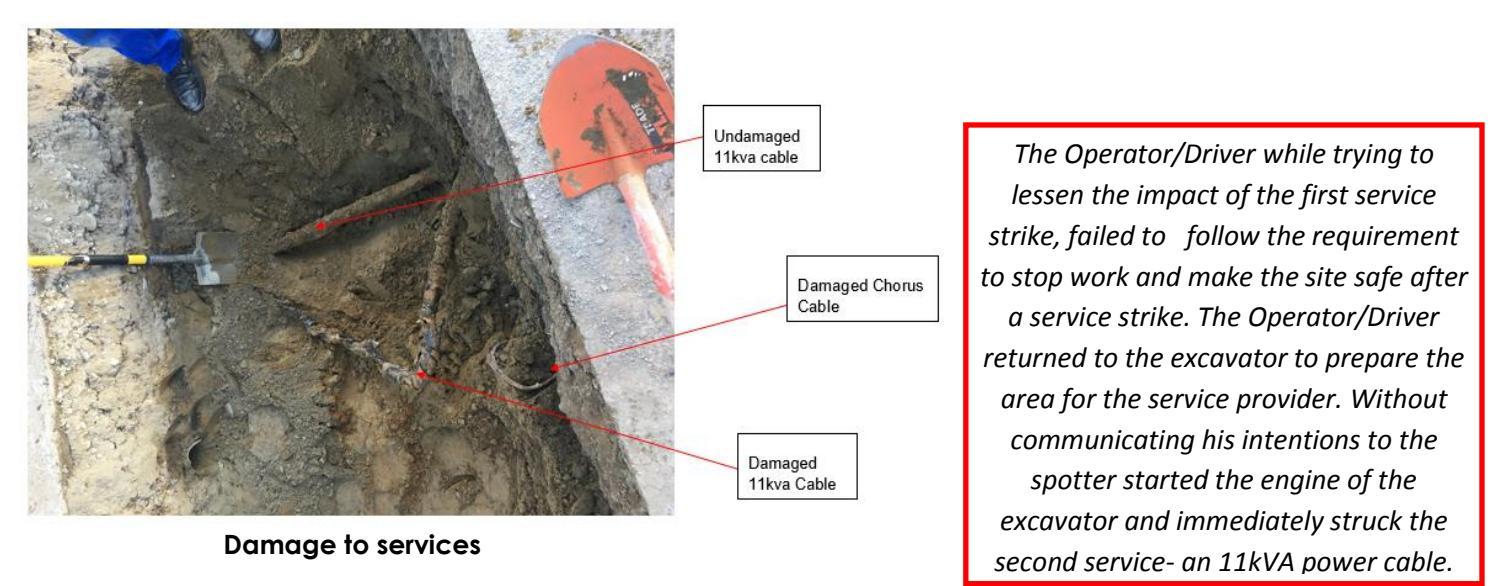
A sub-contractor working for the SCIRT Delivery team was laying a pressure main. The operator first struck a Chorus cable, and then whilst trying to make the work area more accessible for the service provider to fix, struck an 11kVA with the excavator bucket.

- The Service mark out was 4 months old, faded, and covered in soil.
- The Hydro excavation was completed and back filled in Jan/Feb 2016 for a previous drilling methodology. This was not done with the current crew, so the crew was not able to visually identify the services prior to excavating the trench line.

- The crew were supplied an inaccurate As-Build service document prepared from the information gained in the service location. The 11kva and Chorus cables were shown in this document in different locations to their actual locations.

- The crew used this As-Build document as a guide, rather than using the service provider plans, which would have shown the correct location on the services and was in line with the dig procedure.

- There was inconsistent leadership on site from both the delivery team and the subcontractor. Site Engineer and Foreman were away from site for a number of days, and the Section Engineer did not take over management of the site. The crew was young and inexperienced.

- The Delivery team will revise the current pre-start form to act more as a daily permit to work. This will engage the site staff more in the excavation permit and require the constant management of risk, such as underground services.

- A formal Site Handover process will be developed for when Site Engineers are absent from site. This will ensure that the communication and risk management on site will be consistent from as the lead contractor.

- Coaching and training will be made available to Contractor Foremen or Leading Hands across the SCIRT Delivery Teams, to help develop their site leadership and management skills.

- The Project Engineers will now be involved in the sections of successful contractors to tenders. This will help to ensure that the contracting crew that is selected are able to meet their safety and quality requirements. This will be complimented with the current Health and Safety pre-qualification system.

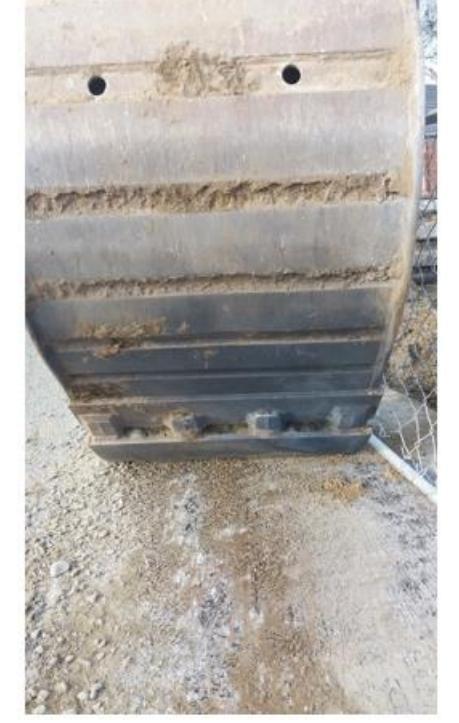
Flash Marks from the strike on the excavator bucket
