Lessons learned from one of New Zealand's most challenging civil engineering projects: rebuilding the earthquake damaged pipes, roads, bridges and retaining walls in the city of Christchurch 2011 - 2016.

Lest we forget – SCIRT restores Memorial Arch

Story: Bridge of Remembrance and Memorial Arch

A document which describes the process that SCIRT took to restore the Bridge of Remembrance and Memorial Arch.

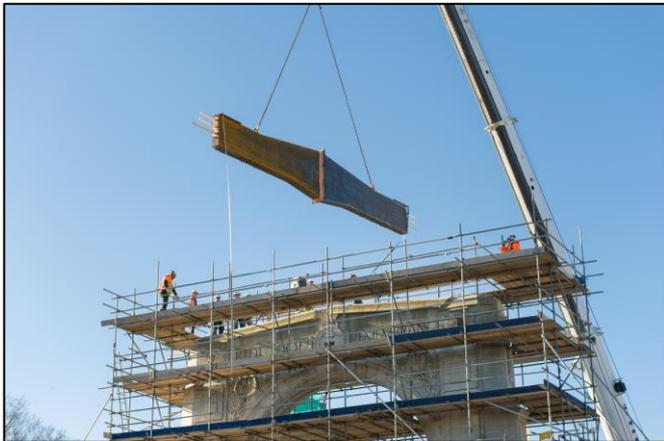
An 8.2-tonne beam with a central sliding plate is hoisted into place on the Memorial Arch.

Repairs to the 360-tonne, 14-metre high and 20-metre wide Memorial Arch – an imposing structure of sharp

lines and ornate decoration – included the insertion of steel inside the masonry columns to strengthen the structure and concrete that increased the weight of the arch to 470 tonnes.

The addition of a "rocking collar" at the base would help the reinforced arch withstand a one in 2500 year earthquake. Significant modifications to the articulation of the structure allowed the rocking action to occur in any direction.

The octagonal rocking collar was laced with reinforcing bars that connected each end of the arch to the micro-piles. The rocking collars allowed the arch to rock backwards and forwards in response to ground movement. Sliding joints were installed in the top of the three arches to allow the arch to move from side to side. Combined, these features would allow the structure to move in a controlled manner if there was an earthquake and reduce the likelihood of damage.

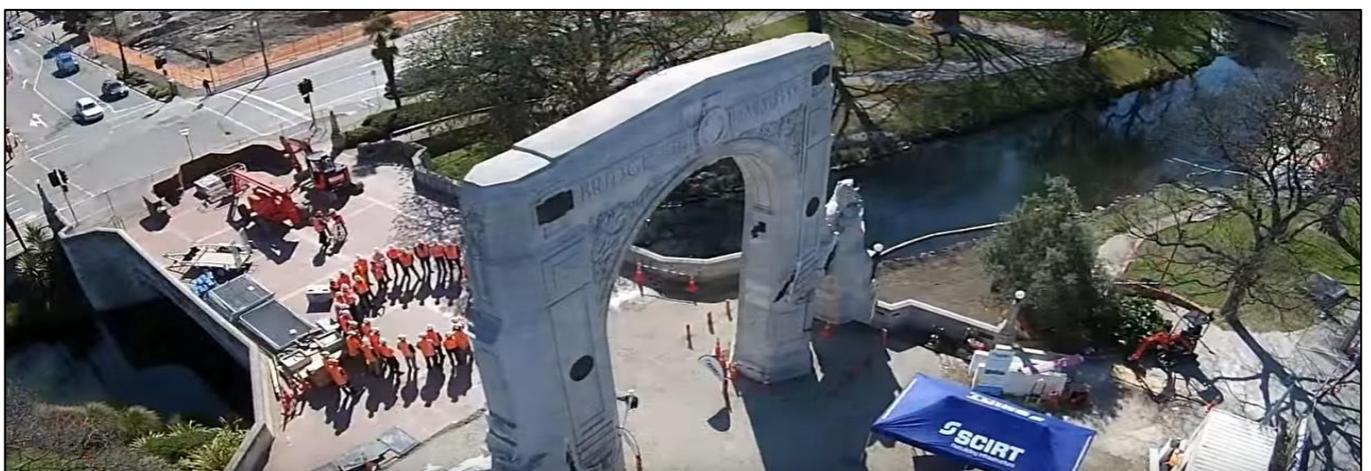
The restored Memorial Arch on the Bridge of Remembrance in Christchurch.
