Lessons learned from one of New Zealand's most challenging civil engineering projects: rebuilding the earthquake damaged pipes, roads, bridges and retaining walls in the city of Christchurch 2011 - 2016.

Asset Assessment using GIS and InfoNet

A technical paper prepared for the Water NZ conference and expo 2012, which details how GIS and InfoNet were used to complement SCIRT's asset assessment process.

ASSET ASSESSMENT USING GIS AND INFONET

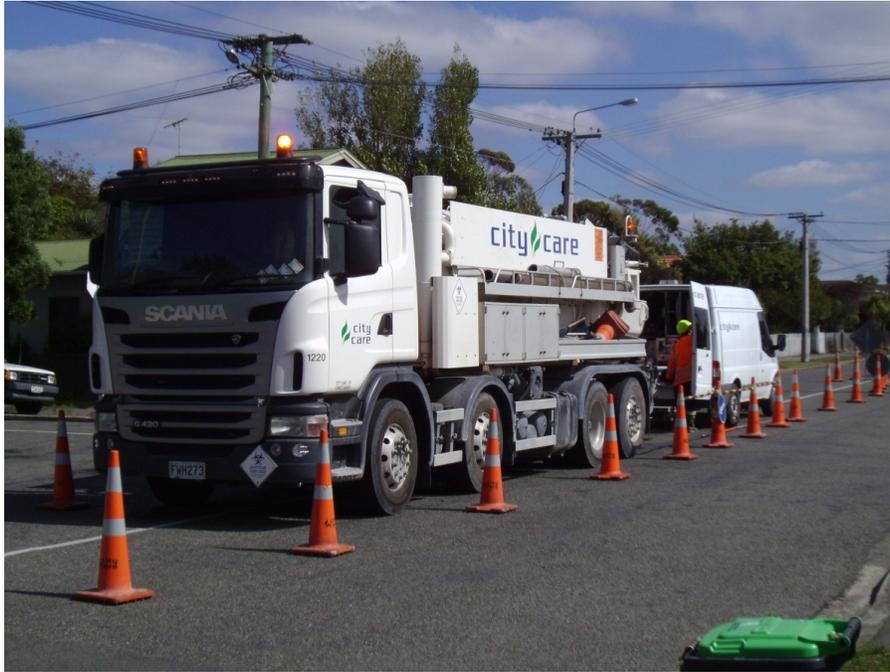
Figure 1: Typical CCTV Operation with combined jetter/sucker truck and CCTV Van

There are currently 20 combined camera, jetting, and suction crews operating across the SW and WW networks. City Care Ltd is managing this operation on behalf of SCIRT and have modified their own in-house, web-based job management system to allow for an online, real-time coding of defects to the NZPIM. The CCTV operation involves around 150 full time equivalent staff and equates to around half of the New Zealand's current CCTV field resource. The combined team is currently achieving around 50km/month of physical survey. Due to the large amount of cleaning involved this is costing around \$55/m to collect and code to the NZPIM.

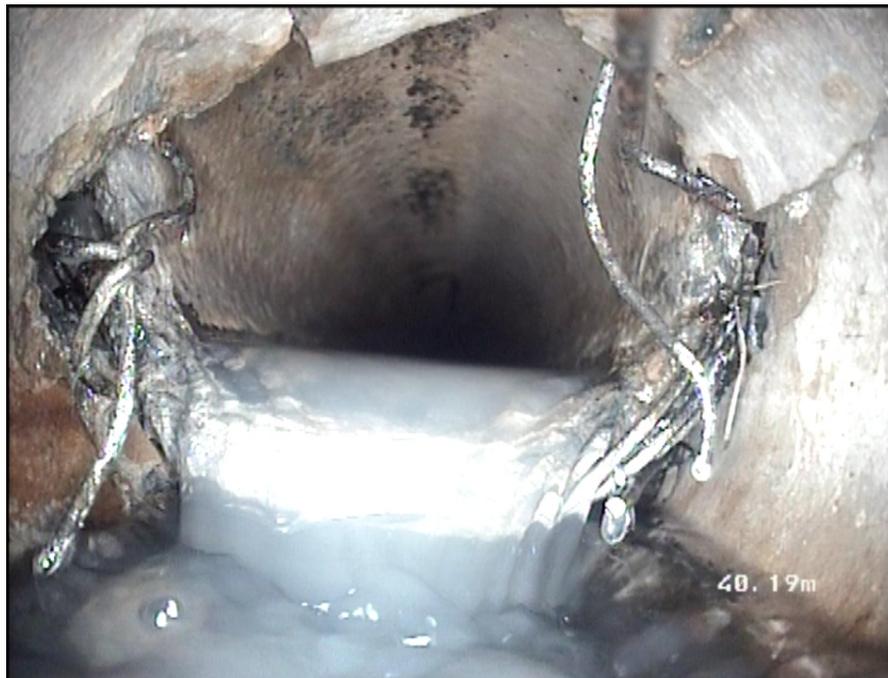
Figure 2: Joint defect and displacement in RC pipe, resulting in exposure of reinforcing steel

Initial quality audits completed by SCIRT found significant variation in the quality of CCTV field work and defect coding across the CCTV teams. An extensive training programme was implemented to up-skill all CCTV teams in undertaking surveys and coding defects to the NZPIM. This has led to a significant lift in the quality of CCTV work, resulting in a reduction in the number of non-conformances. Some typical pipe defects encountered through CCTV are shown in Figures 2 and 3 below.

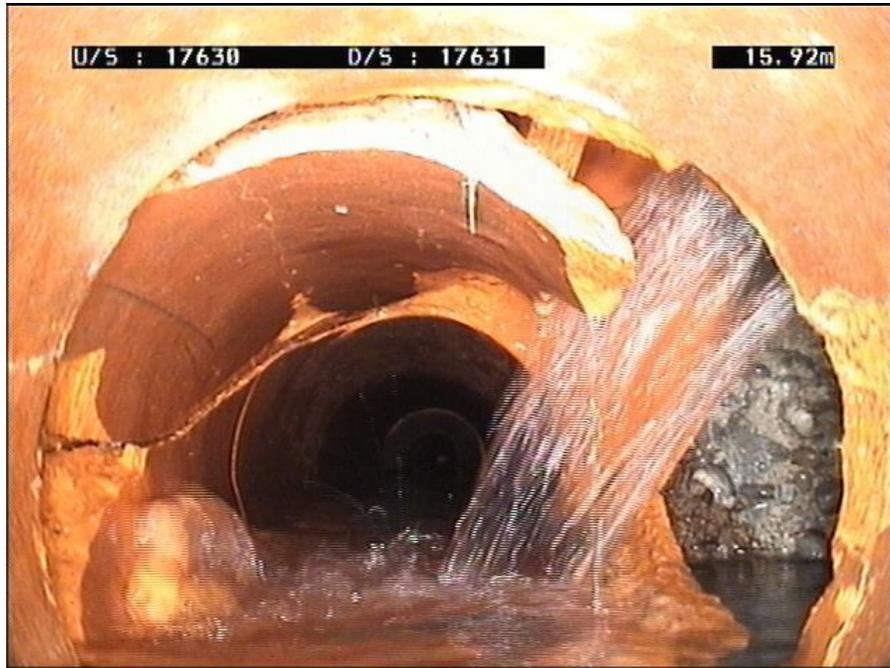
Figure 3: Breaks in EW pipe resulting in Tomo

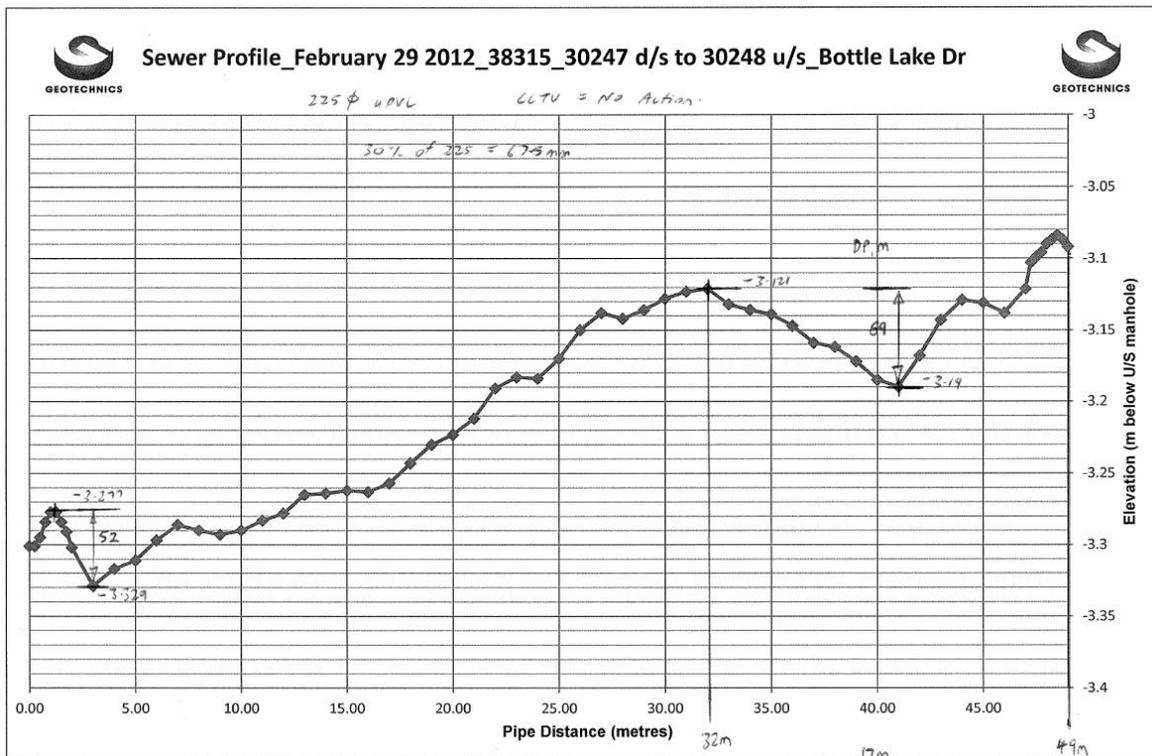
Figure 4: Pipe Profile between MHs recorded using Profilometer

Profilometers are used to determine the long section profile of gravity pipe invert between manholes. It makes use of profilometer technology developed for geotechnical settlement monitoring. Following cleaning of the pipe, a level sond is pulled through the pipe and relative levels recorded at 1m intervals (0.25m intervals near MH connections).

The determination of the pipe profile allows for a quantitative assessment of dips, which is not possible with CCTV. Although CCTV can identify dips, there is inconsistency in the coding due to the CCTV often being undertaken directly behind the jetter head, which displaces water from the pipe, making dip identification more difficult.

The IRTS&G requires dips greater than 30% of the pipe diameter to be repaired. Investigations have found that in high liquefaction areas with relatively new PVC pipe (eg Parklands and Brookhaven), pipe dips have resulted in a higher number of pipe repairs and renewals than caused by structural defects alone. An example of a typical pipe profile plot is provided in Figure 4.

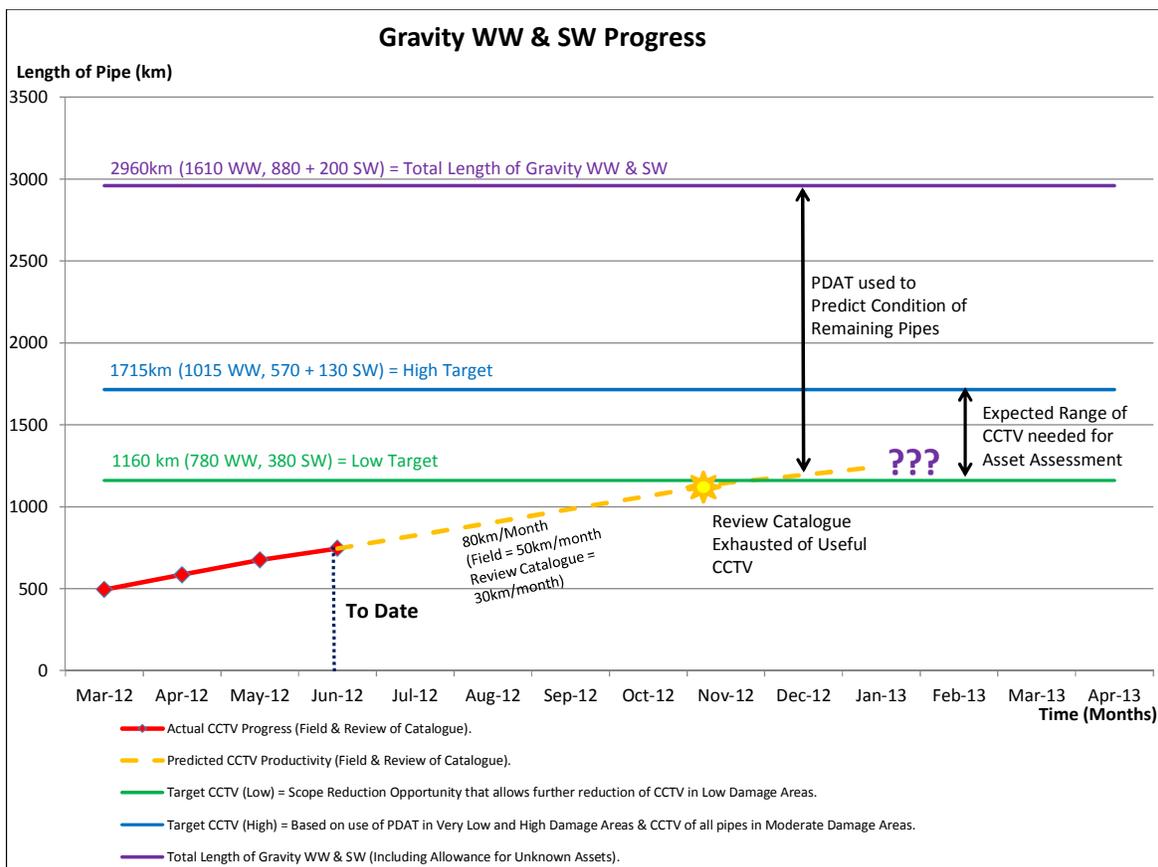
Figure 5: Gravity SW and WW CCTV for Condition Assessment and Application of the PDAT

The PDAT is an integral part of the pipe assessment strategy. Figure 5 shows how the PDAT is being used to predict the condition of pipes at various stages of the rebuild. At present SCIRT is collecting a sample of CCTV in low damage areas (where no damage investigations have been completed) to allow the PDAT to be used to estimate the total amount of damage across the city. Where an understanding of damage is available, the PDAT is used for targeting where further CCTV is required to inform detailed design.

The accuracy of the PDAT varies across the city. Where damage trends are strong, the tool is predicting the presence or absence of damage in individual pipes with more than 90% accuracy. In areas where damage appears to more random (eg RCRR pipe in badly damaged areas) the prediction accuracy reduces, requiring a greater level of CCTV to inform the rebuild. The High Target line on Figure 5 follows this approach.

There is an opportunity to further reduce the amount of CCTV required by not chasing down the location of defects in low damage areas. In these areas the return on investigation investment can be very low as the investigation costs can be similar to the value of the repairs made. The prerequisites for following this approach are that the area in question is not generating unsustainable levels of infiltration or incurring high maintenance costs. Where this is true, adopting this strategy effectively results in a deferral of repairs to the defects that are present. This has some funding issues that are still being reviewed with CCC. The Low Target line on Figure 5 follows this approach.

It is expected that the final amount of CCTV required for condition assessment will fall somewhere between the High and Low targets.

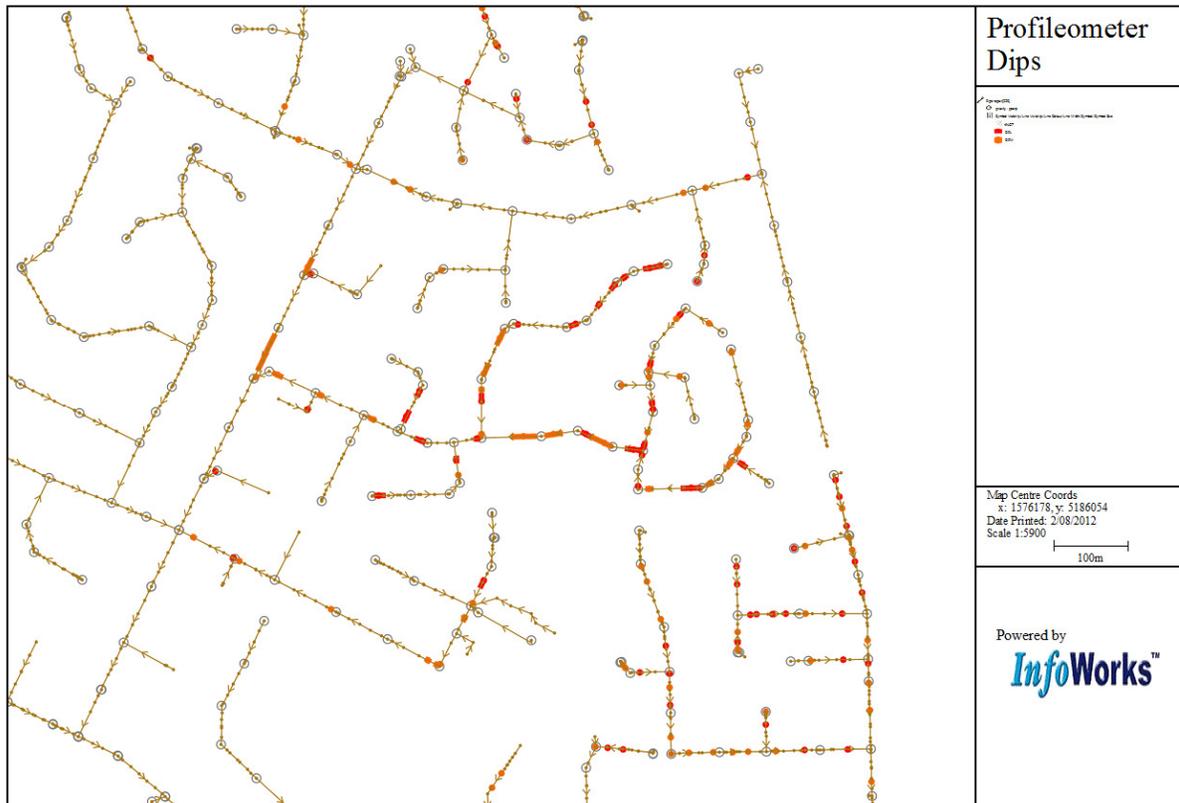
For Figure 6 (InfoNet plot of dips in WW network based on Profilometer Survey), red dots are large (>50%) dips and orange dots are medium (25 to 50%) dips.

Figure 6: InfoNet plot of dips in WW network based on Profilometer Survey

Figures 6 and 7 provide examples of different queries written to assist designers in pulling useful information out of InfoNet.

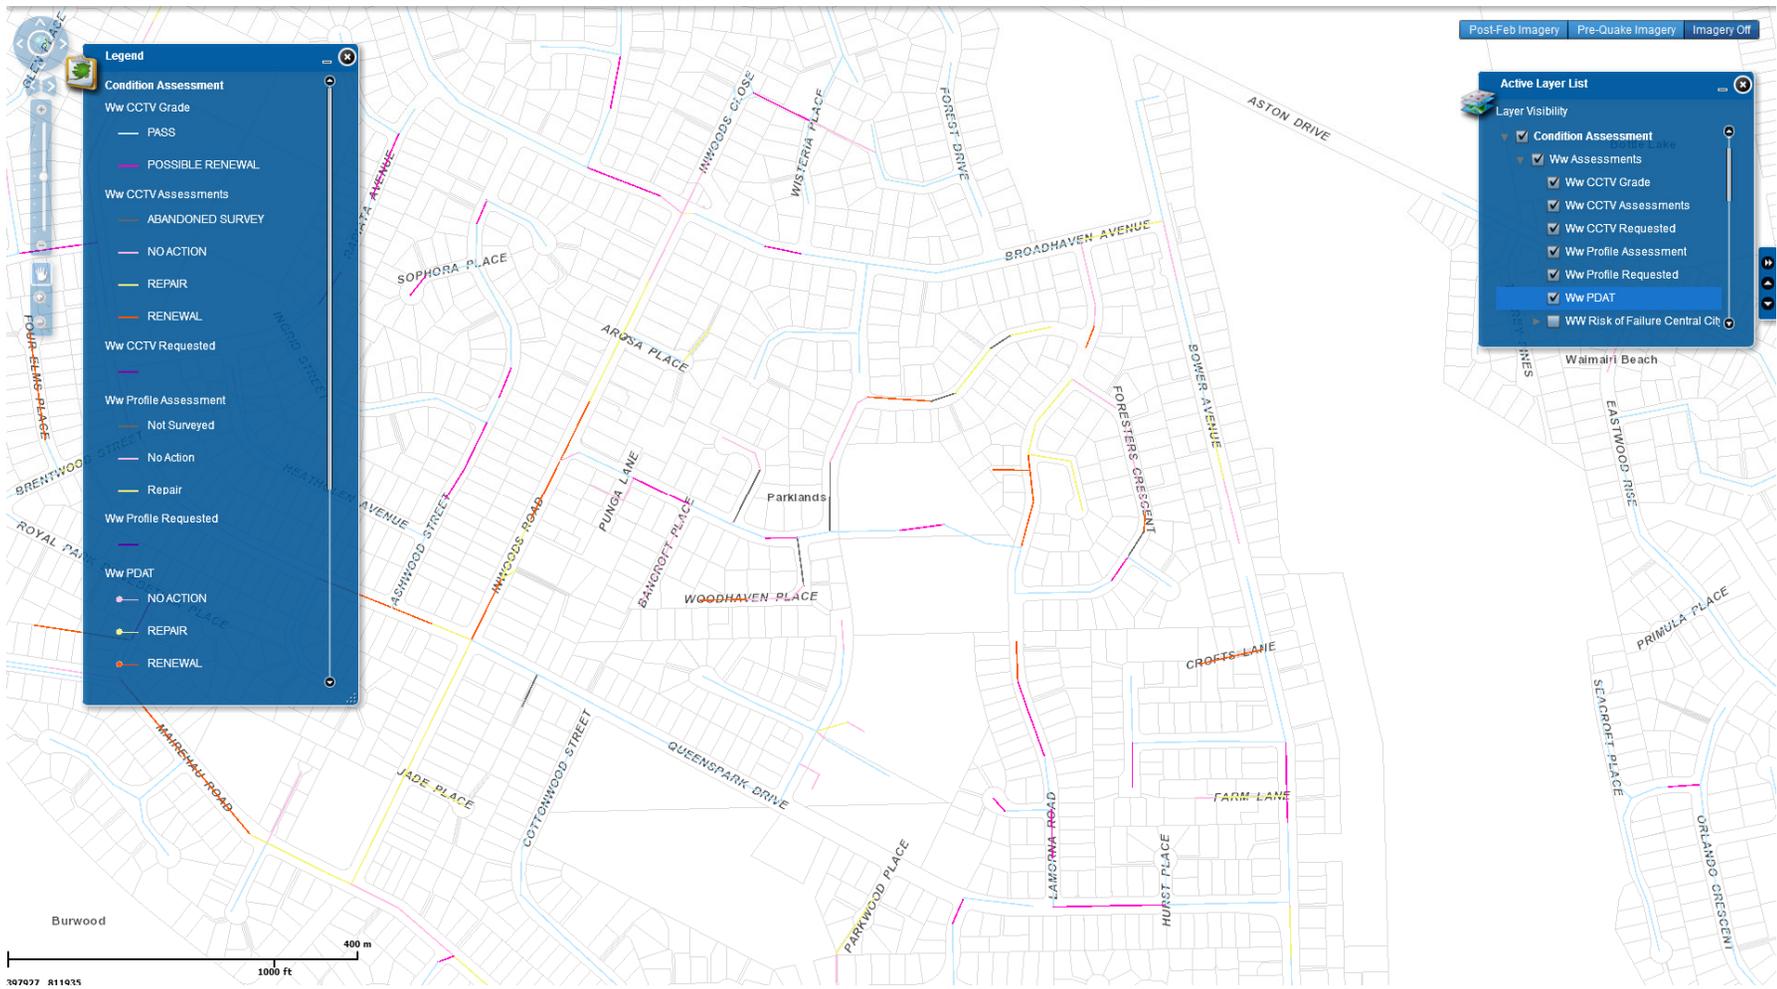
Figure 8: SCIRT GIS plot of pipe condition assessments for the WW network

For Figure 7 (InfoNet plot of assessments in WW network based on CCTV, PDAT and MH Level Survey), purple lines are Renewals based on pipe condition or grade (MH level, CCTV or PDAT derived), orange lines are Repairs based on pipe condition (Pipe Profile, CCTV or PDAT), green lines are No Action based on pipe condition (Pipe Profile, CCTV or PDAT derived).
