Lessons learned from one of New Zealand's most challenging civil engineering projects: rebuilding the earthquake damaged pipes, roads, bridges and retaining walls in the city of Christchurch 2011 - 2016.

Armagh Street bridge – heritage diary

A document which details Downer's approach to heritage management when repairing the Armagh Street bridge.

Armagh Street Bridge Heritage Diary

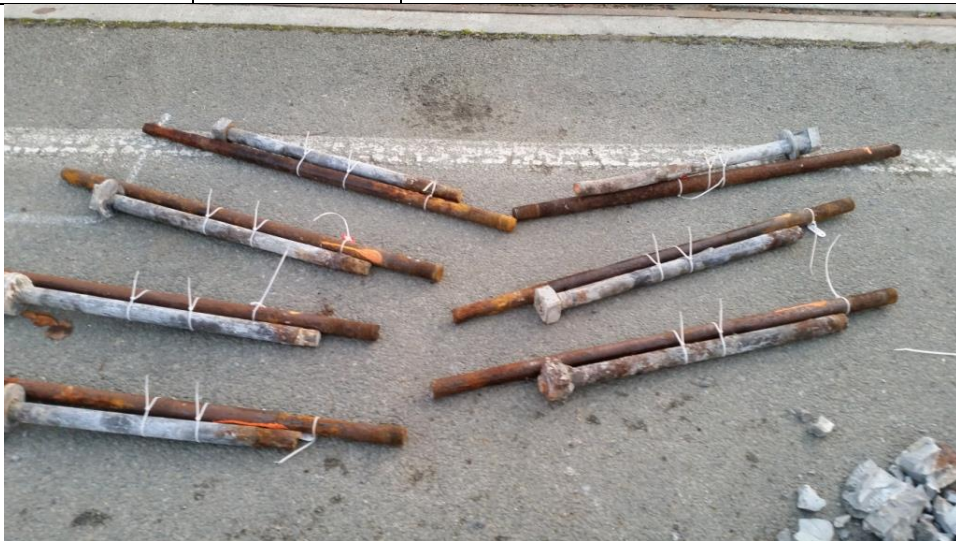
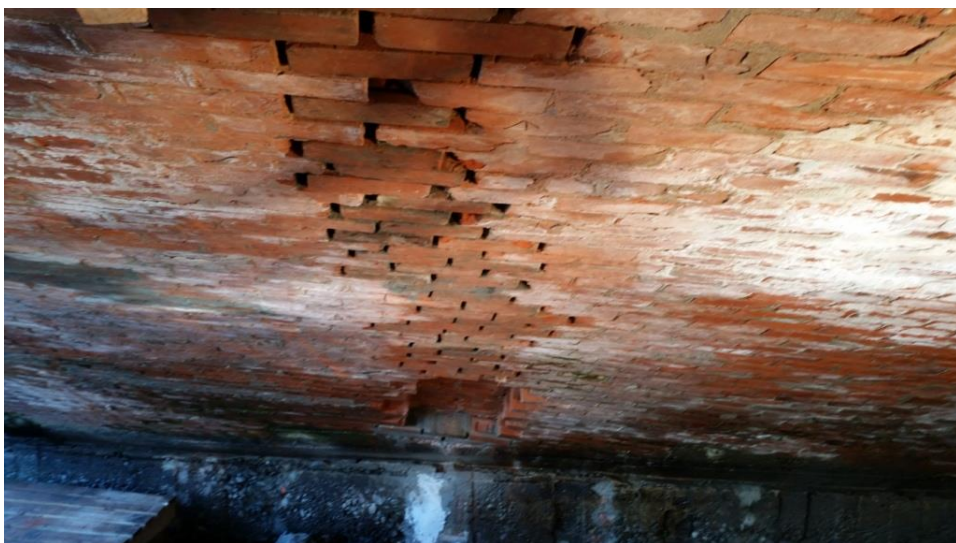
<p>Number of bricks installed so far:</p> <p>11/6 – 8</p> <p>12/6 – 10</p> <p>13/6 – 10</p> <p>16/6 – 16</p> <p>17/6 – 18</p> <p>18/6 – 24</p> <p>19/6 – 19</p> <p>20/6 – 6</p> <p>23/6 – 20</p> <p>Pic below of progress</p>
--	--	-------------------------------------------------------------------------------------------------------------------------------------------------------------------------------------------------------------------------------

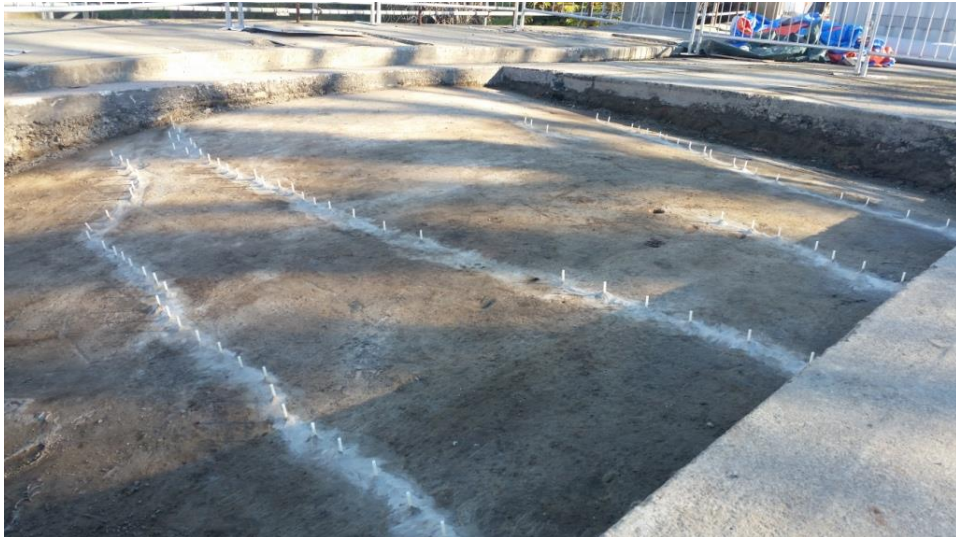
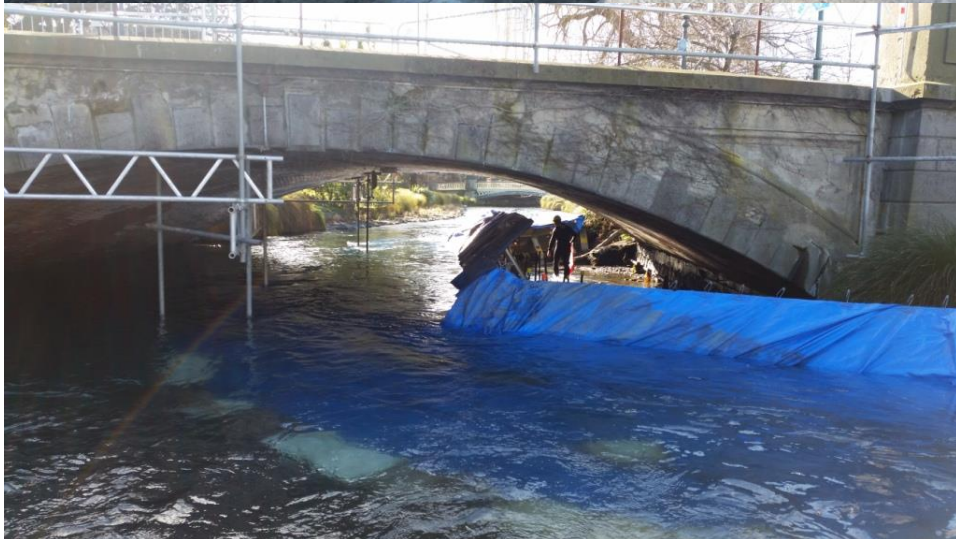
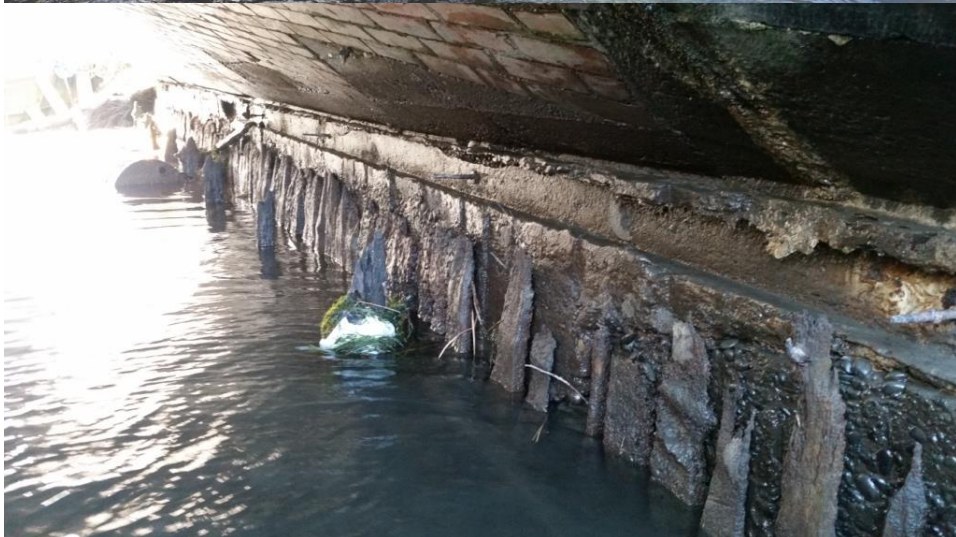
8 th August 2014	Tom	<p>Dam has been shifted to opposite abutment.</p> <p>Goldfield Stone have removed damaged bricks on crack.</p> <p>Grout injected crack today.</p> <p>Cracks on surface of bridge have been injected.</p> <p>No concerns or incidents to report. A few pics below showing progress.</p>
